Asbestos Report

Management Survey

**Site: Belle Vue North West entrance
Lowestoft
Suffolk**

Project Number: P-00116

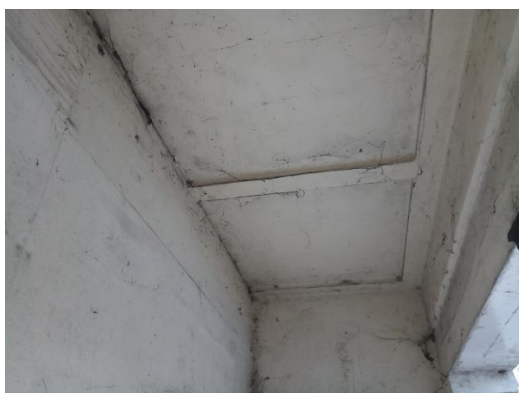
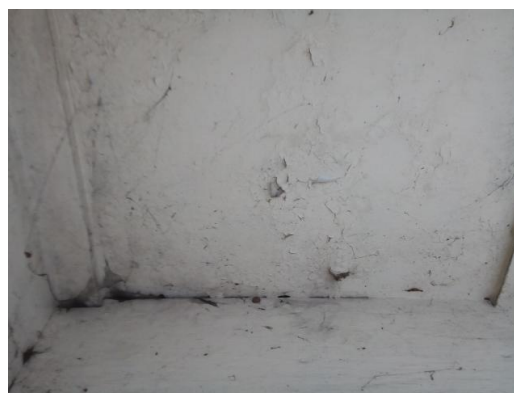
Floor:	External	Sample Ref:	X001-CMP
		Lab Ref:	
Location:	001 - External	Identification:	Cross Reference
Reported:	08/03/2019	Asbestos Type:	Chrysotile
Updated:		Condition:	Low Damage
Quantity:	3 m ²	Product:	Cement Product
Item	Canopy ceiling		
Sample Notes	Cement panels to canopy ceiling.		
Access:	Exposed, but above head height

Material Assessment (MA) Score		MA Score	Risk Rating
Product Type:	1	3	VERY LOW
Extent of Damage:	1		
Surface Treatment:	0		
Asbestos Type:	1

Recommendation:	Manage In-Situ
Recommendation Comments:	The cement ceiling panels can be managed in-situ via periodic re-inspection, however any maintenance must be undertaken by suitably training persons, in accordance with HSE Essentials.

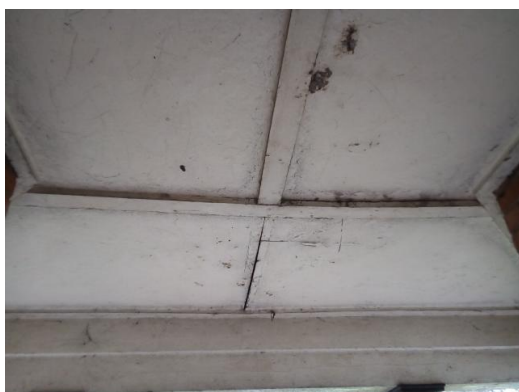
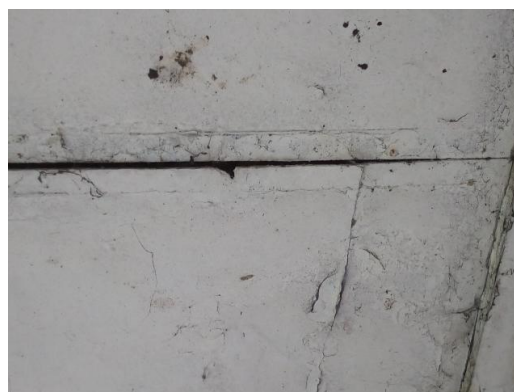
Floor:	External	Sample Ref:	S001-CMP
		Lab Ref:	SCO/19/4961
Location:	001 - External	Identification:	Sampled
Reported:	08/03/2019	Asbestos Type:	Chrysotile
Updated:		Condition:	Low Damage
Quantity:	8 m ²	Product:	Cement Product
Item	Canopy ceiling		
Sample Notes	Cement panels to canopy ceiling.		
Access:	Exposed, but above head height

Material Assessment (MA) Score		MA Score	Risk Rating
Product Type:	1	3	VERY LOW
Extent of Damage:	1		
Surface Treatment:	0		
Asbestos Type:	1

Recommendation:	Manage In-Situ
Recommendation Comments:	The cement ceiling panels can be managed in-situ via periodic re-inspection, however any maintenance must be undertaken by suitably training persons, in accordance with HSE Essentials.

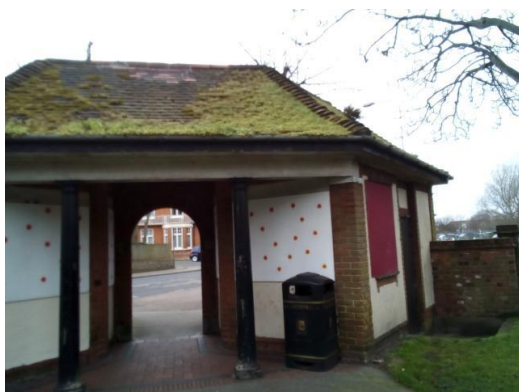
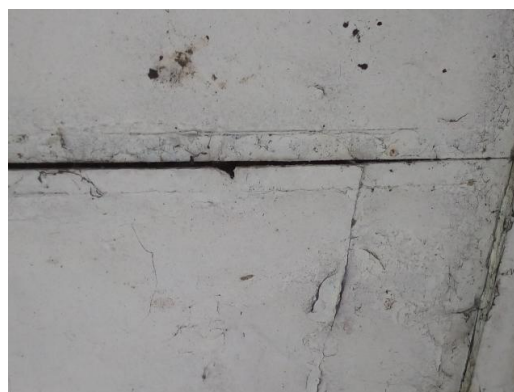
Floor:	External	Sample Ref:	S002-CMP
		Lab Ref:	SCO/19/4961
Location:	001 - External	Identification:	Sampled
Reported:	08/03/2019	Asbestos Type:	Chrysotile
Updated:		Condition:	Low Damage
Quantity:	8 m ²	Product:	Cement Product
Item	Canopy ceiling		
Sample Notes	Cement panels to canopy ceiling.		
Access:	Exposed, but above head height

Material Assessment (MA) Score		MA Score	Risk Rating
Product Type:	1	3	VERY LOW
Extent of Damage:	1		
Surface Treatment:	0		
Asbestos Type:	1

Recommendation:	Manage In-Situ
Recommendation Comments:	The cement ceiling panels can be managed in-situ via periodic re-inspection, however any maintenance must be undertaken by suitably training persons, in accordance with HSE Essentials.
