LOWESTOFT TOWN HALL

ROTHOUND INVESTIGATION OF DRY ROT INFECTION AND DECAY

JOB NO. 158-97

LOWESTOFT TOWN COUNCIL

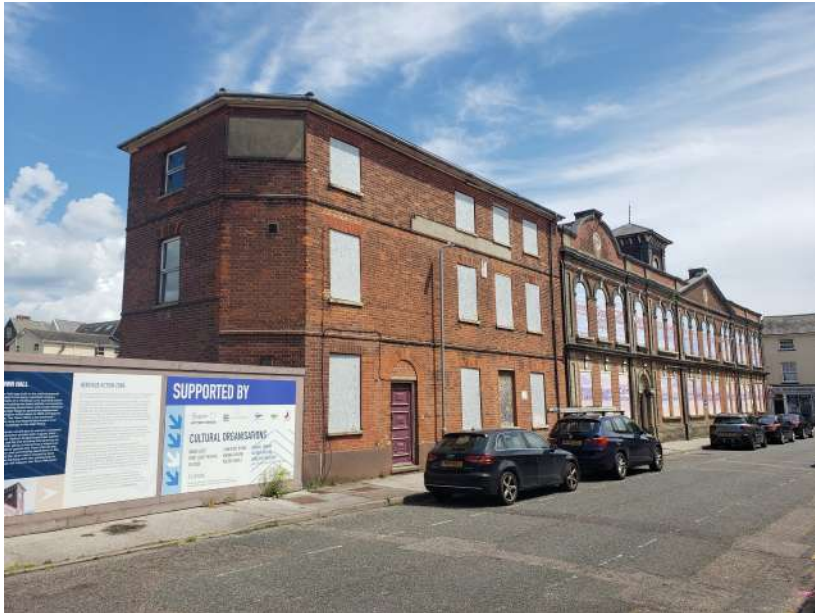
Fig 1:

External, south elevation; photo showing a general view of the condition and structural arrangement of the south elevation. Note the presence of boarding over windows indicated that the property had not been inhabited for a significant period which would have likely led to the degradation of building materials over this time, in the absence of a regular maintenance schedule

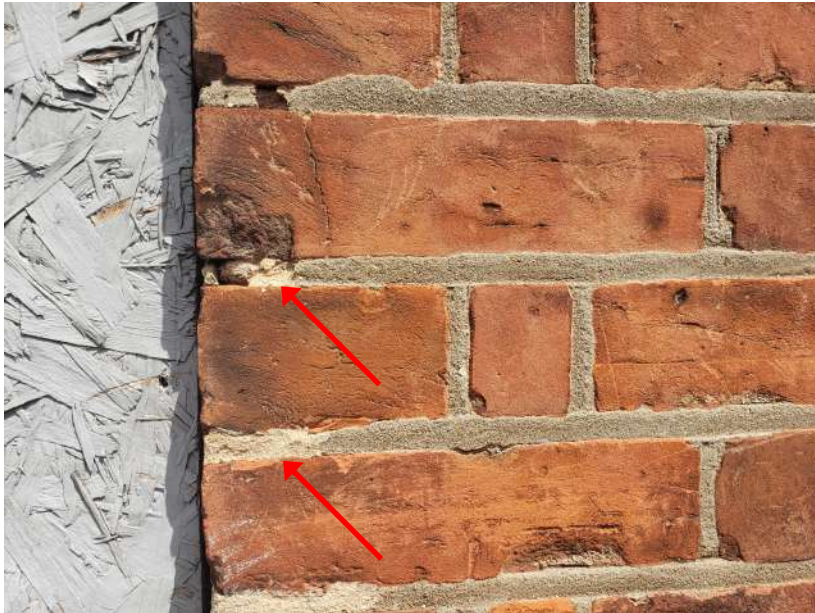
Fig 5:

External,
south elevation; showing a focused view of the condition of brickwork and mortar beds. Note that's lightly cementitious mortar had been used to re-point brickwork across the entire elevation, localised failure revealed the original lime mortar beneath that was softer and more permeable. The widespread use of cementitious mortar likely contributed to the spalling of brickwork due to the impermeable characteristics of cementitious mortar causing moisture to be forced inward and preventing it from evaporating at an adequate rate, leading to continual freeze/thaw action during low temperatures leading to damage to brickwork

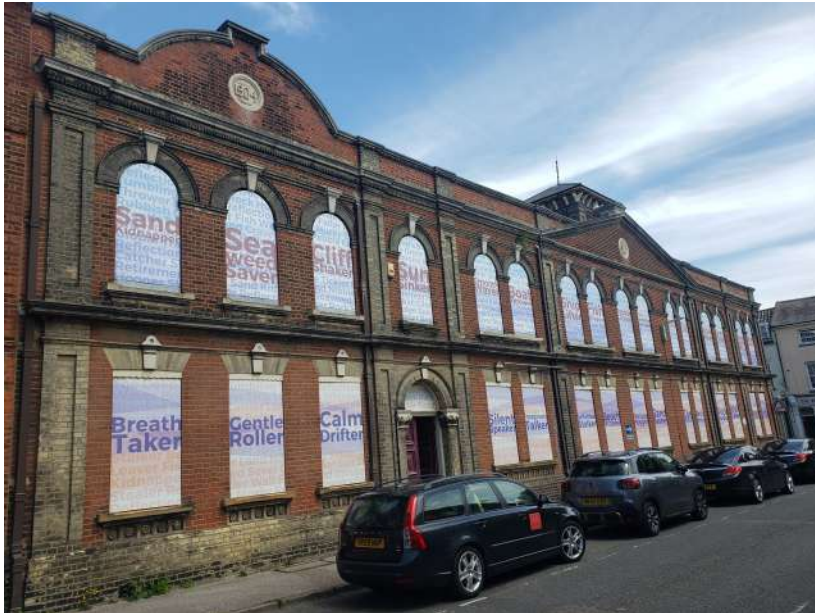
Fig 7:

External,
south elevation; showing a general view of the central section and east end of the elevation. Note that similar conditions seen over the west end were also observed at this location. Further note the presence of plant growth beneath the upper moulded course, this suggested that significant moisture ingress had occurred in close proximity to this location. In addition to the detrimental effects of excess moisture within a structure, continual plant growth could independently lead to the damage of building materials as roots and root balls increased in diameter, this would lead to the separation of crucial elements such as brickwork

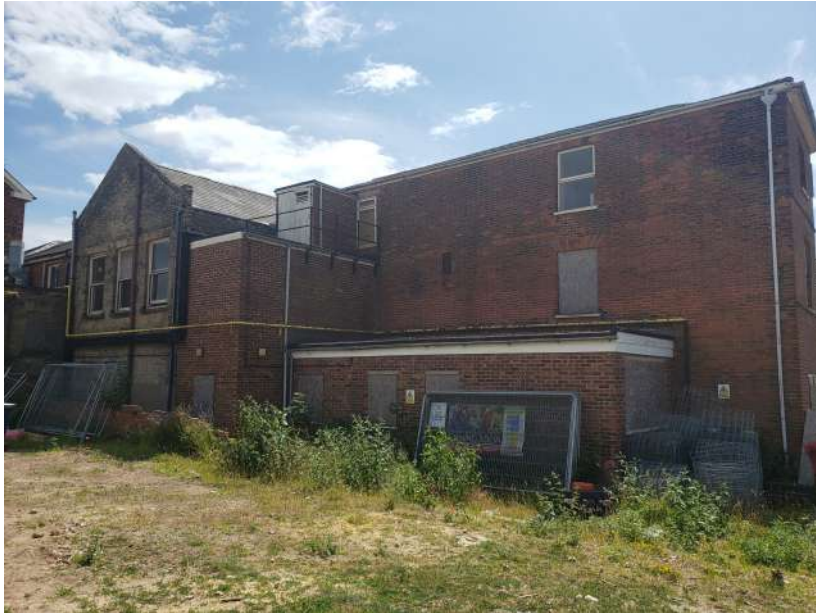
Fig 15:

External, north elevation; showing a general view of the west section of the north elevation, from within the enclosed yard. Note that certain building structures at this location had been confirmed for demolition therefore these were not included in the survey

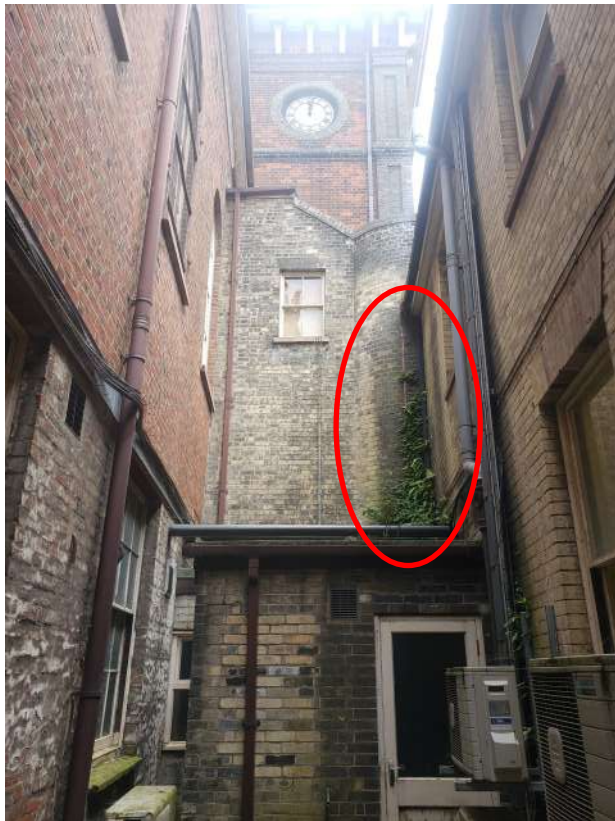
Fig 23:

External, central lightwell/courtyard; showing a general view of the internal west elevation. Note that plant growth was identified as well as minor spalling of brickwork

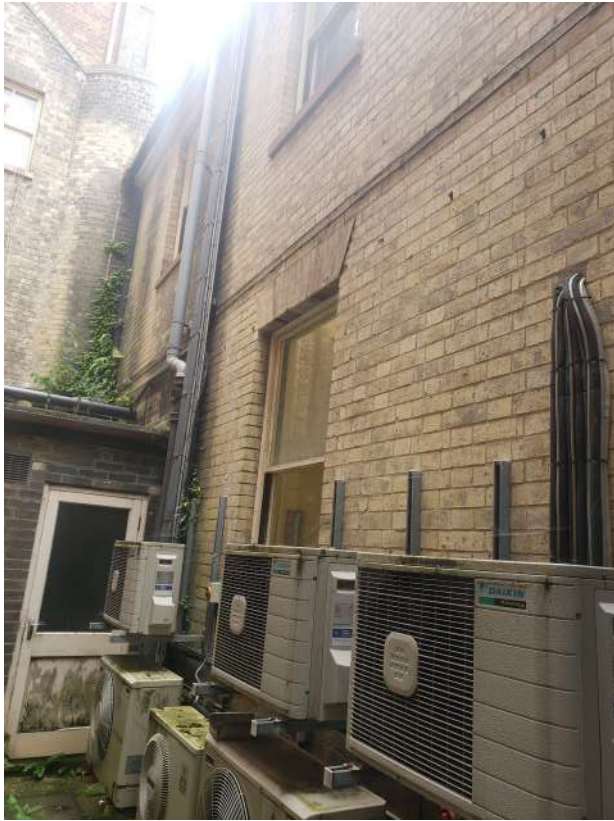
Fig 25:

External, central lightwell/courtyard; showing a general view of the internal north elevation. Note that no significant degradation was noted to the brickwork, largely due to this building section being of later construction, as well as the sheltered positioning

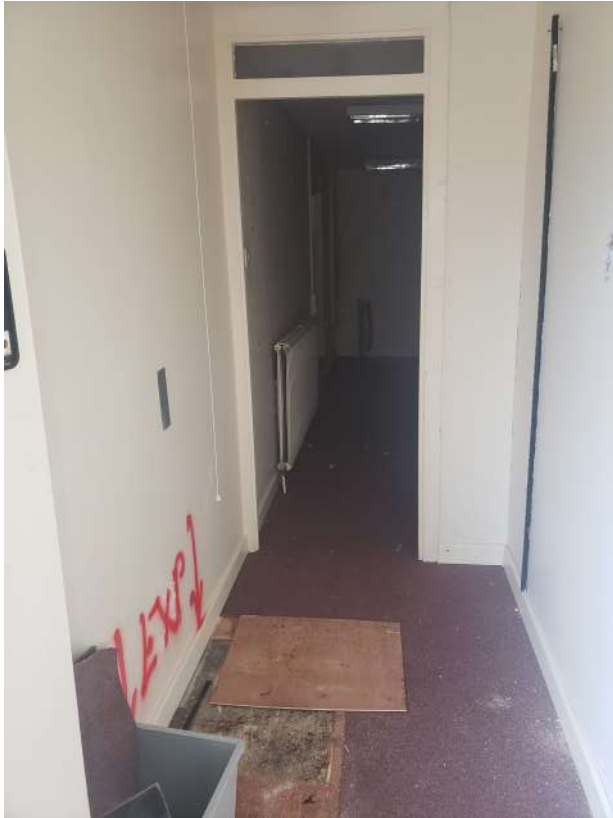
Fig 29:

Internal, second floor; showing a general view looking east of the entrance to the central rooms to the west range. Note the area of the floor marked for advised exposure to allow for further investigation of the encapsulated floor structure, which may be vulnerable to moisture ingress and biological decay organisms

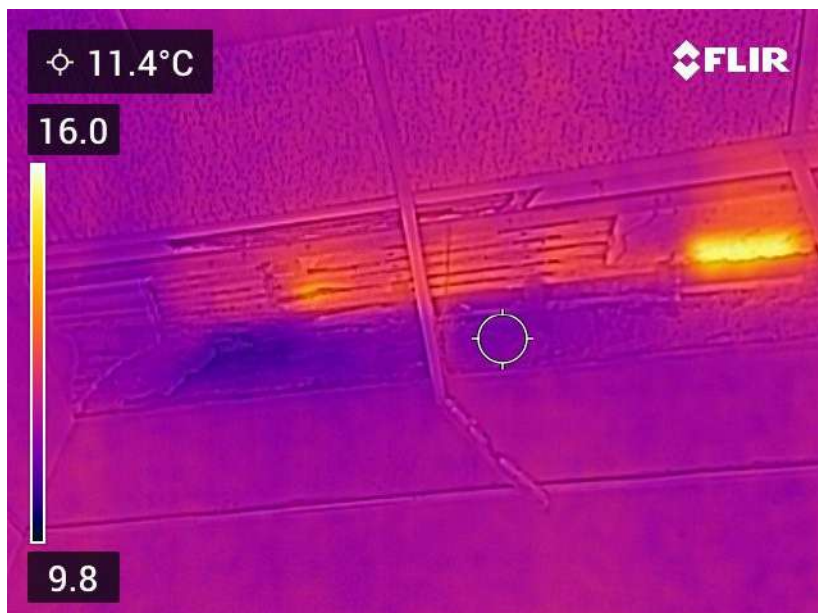
Fig 43:

Roof 1; showing thermal image to decayed structures shown at fig.42. Note no evidence of significant active moisture penetration at the time of investigation

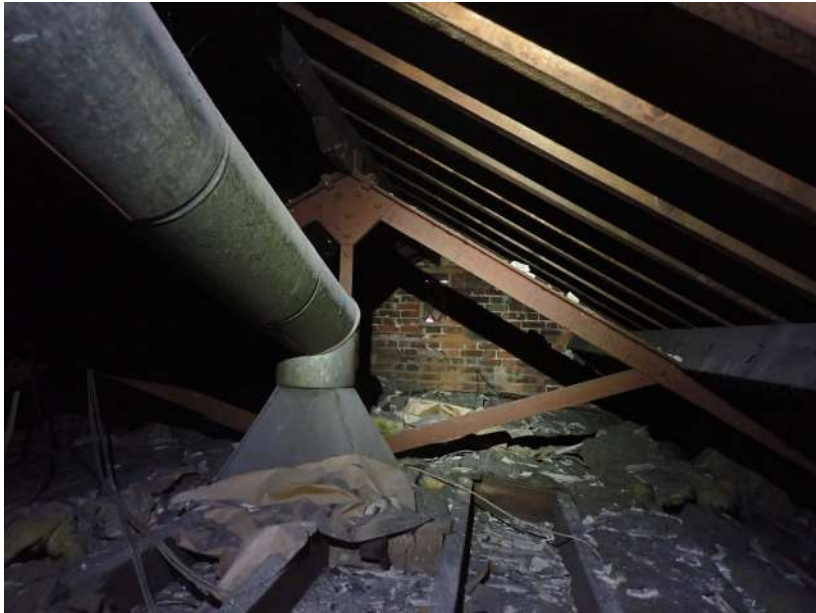
Fig 67:

Roof 6; showing general view of roof void looking towards the north gable

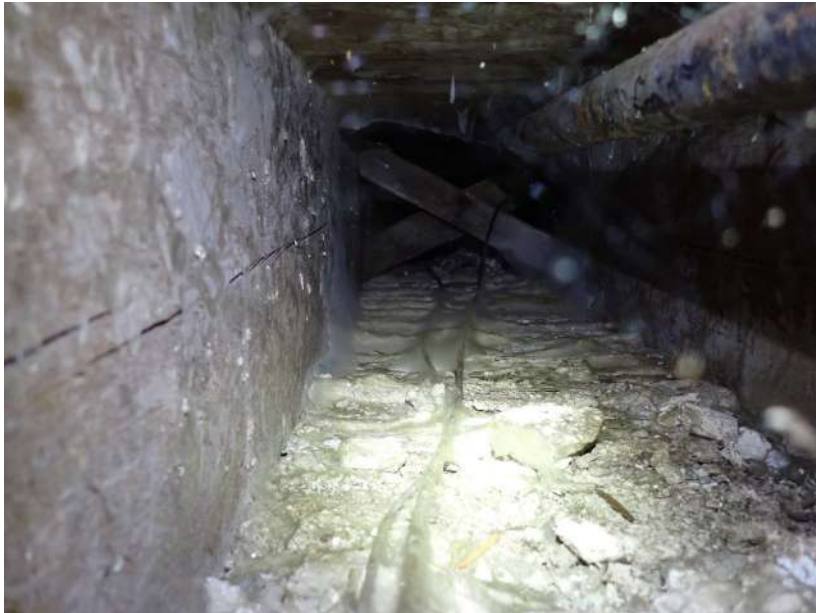
Fig 81:

First floor, south range; showing further extensive evidence for an active blanket of mycelial growth spreading through unventilated floor void indicative of dry rot decay (*Serpula lacrymans*)

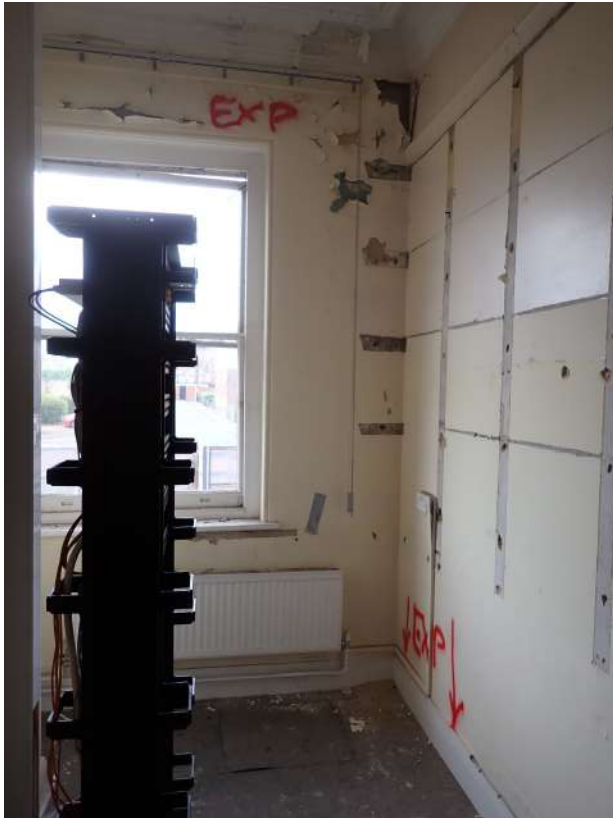
Fig 85:

First floor, west range; showing view towards the east rooms south perimeter wall. Note damp issues visible to masonry walls potentially indicative of decay issues to concealed timber elements including floor and lintel structures. All vulnerable inaccessible items identified for exposure/further investigations on site via water soluble red spray paint
