# Asbestos Report Management Survey

**Site: Belle Vue North West entrance  
Lowestoft  
Suffolk**

**On Behalf of: Lowestoft Town Council**

**Project Number: P-00116**

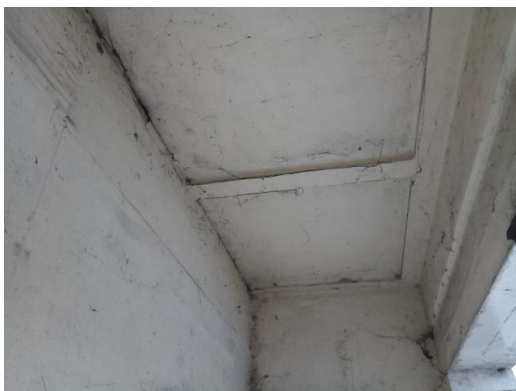
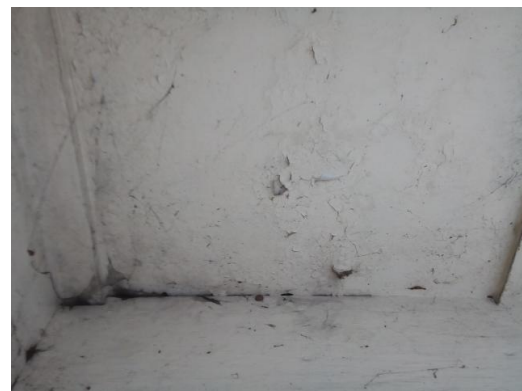
<b>Floor:</b>	External	<b>Sample Ref:</b>	X001-CMP
		<b>Lab Ref:</b>	
<b>Location:</b>	001 - External	<b>Identification:</b>	Cross Reference
<b>Reported:</b>	08/03/2019	<b>Asbestos Type:</b>	Chrysotile
<b>Updated:</b>		<b>Condition:</b>	Low Damage
<b>Quantity:</b>	3 m <sup>2</sup>	<b>Product:</b>	Cement Product
<b>Item</b>	Canopy ceiling		
<b>Sample Notes</b>	Cement panels to canopy ceiling.		
<b>Access:</b>	Exposed, but above head height

Material Assessment (MA) Score		MA Score	Risk Rating
<b>Product Type:</b>	1	<b>3</b>	<b>VERY LOW</b>
<b>Extent of Damage:</b>	1		
<b>Surface Treatment:</b>	0		
<b>Asbestos Type:</b>	1

<b>Recommendation:</b>	Manage In-Situ
<b>Recommendation Comments:</b>	The cement ceiling panels can be managed in-situ via periodic re-inspection, however any maintenance must be undertaken by suitably training persons, in accordance with HSE Essentials.

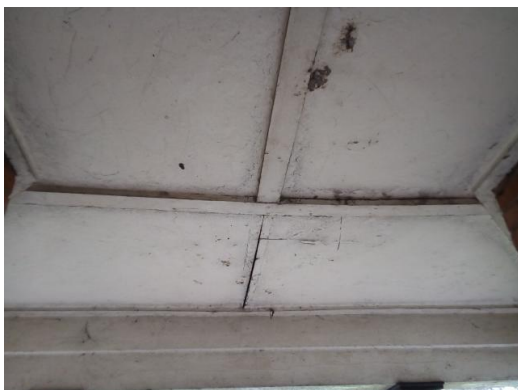
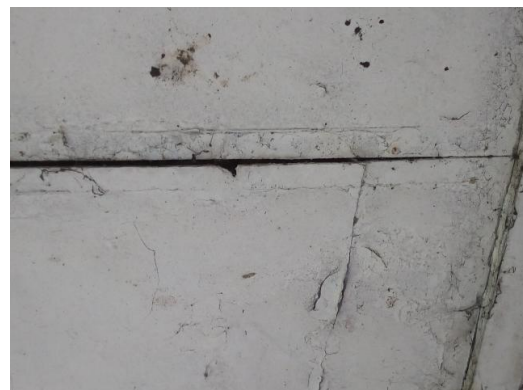
<b>Floor:</b>	External	<b>Sample Ref:</b>	S001-CMP
		<b>Lab Ref:</b>	SCO/19/4961
<b>Location:</b>	001 - External	<b>Identification:</b>	Sampled
<b>Reported:</b>	08/03/2019	<b>Asbestos Type:</b>	Chrysotile
<b>Updated:</b>		<b>Condition:</b>	Low Damage
<b>Quantity:</b>	8 m <sup>2</sup>	<b>Product:</b>	Cement Product
<b>Item</b>	Canopy ceiling		
<b>Sample Notes</b>	Cement panels to canopy ceiling.		
<b>Access:</b>	Exposed, but above head height

Material Assessment (MA) Score		MA Score	Risk Rating
<b>Product Type:</b>	1	<b>3</b>	<b>VERY LOW</b>
<b>Extent of Damage:</b>	1		
<b>Surface Treatment:</b>	0		
<b>Asbestos Type:</b>	1

<b>Recommendation:</b>	Manage In-Situ
<b>Recommendation Comments:</b>	The cement ceiling panels can be managed in-situ via periodic re-inspection, however any maintenance must be undertaken by suitably training persons, in accordance with HSE Essentials.

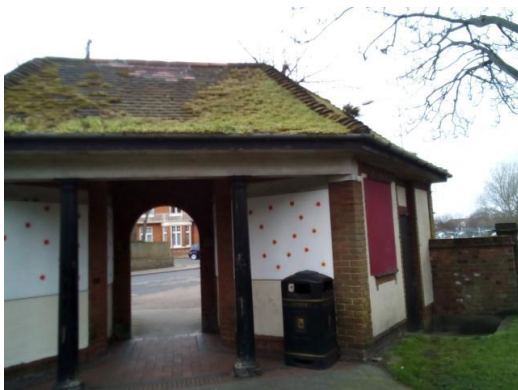
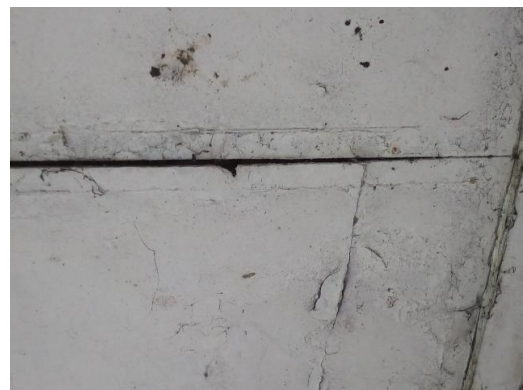
<b>Floor:</b>	External	<b>Sample Ref:</b>	S002-CMP
		<b>Lab Ref:</b>	SCO/19/4961
<b>Location:</b>	001 - External	<b>Identification:</b>	Sampled
<b>Reported:</b>	08/03/2019	<b>Asbestos Type:</b>	Chrysotile
<b>Updated:</b>		<b>Condition:</b>	Low Damage
<b>Quantity:</b>	8 m <sup>2</sup>	<b>Product:</b>	Cement Product
<b>Item</b>	Canopy ceiling		
<b>Sample Notes</b>	Cement panels to canopy ceiling.		
<b>Access:</b>	Exposed, but above head height

Material Assessment (MA) Score		MA Score	Risk Rating
<b>Product Type:</b>	1	<b>3</b>	<b>VERY LOW</b>
<b>Extent of Damage:</b>	1		
<b>Surface Treatment:</b>	0		
<b>Asbestos Type:</b>	1

<b>Recommendation:</b>	Manage In-Situ
<b>Recommendation Comments:</b>	The cement ceiling panels can be managed in-situ via periodic re-inspection, however any maintenance must be undertaken by suitably training persons, in accordance with HSE Essentials.
