Photographic schedule of condition – Sparrow's Nest Public Conveniences – 20.11.2020

Sparrow's Nest Public Conveniences

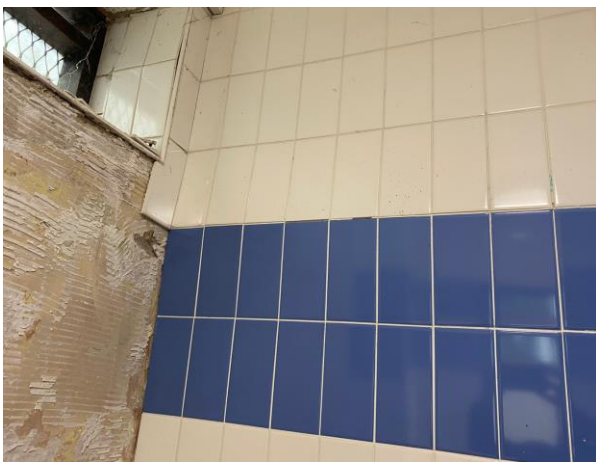
Evidence of blown plaster leading to tiles falling. .

Significant area of wall requires attention.

Root cause of the issue needs to be established.
Evidence of water permeation – possibly caused by leaking roof or blocked guttering.
Surveyor unable to establish cause due to building being closed at the time of visit (during lockdown)

Toilet block is in a good general state of condition. One area that requires further investigation is the wall tiles. Significant areas have seen the plaster blown and tile adhesive fail. Root cause of this is unknown. Recommendation to undertake full roofing survey to establish whether water has penetrated. Equally plausible is an internal water leak from the top story of the building.

Recommendation to consider removing all tiles and replacing with whiterock cladding or similar panelling, once the cause of the fallen tiles has been established.

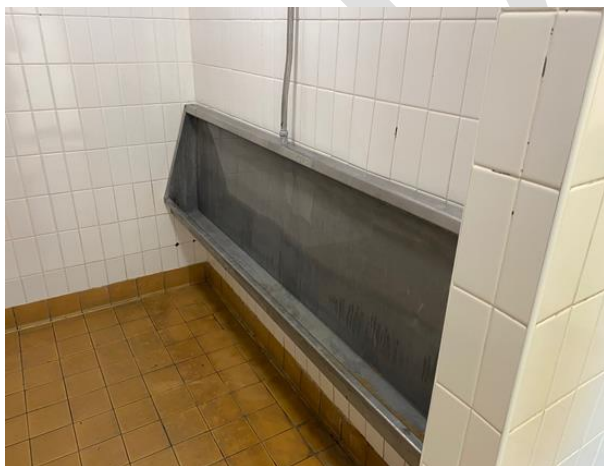
Existing urinal trough not to current guidelines for Public Conveniences.

Suggest removal of existing and replacement with 3no individual cubicles with modesty partitions
NB, Consider 2no urinals rather than three to conform to current social distancing guidelines

Budget estimate - £950

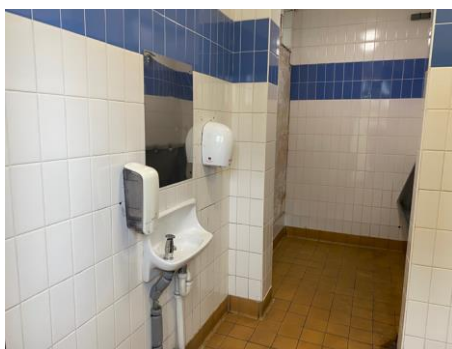
Handwashing station. In reasonable condition. Space does not allow installation of further sanitaryware

Hand drier in good working order

Cold water feed only.

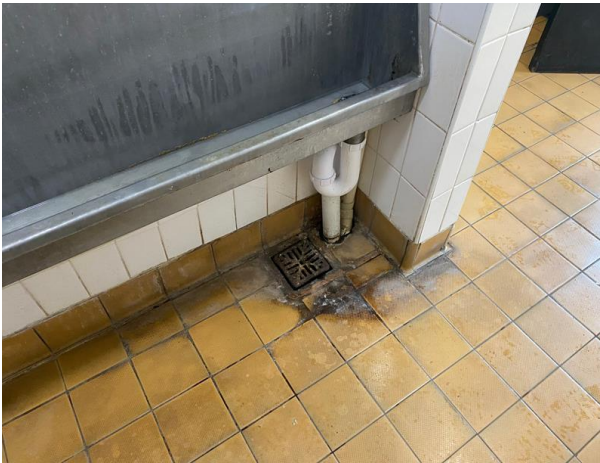
Evidence of previous water leak.

Issue would be addressed if installing new urinals. Otherwise replacement fittings required – Budget estimate £100

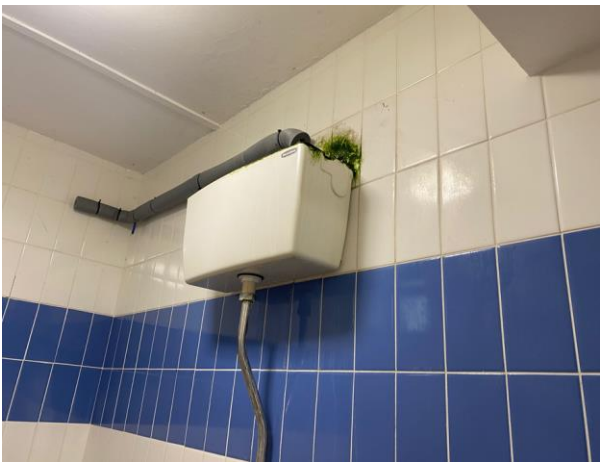
Evidence of algae spread on overhead cistern. Ball valve adjustment required and deep clean.

Replacement cistern included in urinal replacement costings above.

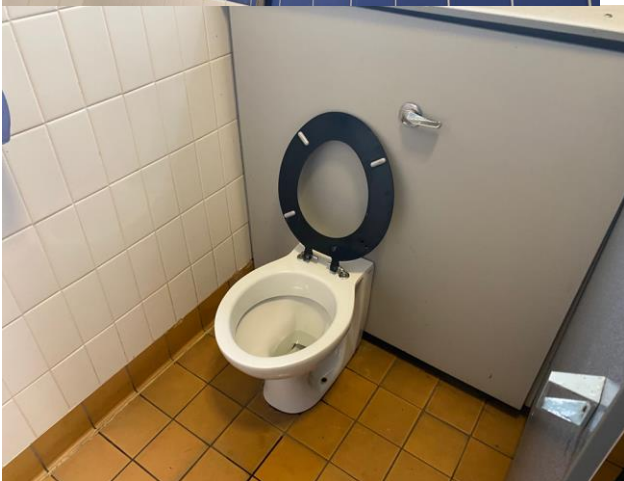
WC cubicle in good working order.

Cubicles and modesty panelling in reasonable order.

Consider replacement in 5-10 years.

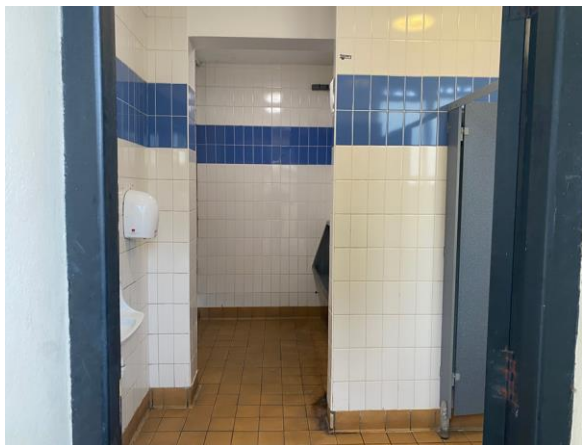
Floor tiles appear to be in fair condition. Would benefit from a deep clean and machine scrub with body fat remover. Allow for replacement between 10-15 years time.

Would benefit from thorough deep clean but no need to replace for 5 years.
Budget estimate - £3500

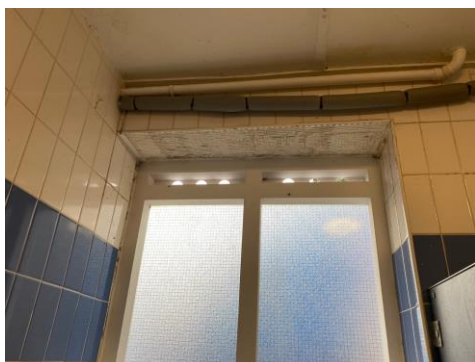
Plaster blown above window frame – tiles removed

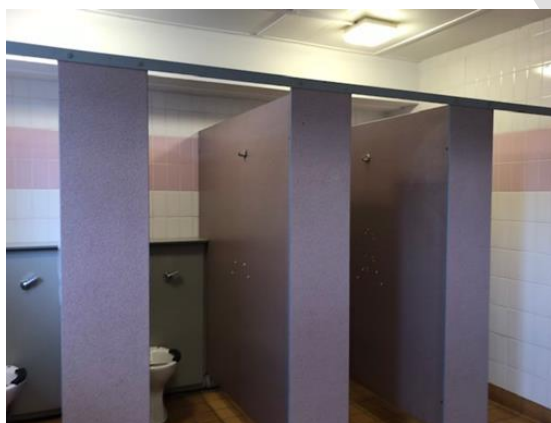
Ladies

In good working order.
Panelling and cubicles appear to have been replaced a short while ago.

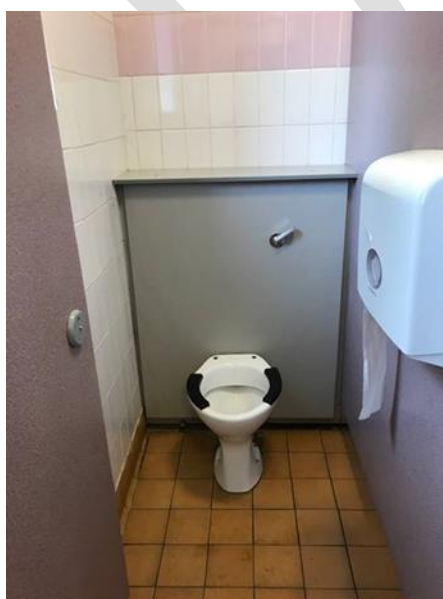
Sanitaryware in reasonable condition.

Consider retrospectively fitting 5no toilet seats – budget estimate £250

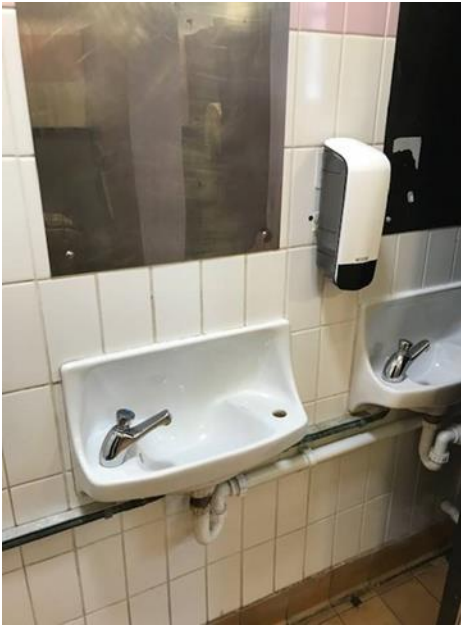
Similar to Gentleman's toilets, handwashing area appears in reasonable condition. Space does not allow installation of further sanitaryware.

Hand drier in good working order

Cold water feed only.

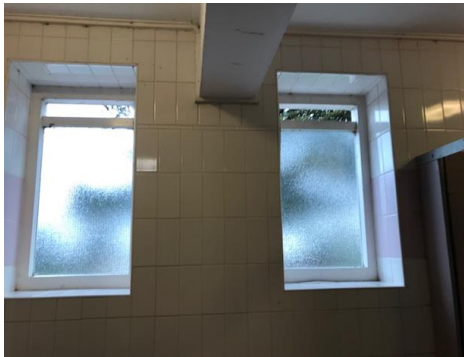
Windows in reasonable condition – allow for redecoration and patch repairs within 3 years or uPVC replacement in 8-10 years

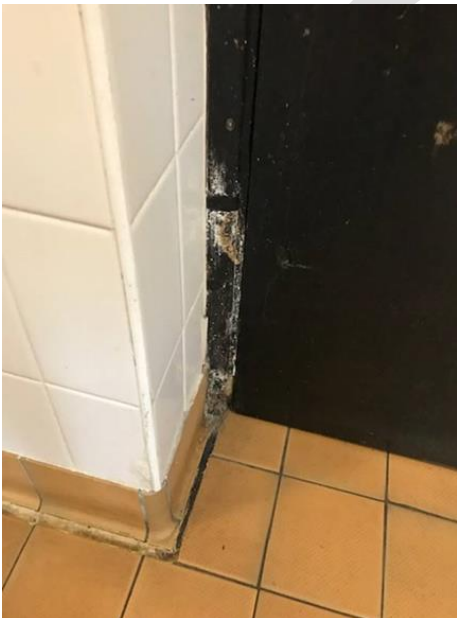
Door frame showing signs of water damage. Likely caused by continual floor mopping rather than water permeation.

Part replacement of frame to be spliced in and redecoration – budget estimate £200

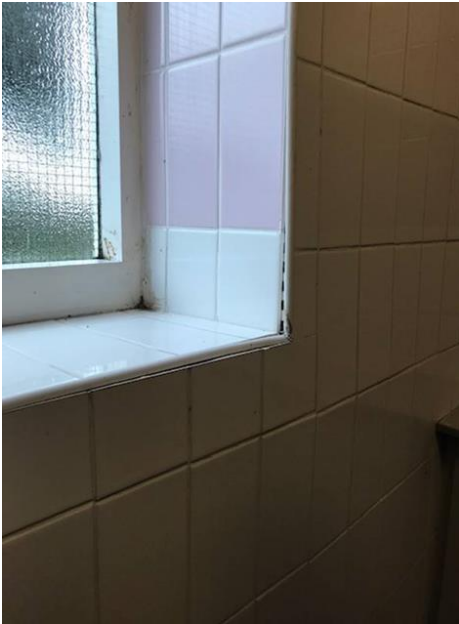
Further evidence of loose tiles within window surround.

Windows in generally reasonable condition.

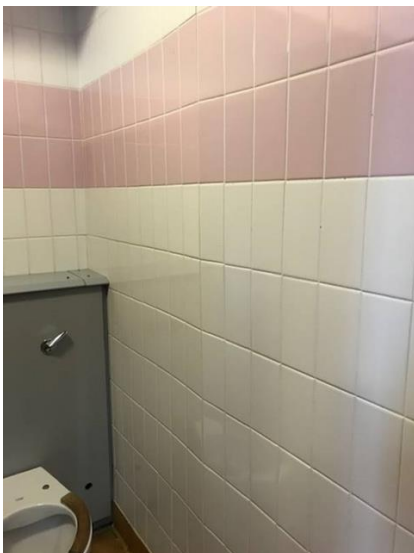
Tile movement floor to ceiling.

Replacement required. Consider complete removal and like for like replacement or change to whiterock panelling
