## **Lowestoft Town Council**

## Notes - Toilet Strategy Working Group 2020-12-17

## **Sparrows Nest**

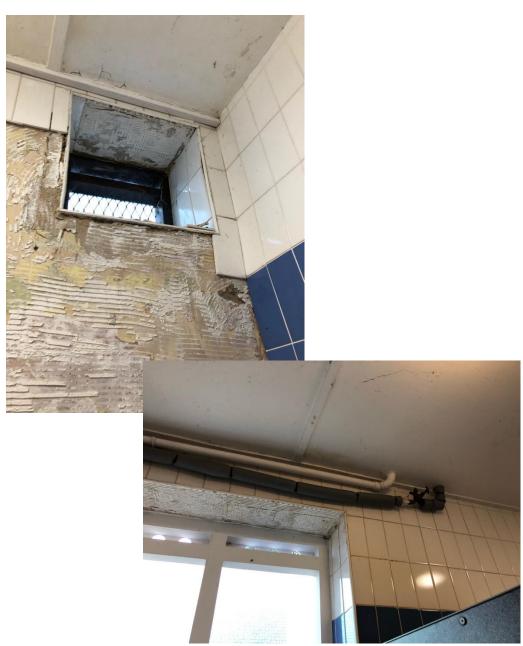
Male toilet rear wall and side wall

Concern was expressed at the failure of areas of wall tiles, possibly because of damp entering the fabric of the building, originating from springs along the cliff face to the rear. In actual fact there is a courtyard between the rear of the toilets and the Lowestoft War Memorial Museum, which does back on to the steep banking.

The affected areas of failed wall tiles are in the vicinity of ventilation openings, as shown:-

To avoid ingress of water or excessive damp, it is suggested that these openings be replaced by sealed double-glazed windows, with motion-activated lights and an extraction fan in each toilet. The condition of the locked disabled toilet is not known.

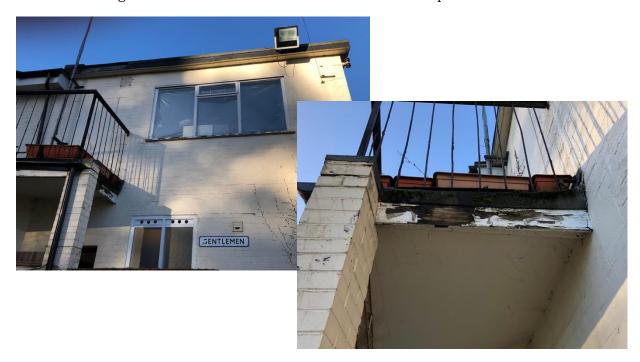
Externally, a drainpipe can be seen on leading down from the roof to the verandah above the side wall of the gents' toilet. The structure of the verandah is in poor condition.

It is considered that full structural repairs to the building, and attention to drainage, should be pre-requisites to refurbishment of the toilets. Obviously this would a costly exercise. Perhaps the proposed reduction in the 2021 precept should be abandoned, and the 2021-22 budget either held at zero, or subjected to a modest increase as necessary to cover the additional expense.
