Photographic schedule of condition – Fenn Park Public Conveniences – 20.11.2020

Fenn Park Public Conveniences

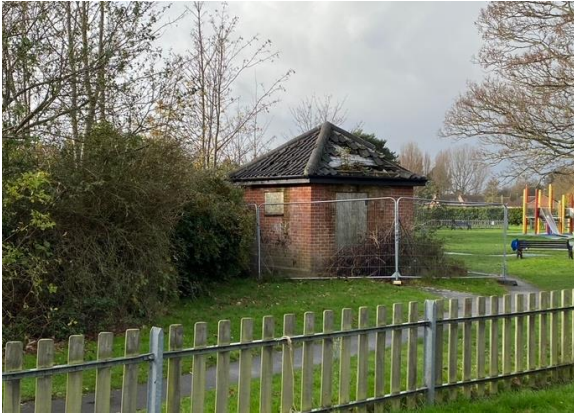
- Brick built construction with tiled roof.
- Evident that building is in dilapidated state in need of major renovation or demolition.
- Building appears to have been withdrawn from operation for a number of years.
- Currently boarded up and cordoned off to public.
- Roof appears to have been vandalised with lead flashing removed at some stage
- Surveyor unable to gain access at time of visit

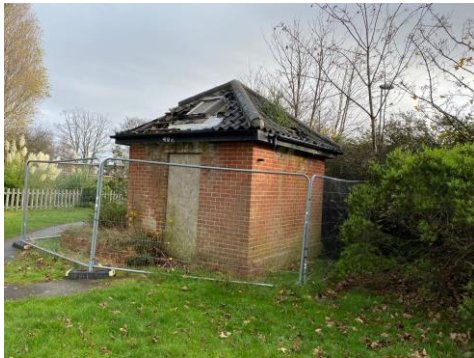
Building appears to be of sound construction
Brickwork and pointing in reasonable condition
New roof required
Replacement entrance doors required – budget estimate
£1200

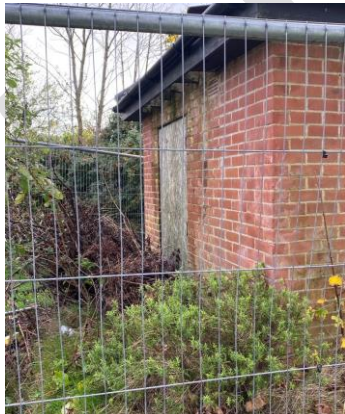
Building currently has no rain water roofline guttering system.
Evidence of water penetration and brick damage in localised areas
Budget estimate to replace (including replacement soffits)
- £600

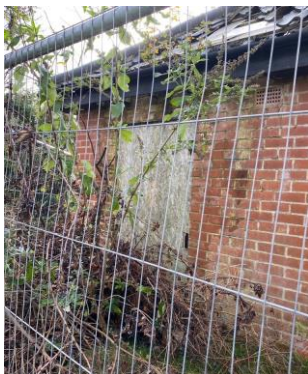
Brickwork pointing in good condition
Graffiti removal and pressure wash required – budget estimate £250

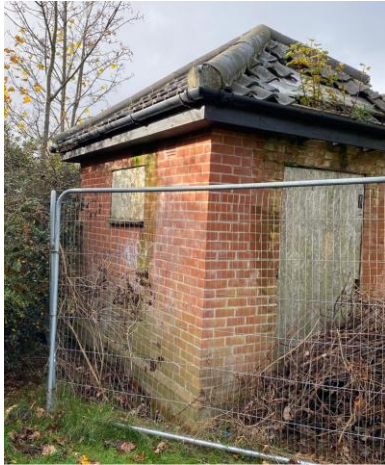
Reinstating of window required – budget estimate cost £450

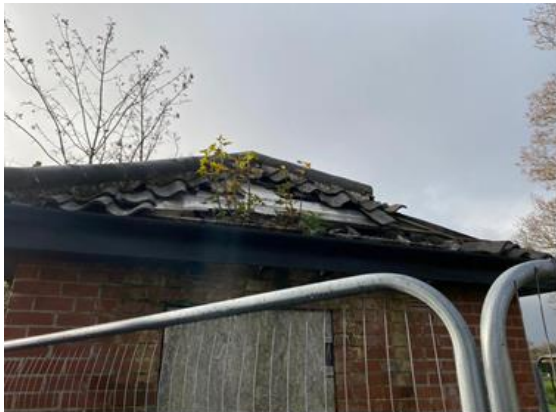
Substantial root growth through rooflight.
Assume roots have penetrated flooring and/or drainage
Indicative of major issues within the toilet block.
– example of damage due to roof issues.

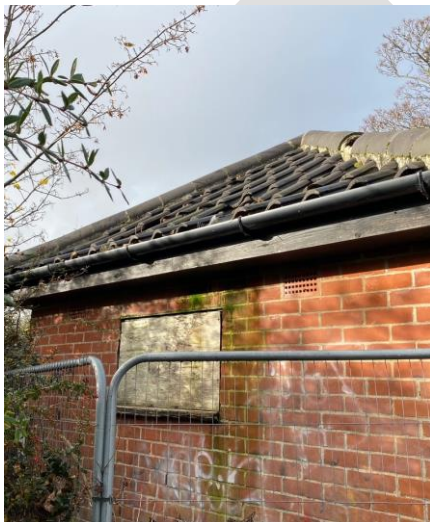
Complete roof replacement required including slate tiles, timber roof trusses, hip tiles, flashing, 2no rooflights – budget estimate £4500
