Multi-Use Games Areas

Lowestoft Town Council has six Multi-Use Games Areas (MUGAs), at Britten Road, Clarkes Lane, Fen Park, Gunton Community Park, Normanston Park and Whitton Green.

These are the results of our most recent annual inspections, from August 2024:

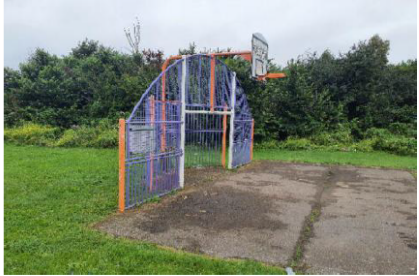
Britten Road

8 - Low Risk	
<p>Item: Goalmouth and Basketball Post Manufacturer: Hags Surface Type: Tarmac Item Quantity: 1 Equipment Compliance: No Surface Area Compliance: N/A</p> <p>Total Findings: 8</p>

<p>Finding 1</p>	<p>Finding 2</p>
<p>The bitumen surface is worn or damaged - Repair the bitumen to provide a uniform surface</p>	<p>There is weed / vegetation growth on, between, or around the edges of the surfacing - Remove weed / vegetation growth</p>
<p>Finding 3</p>	<p>Finding 4</p>
<p>The paintwork on this item has been damaged or worn exposing the metal underneath which is rusting / corroding - Treat affected areas and repaint</p>	<p>The item fails to meet the requirements of BS EN 15312 4.4.2.1 head and neck entrapment in the frame - Monitor - No remedial work recommended</p>
<p>Finding 5</p>	<p>Finding 6</p>
<p>There are trip hazards at the edges of the surface - Remove trip hazard</p>	<p>There is some graffiti present - Remove the graffiti</p>

<p>Finding 7</p>	<p>Finding 8</p>
<p>There is/are finger entrapments in the frame due to missing inserts and the item fails to meet the requirements of BS EN 15312 Clause 4.4.2.2 Entrapment of fingers - Provide inserts to remove entrapment</p>	<p>There are a number of redundant cable ties attached to the equipment - Remove redundant cable ties</p>

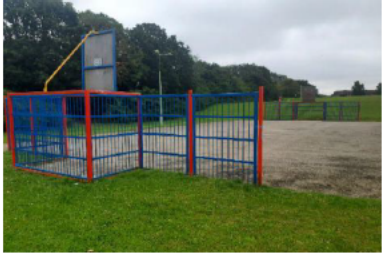
Clarks Lane

12 - Moderate Risk	
Item: Multi Use Games Area (MUGA) Manufacturer: Not Identified Surface Type: Tarmac Item Quantity: 1 Equipment Compliance: No Surface Area Compliance: N/A

Total Findings: 18	
Finding 1 A clearly visible facility sign should be provided in a prominent position with the wording as detailed BS EN 15312- the equipment is not intended for children less than 3 years old- the warning - Do not climb on the framework or nets- the warning - Do not hang on the ring (if provided)- the warning - Do not wear rings or other jewellery- name and telephone number of the administrator- number to call in case of accident - Provide signage to BS EN 15312	Finding 2 The free space between the backboard and the framework is less than 600mm and fails the requirements of BS EN15312:2007 +A1 2010 - Monitor - No remedial work recommended
Finding 3 The ring is not fixed to the framework and force from the ring can be transmitted directly to the backboard in contravention of BS EN 15312:2007+A1:2010 - 5.2.2.1 - Monitor condition and replace as required	Finding 4 There are projecting bolt thread(s) present - Remove excess thread length and deburr or provide cap

Finding 5 There is weed / vegetation growth on, between, or around the edges of the surfacing - Remove weed / vegetation growth	Finding 6 There is or are fixings missing on the item - Replace all missing fixings
Finding 7 The paint is flaking off the metalwork - Rub down and re-paint	Finding 8 There is or are fixings missing on the backboards - Replace all missing fixings
Finding 9 The bitumen surface is worn or damaged - Repair the bitumen to provide a uniform surface	Finding 10 There is/are finger entrapments in the frame due to missing fixings and the item fails to meet the requirements of BS EN 15312 Clause 4.4.2.2 Entrapment of fingers - Provide missing fixings to remove entrapment
Finding 11 The weld(s) on this item have failed - Repair item	Finding 12 A hoop is damaged - Repair or replace hoop
Finding 13 There is or are fixings missing on the item - Replace all missing fixings	Finding 14 There is or are fixings missing on the item - Replace all missing fixings

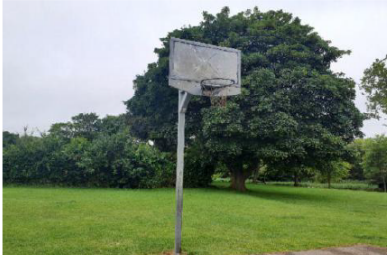
Fen Park

8 - Low Risk	
Item: Basketball Post Manufacturer: Not Identified Surface Type: Tarmac Item Quantity: 1 Equipment Compliance: No Surface Area Compliance: N/A

Total Findings: 4	
Finding 1 The bitumen surface is worn or damaged - Repair the bitumen to provide a uniform surface	Finding 2 There is weed / vegetation growth on, between, or around the edges of the surfacing - Remove weed / vegetation growth
Finding 3 There are trip hazards at the edges of the surface - Remove trip hazard	Finding 4 The backboard is missing - Replace the backboard

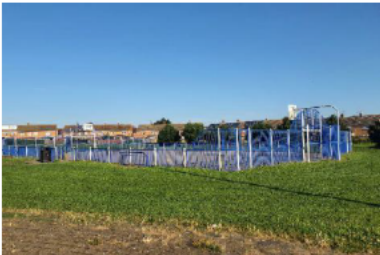
Item:	Site General

6 - Low Risk

Manufacturer:	Owner/Operator	
Surface Type:	N/A	
Item Quantity:	1	
Equipment Compliance:	N/A	
Surface Area Compliance:	N/A	
Total Findings:	1

Finding 1
There is weed / vegetation growth on, between, or around the edges of the surfacing - Remove weed / vegetation growth

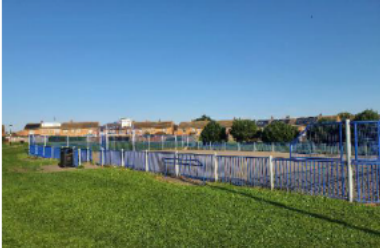
Item:	Multi Use Games Area (MUGA)

8 - Low Risk

Manufacturer:	Hags	
Surface Type:	Tarmac	
Item Quantity:	1	
Equipment Compliance:	No	
Surface Area Compliance:	N/A	
Total Findings:	6

Finding 1
A clearly visible facility sign should be provided in a prominent position with the wording as detailed BS EN 15312- the equipment is not intended for children less than 3 years old- the warning - Do not climb on the framework or nets- the warning - Do not hang on the ring (if provided)- the warning - Do not wear rings or other jewellery- name and telephone number of the administrator- number to call in case of accident - Provide signage to BS EN 15312

Finding 2
The item fails to meet the requirements of BS EN 15312 4.4.2.1 head and neck entrapment in the frame - Monitor - No remedial work recommended

Finding 3
The paintwork on this item has been damaged or worn exposing the metal underneath which is rusting / corroding - Treat affected areas and repaint

Finding 4
There is some graffiti present - Remove the graffiti

Finding 5
There are trip hazards at the edges of the surface - Remove trip hazard

Finding 6
There is or are fixings missing on the item - Replace all missing fixings

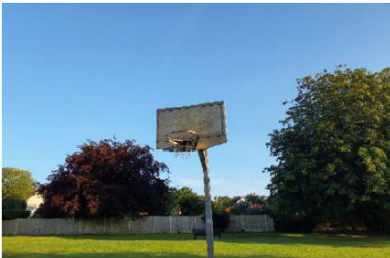
Item:	Basketball Post

8 - Low Risk

Manufacturer:	Not Identified	
Surface Type:	Tarmac	
Item Quantity:	1	
Equipment Compliance:	Yes	
Surface Area Compliance:	N/A	
Total Findings:	4

Finding 1
There are trip hazards at the edges of the surface - Remove trip hazard

Finding 2
There are projecting bolt thread(s) present - Remove excess thread length and deburr or provide cap

Finding 3
There is some graffiti present - Remove the graffiti

Finding 4
There is weed / vegetation growth on, between, or around the edges of the surfacing - Remove weed / vegetation growth

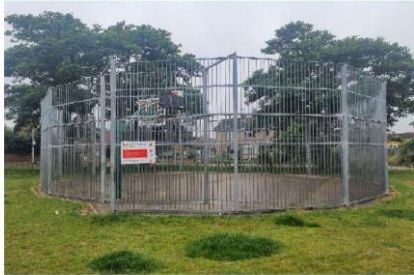
Whitton Green

8 - Low Risk	
<p>Item: Multi Use Games Area (MUGA) Manufacturer: Not Identified Surface Type: Tarmac Item Quantity: 1 Equipment Compliance: Yes Surface Area Compliance: N/A</p> <p>Total Findings: 9</p>

<p>Finding 1 The sign is damaged - Replace</p>	<p>Finding 2 There are trip hazards at the edges of the surface - Remove trip hazard</p>
<p>Finding 3 There are projecting bolt thread(s) present - Remove excess thread length and deburr or provide cap</p>	<p>Finding 4 There is weed / vegetation growth on, between, or around the edges of the surfacing - Remove weed / vegetation growth</p>
<p>Finding 5 The bitumen surface is worn or damaged - Repair the bitumen to provide a uniform surface</p>	<p>Finding 6 A number of weld(s) on this item have failed along the fence - Repair item</p>
<p>Finding 7 There are a number of missing uprights along the fence leaving sharp metal edges - Repair fence</p>	<p>Finding 8 There is some graffiti present - Remove the graffiti</p>

<p>Finding 9 There is some damage to the fence sections - Monitor for any further deterioration and repair as required</p>
