LOWESTOFT TOWN HALL

ROTHOUND INVESTIGATION OF DRY ROT INFECTION AND DECAY

JOB NO. 158-97

LOWESTOFT TOWN COUNCIL

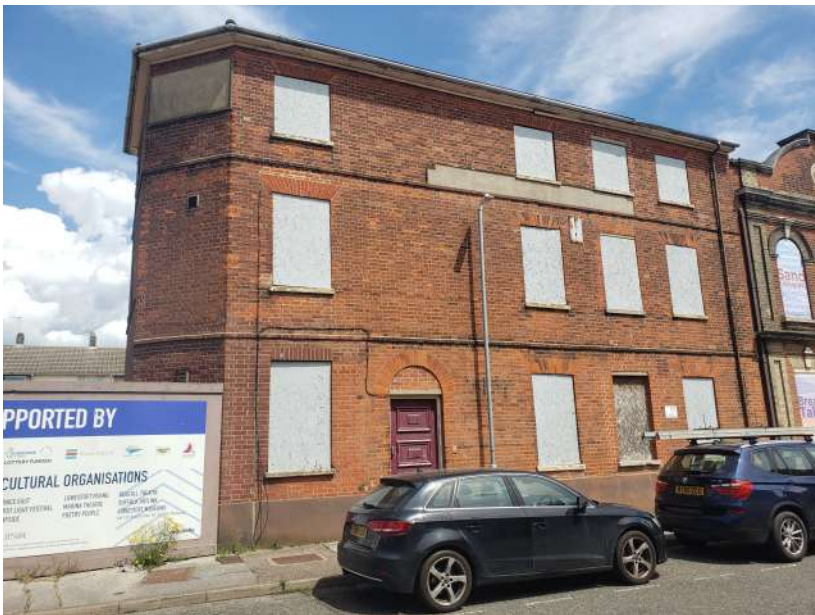
Fig 2:

External, south elevation; photo showing a focused view of the west end of the south elevation. Note the widespread presence of spalling and localised cracking the brickwork forming this elevation, this had likely occurred due to prolonged exposure to inclement weather leading to the saturation of masonry materials and structural movement leading to the failure of subsequent structural elements, causing partial separation of brickwork at the mortar joints

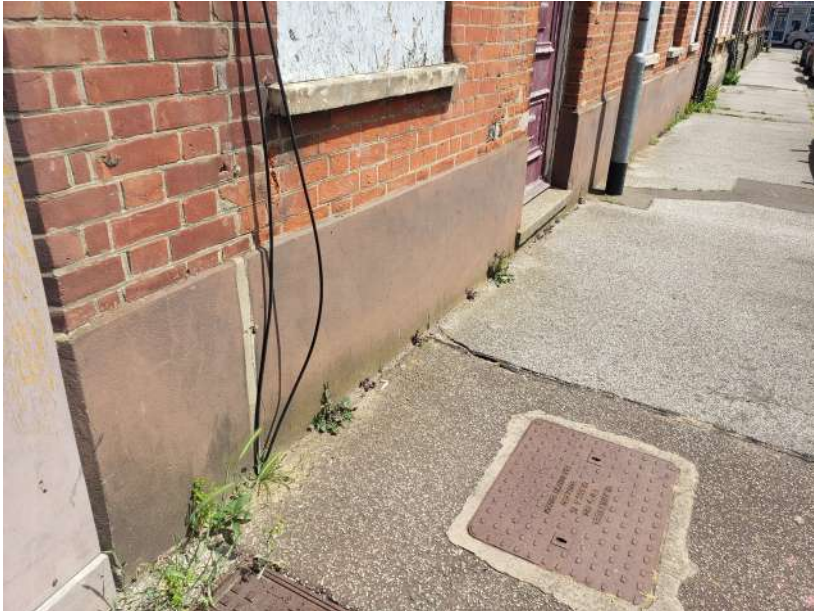
Fig 3:

External,
south elevation; showing a focused view of the lower section of the south elevation and the interface with the pavement. Note the up stand/external tanking was deemed to likely be of a cementitious material which would prevent saturated moisture due to wind driven rain from evaporating from within the brickwork. This would likely direct it internally and possibly lead to the saturation of vulnerable timber elements and subsequent materials in close proximity

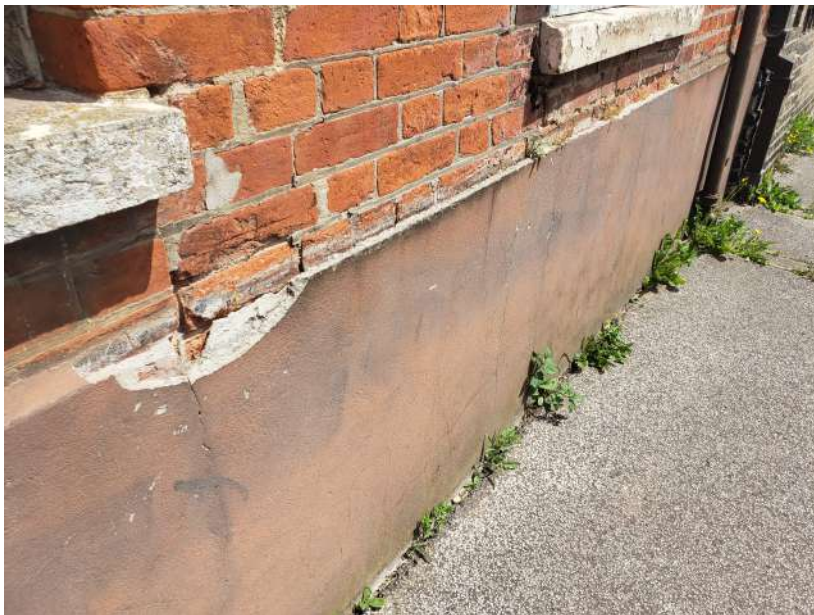
Fig 4:

External,
south elevation; showing a further image of the up stand/external tanking and the localised damage that was visible along the top edge. Note that mortar washout had occurred from the mortar beds connecting the course of brick directly above the top edge of the cementitious tanking. This confirms the suspicion that moisture was being excessively harboured within the brickwork at this location

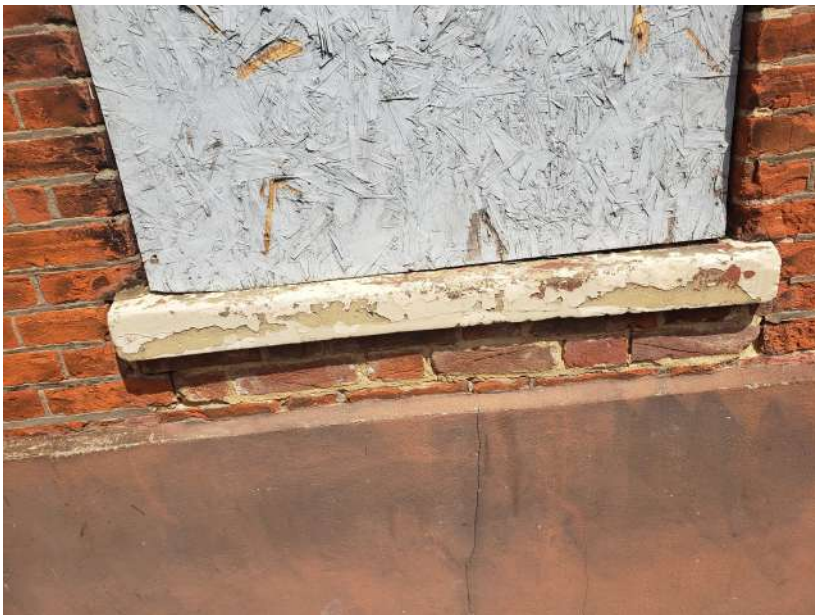
Fig 6:

External,
south elevation; showing a focused view of and external sandstone windows the type and condition of which were typical throughout the entire elevation. Note that significant spalling had occurred, again likely due to the saturation of moisture during periods of inclement weather leading to excessive spalling, due to the level of saturation and the characteristics and properties of the masonry type

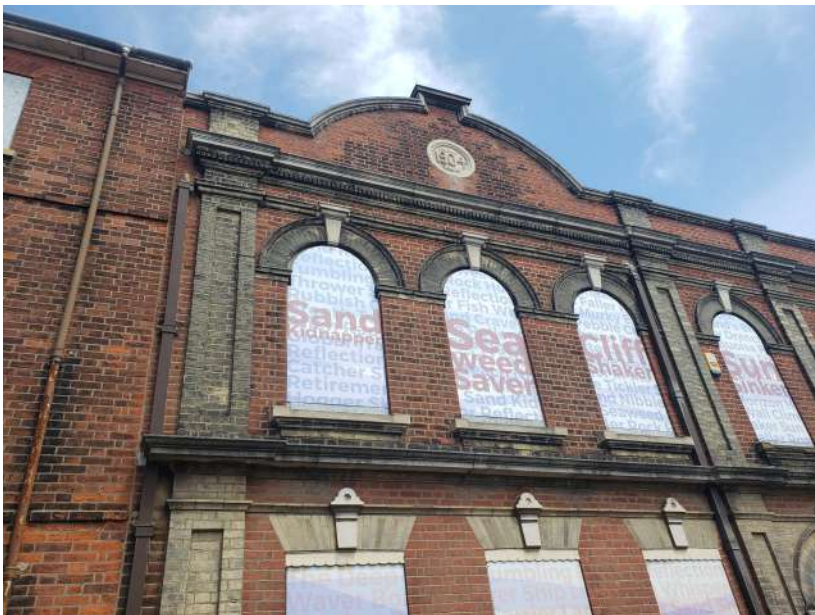
Fig 8:

External, south elevation; showing a general view of the condition of the upper section of the east end of the elevation. Note that widespread staining of masonry was observed due to continue exposure to airborne pollutants. Also note the replacement of historic downpipes with contemporary square sections, these had been connected to historic elements at the interface of the wall, historic rainwater drainage elements and their connection to contemporary elements may be deemed inadequate

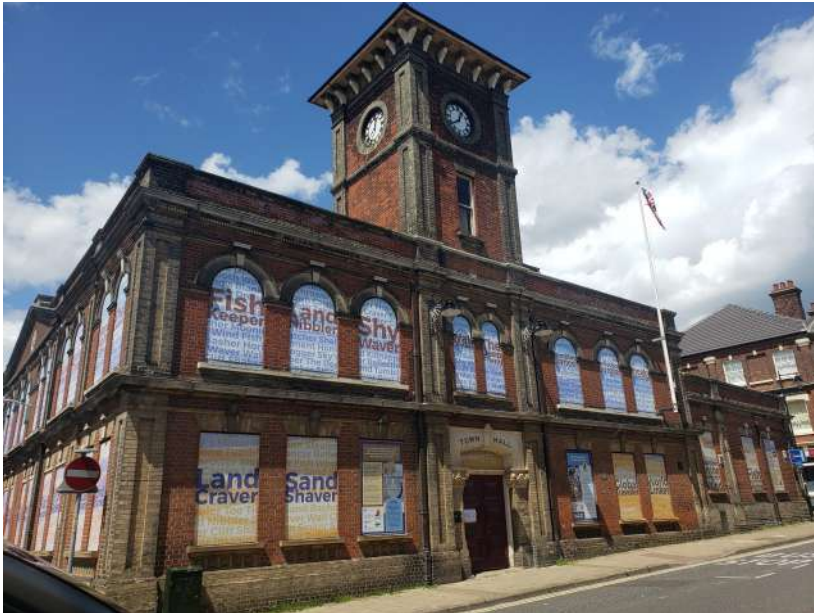
Fig 9:

External, east elevation; know your general view of the structural arrangement and condition of the east elevation

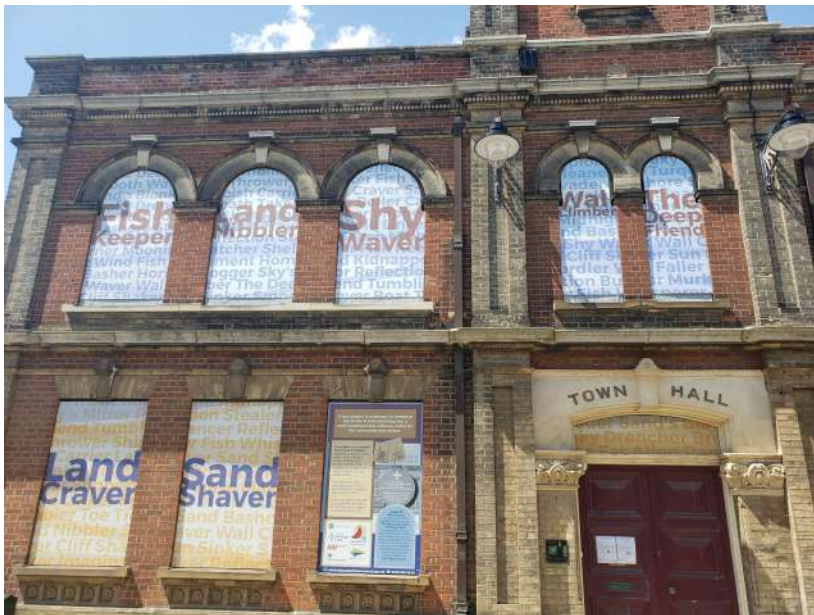
Fig 10:

External, east elevation; showing a focused view of the south side of the east elevation, note the presence of cracking to the flat gauge brick arch above the lower right-hand window and further cracking to the brickwork and what appeared to be slight separation of the masonry moulded course above, which suggested that movement had occurred in this location, possibly due to the failure of internal structural elements

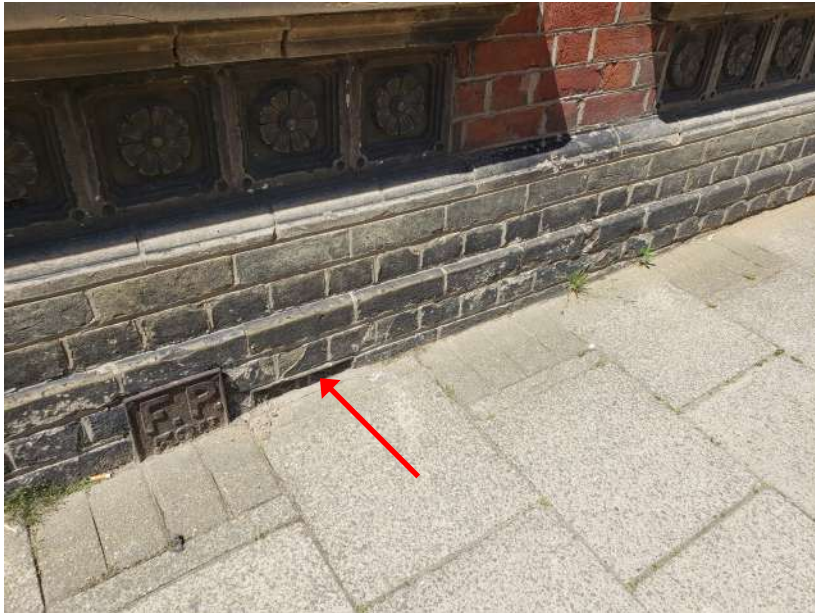
Fig 11:

External, east elevation; showing a focused view of the interface between the foot of the elevation and the pavement. Note that external vents serving the internal sub-floor void had been partially blocked due to excessive debris and raised ground levels, this would inevitably lead to significant moisture ingress during periods of inclement weather

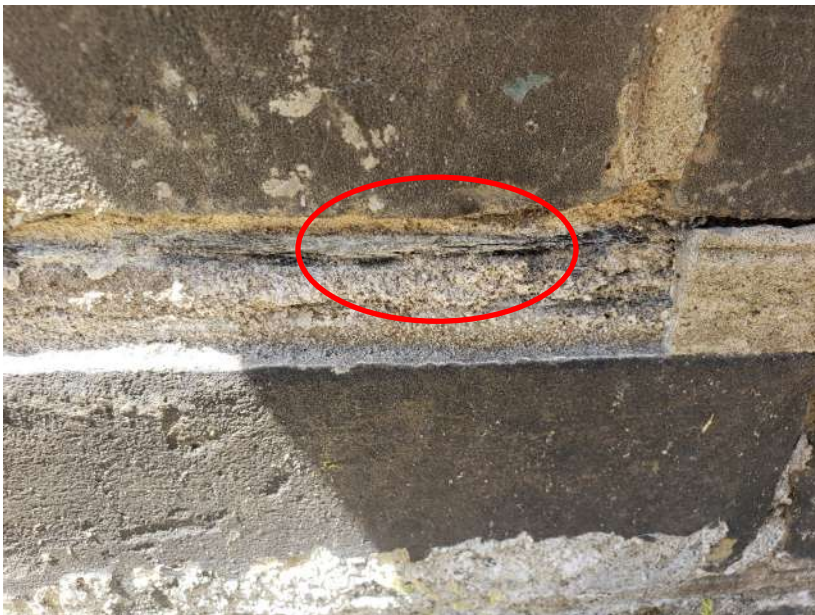
Fig 12:

External, east elevation; showing a focused view of the damp proof course that was identified at the foot of the elevation, note that the material was deemed to be slate. Further note that ground levels at the north end of the elevation were raised to approximately 25 mm below the slate damp proof course which is significantly less than the required amount. This could allow the saturation of brickwork above the damp proof course during periods of rainfall

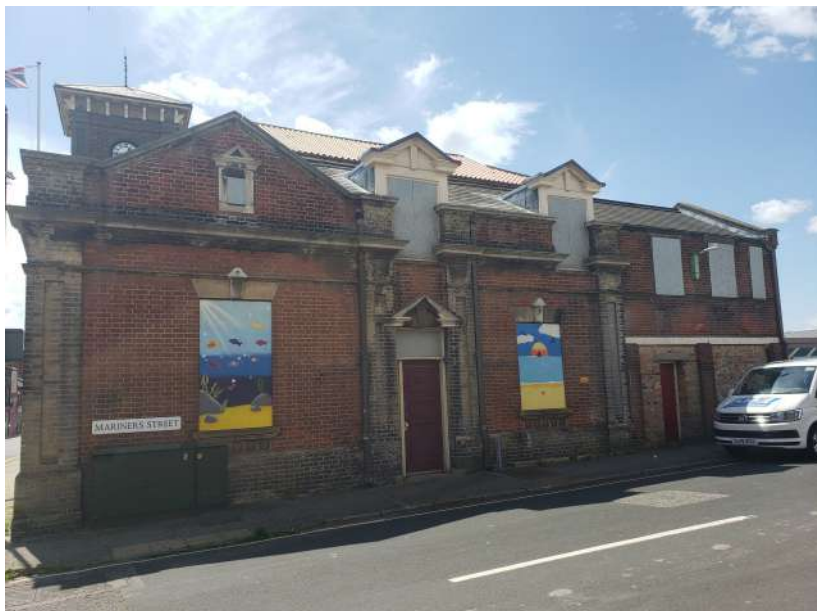
Fig 13:

External, north elevation; showing a general view of the condition and structural arrangement of the east end of the elevation. Note that similar characteristics noted on previous elevations were seen at this location including spalling and localised cracking particularly at the west side of the elevation, including multiple areas of plant growth along the top edges of the parapet wall, and ground levels raised above the slate damp proof course, rendering it completely ineffective. Additionally, widespread moderate levels of degradation to window and door units was also noted again due to prolonged exposure to inclement weather and being finished with inappropriate paint systems

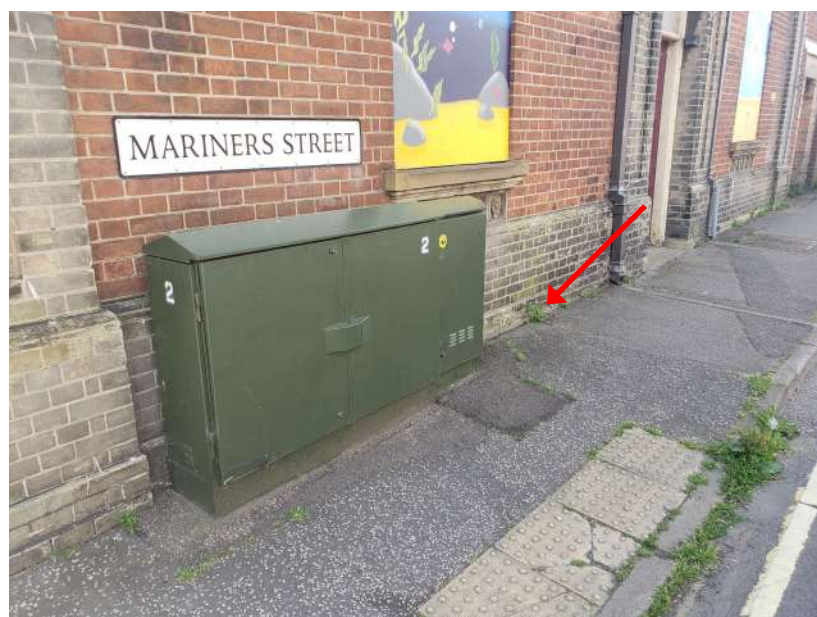
Fig 14:

External, north elevation; showing a general view of the interface between the foot of the elevation and the pavement, note that ground levels at this position were seen to be above the slate damp proof course as mentioned previously. The presence of plant growth at the interface indicated that there were high levels of moisture at this location, which was likely tracking inwards and possibly affecting structural timber elements on the opposing side

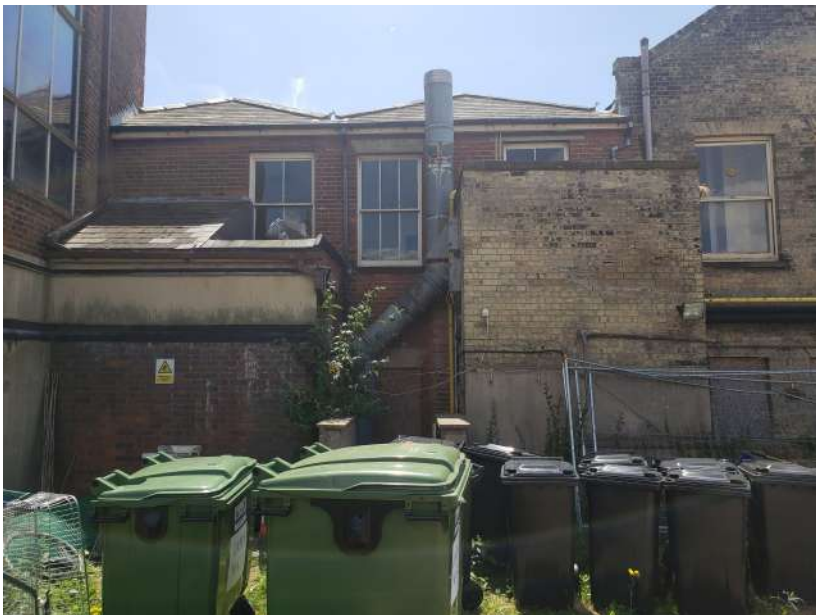
Fig 16:

External, north elevation; showing a general view of the central section of the elevation. Note that significant plant growth was identified which was an indicator of excessive moisture in that location. Moderate levels of spalled brickwork were identified, as well as general levels of wear and tear however, a number of structures at this location were to be demolished. Widespread staining was also noted to the eaves soffits likely due to the corrosion of mechanical fixings over time. Paint delamination was also noted along the soffits, likely due to exposure to UV rays and inclement weather

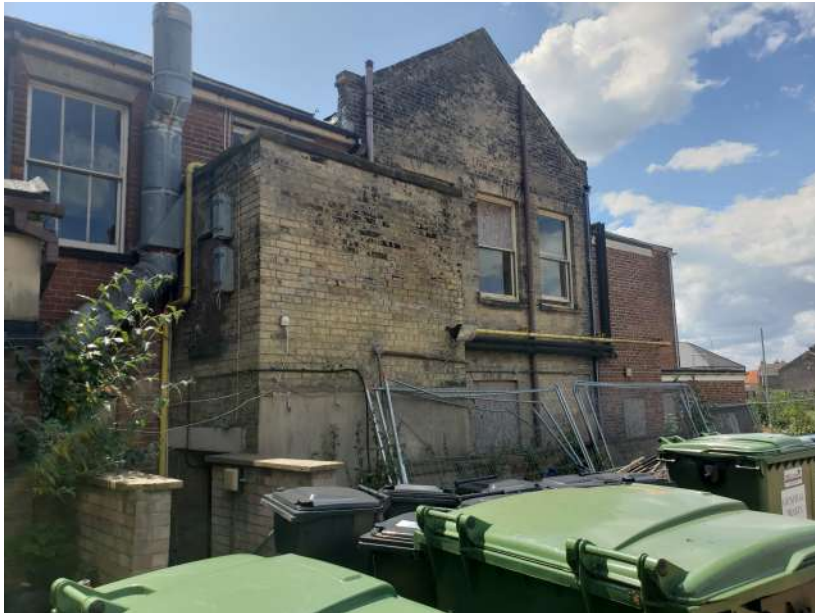
Fig 17:

External, north elevation; showing a general view of the west end of the elevation. Note that all windows displayed wear and tear to external elements and the brickwork again showed widespread spalling. Additionally, the window sills beneath the pitched gable section were again found to be spalled and the visible pipework and other metal elements were significantly corroded, which could lead to damage of the surrounding materials due to the associated expansion of the corroding metal

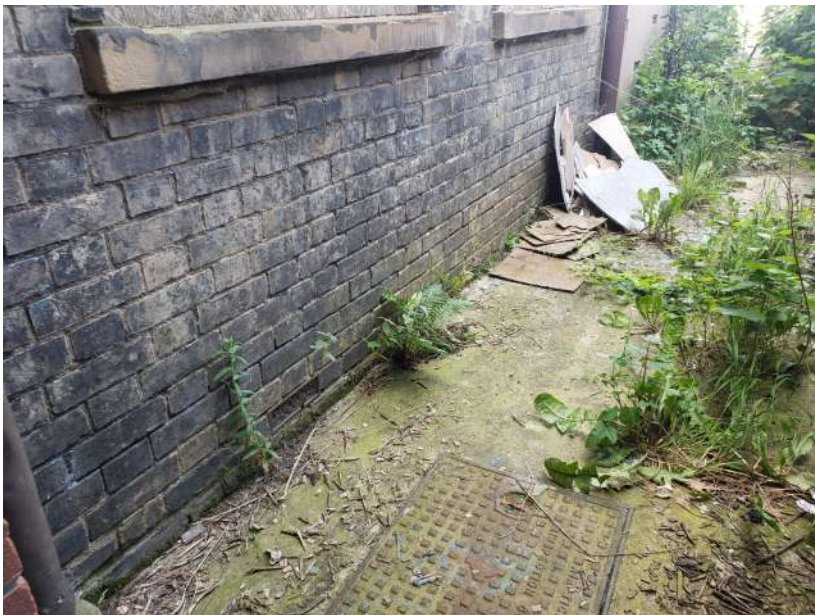
Fig 18:

External, north elevation; showing a focused view of the interface between the foot of the wall and the ground at this location. Note that widespread mortar washout had occurred, and the cementitious ground material had been laid to a height that was close to the damp proof course. Also note further plant growth which suggested moisture ingress internally, as well as blocked vents

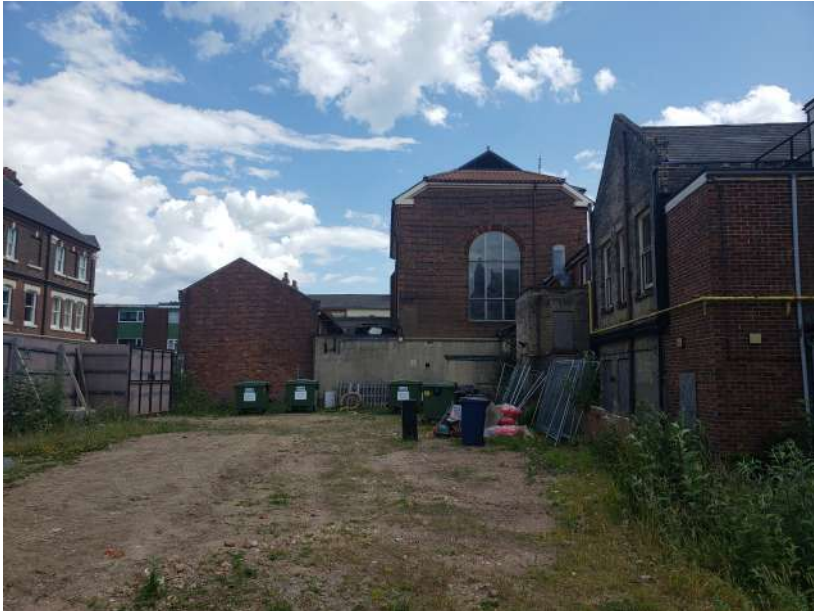
Fig 19:

External, west elevation; showing a general view of the structural arrangement and condition of the elevation at this location

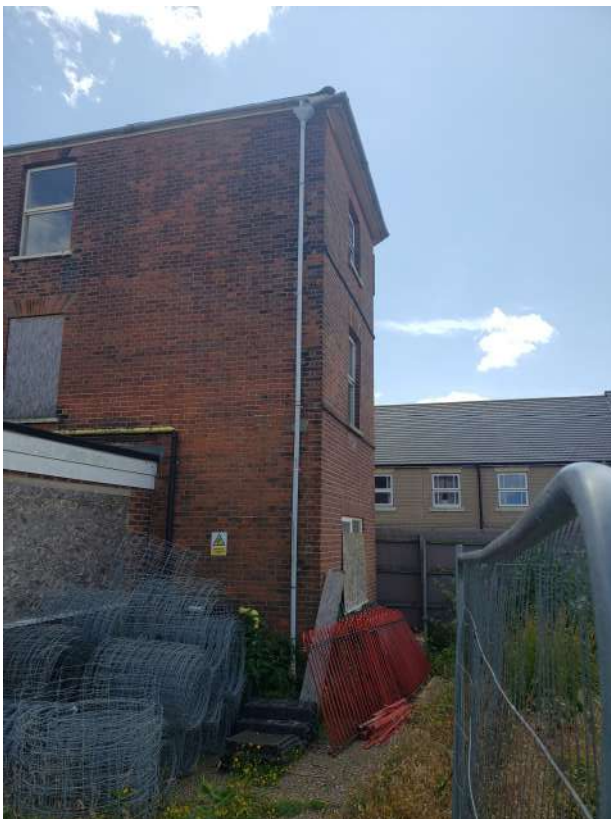
Fig 20:

External, west elevation; showing a partial view of an additional section of the elevation, located at the very west end of the building. Full view was obscured by the positioning of fencing, which prevented full access

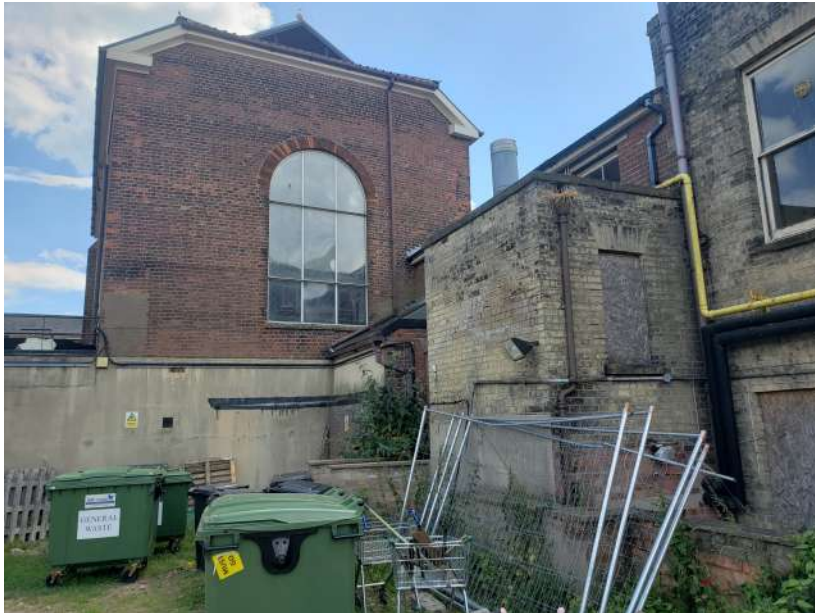
Fig 21:

External, west elevation; showing general spalling to brickwork, and a large section of cementitious render to the lower section. In this, were external vents which were considered to be inadequate due to their likely blockage and significant corrosion. Also note the presence of multiple cracks to the cementitious render, which would inevitably enable moisture ingress into the brick substrate beneath

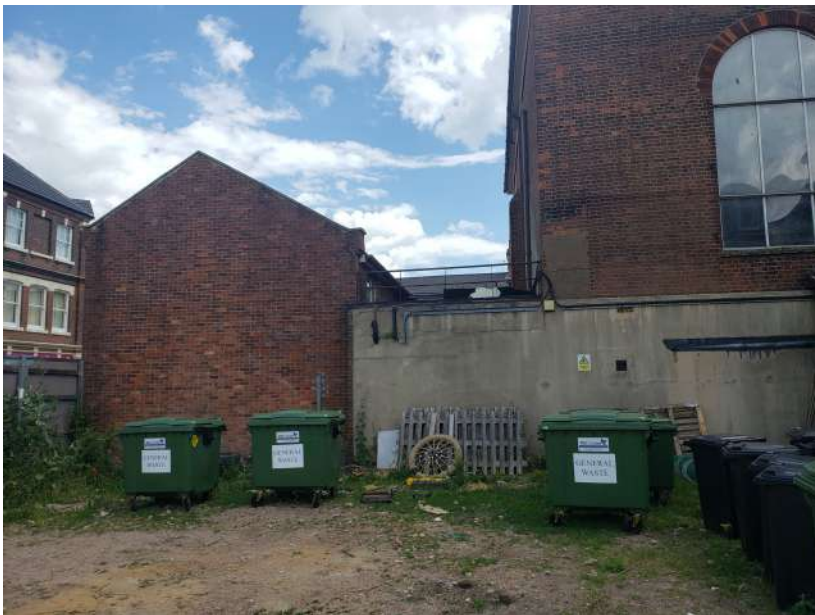
Fig 22:

External, west elevation; showing general view towards gabled end subject to presumed failed coping elements leading to damp ingress to internal structures

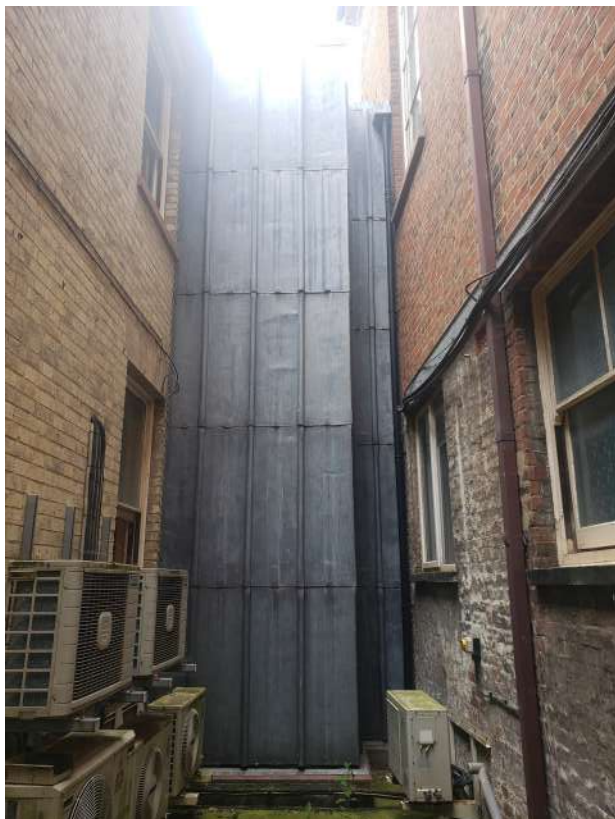
Fig 24:

External, central lightwell/courtyard; showing a general view of the internal east elevation. Note that plant growth was identified at ground level, likely due to inadequate provisions for drainage and the use of improper materials

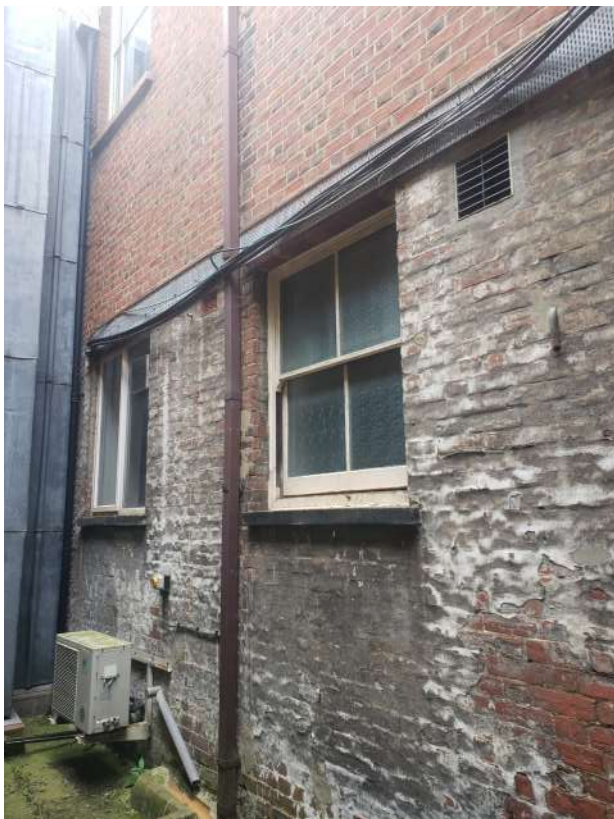
Fig 26:

External, central lightwell/courtyard; showing a general view of the internal south elevation. Note that an increased level of degradation to brickwork and render seen to the lower section, however the upper section was of later construction and therefore in an improved condition. Rainwater drainage systems in this location appeared to be of recent installation, however provisions for ground drainage were deemed to likely be blocked and therefore of inadequate capacity

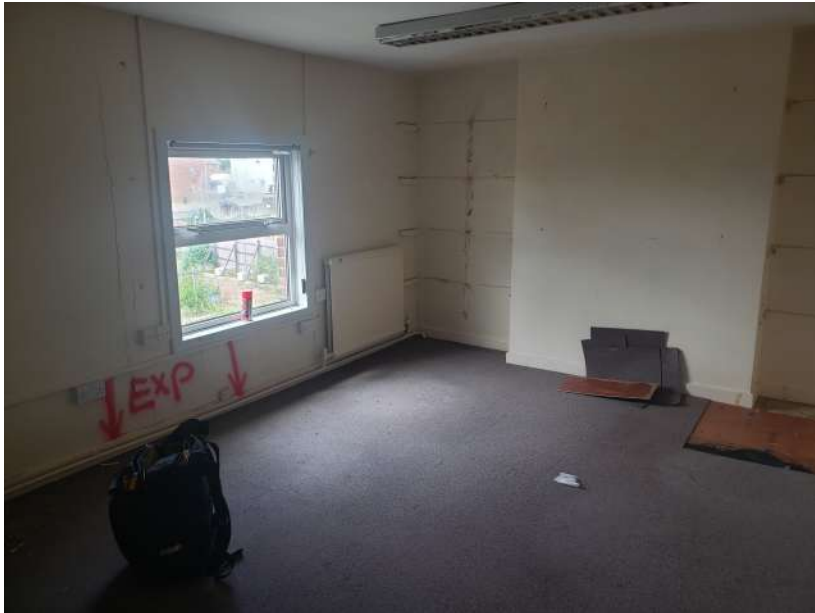
Fig 27:

Internal, second floor; showing a general view of the room south-west to the west range. Note the area of the floor marked for advised exposure to allow for further investigation of the encapsulated floor structure, which may be vulnerable to moisture ingress and biological decay organisms

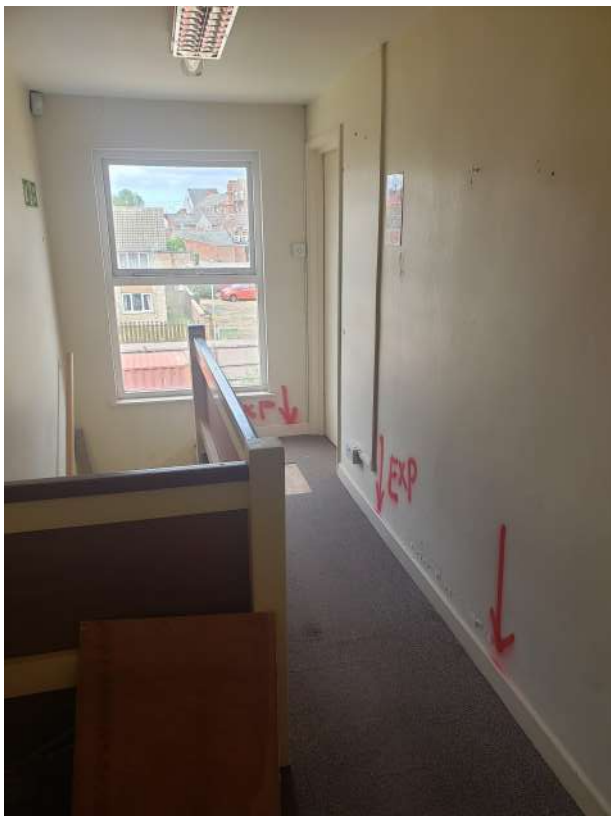
Fig 28:

Internal, second floor; showing a general view of the west range landing area looking north. Note the 2 no. areas of the floor marked for advised exposure to allow for further investigation of the encapsulated floor structure (at the discretion of future demolition plans), which may be vulnerable to moisture ingress and biological decay organisms

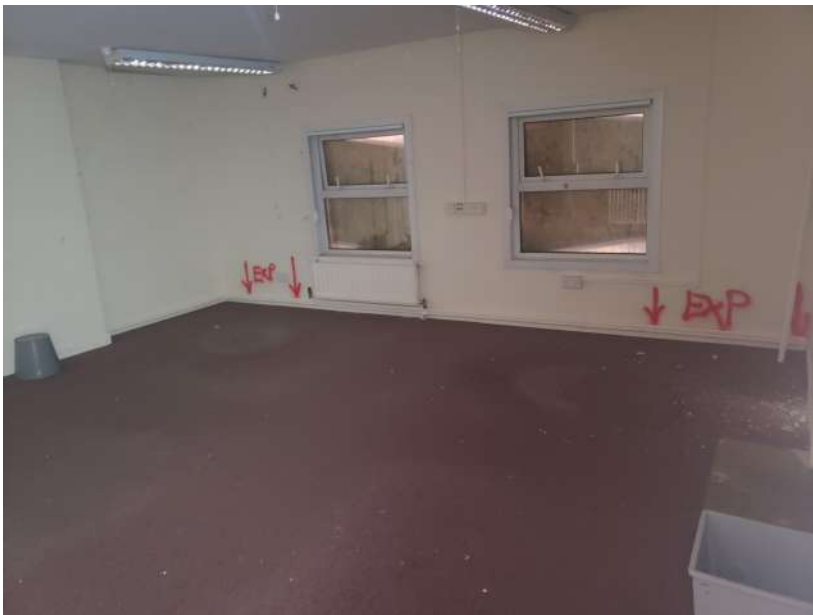
Fig 30:

Internal, second floor; showing a general view looking south of the south-east room to the west range. Note the 2 no. areas of the floor marked for advised exposure to allow for further investigation of the encapsulated floor structure (at the discretion of future demolition plans), which may be vulnerable to moisture ingress and biological decay organisms

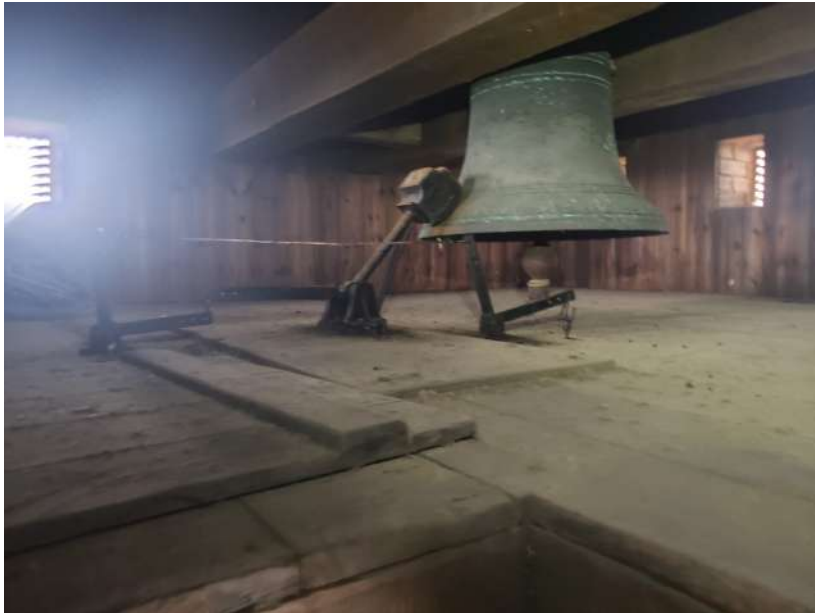
Fig 31:

Clocktower, fourth floor; showing a general view of the floor structure at this floor level. Note that the presence of floorboards and ceiling cladding on the underside restricted full investigations of the structural timber elements. Evidence of moisture saturation of the external brickwork was noted on both the east and west sides. This indicated that there was an increased possibility of moisture saturation of internal structural timbers, that could lead to the onset of biological decay organisms

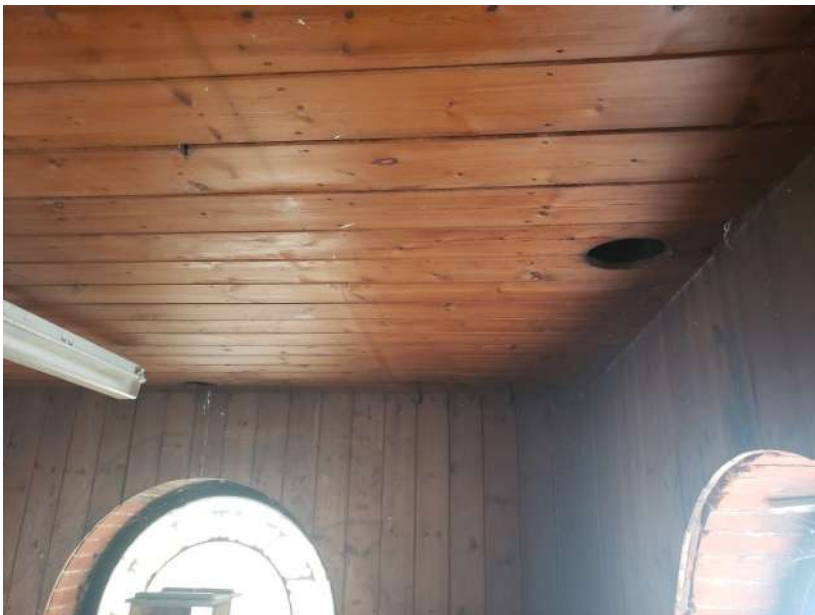
Fig 32:

Clocktower, fourth floor; showing view towards boarded ceiling soffit beneath bell chamber floor

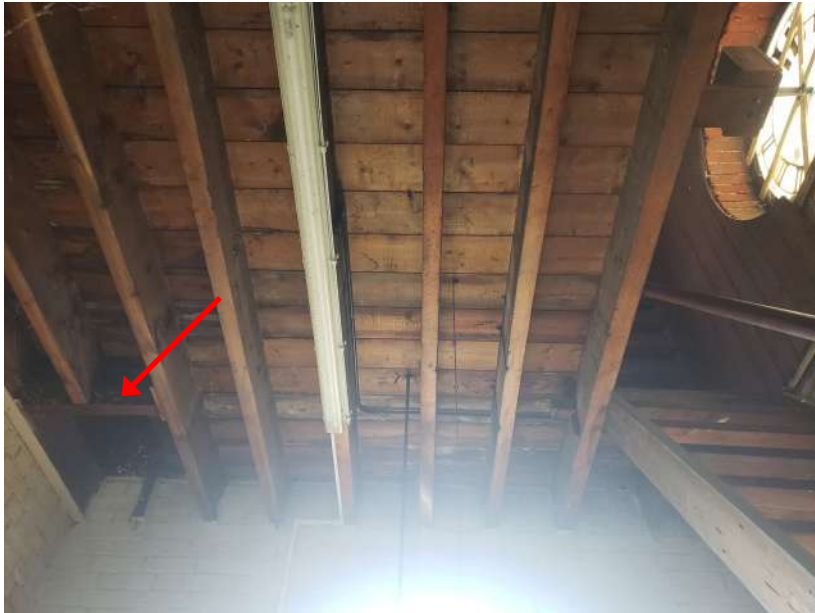
Fig 33:

Clocktower, third floor; showing a general view of the exposed joists and their east embedded ends. Note that 1 no. joist end had previously been identified as decayed and therefore it had been docked and a trimmer joist/nogging had been installed as a remedial measure. Also note that all joists ends forming this floor level had been embedded into the external masonry of the tower, increasing their likelihood of moisture saturation and decay

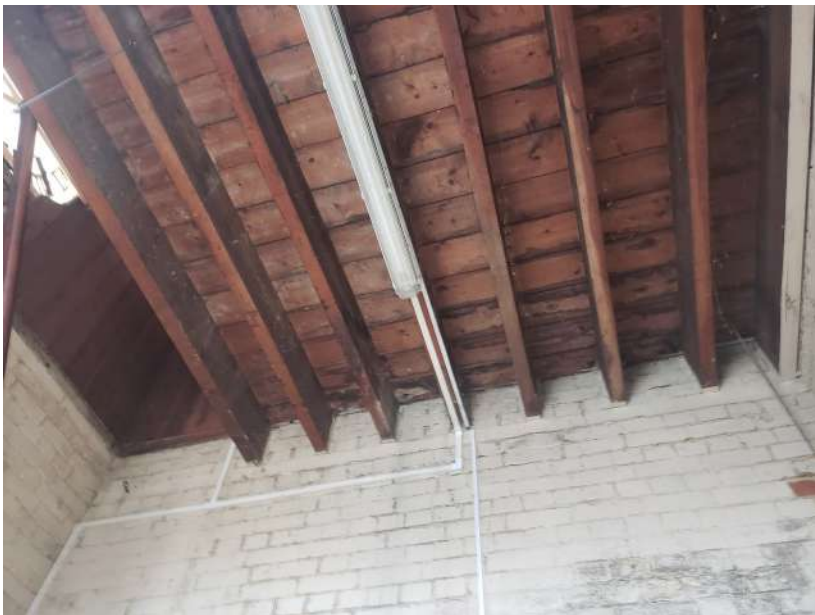
Fig 34:

Clocktower, third floor; showing a general view of the exposed joists and their west embedded ends. Again, the same support method had been employed on this side, increasing the likelihood of moisture saturation and decay to the joist ends

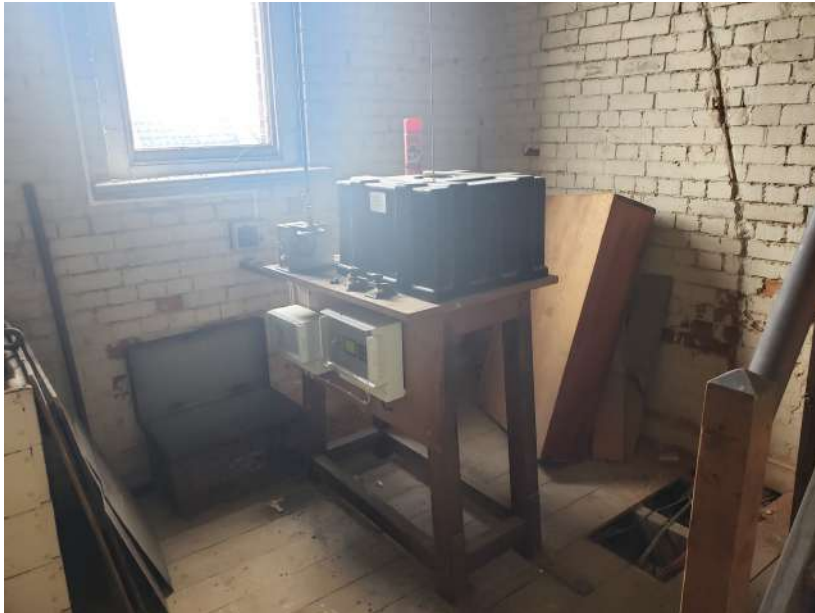
Fig 35:

Clocktower, second floor; showing a general view of the clocktower room at this level. Note the presence of spalling of internal brickwork which suggested that significant moisture saturation had occurred. This would certainly increase the risk of moisture saturation of structural floor timbers that were considered likely to have been embedded into external masonry, as was seen to the floor structure above

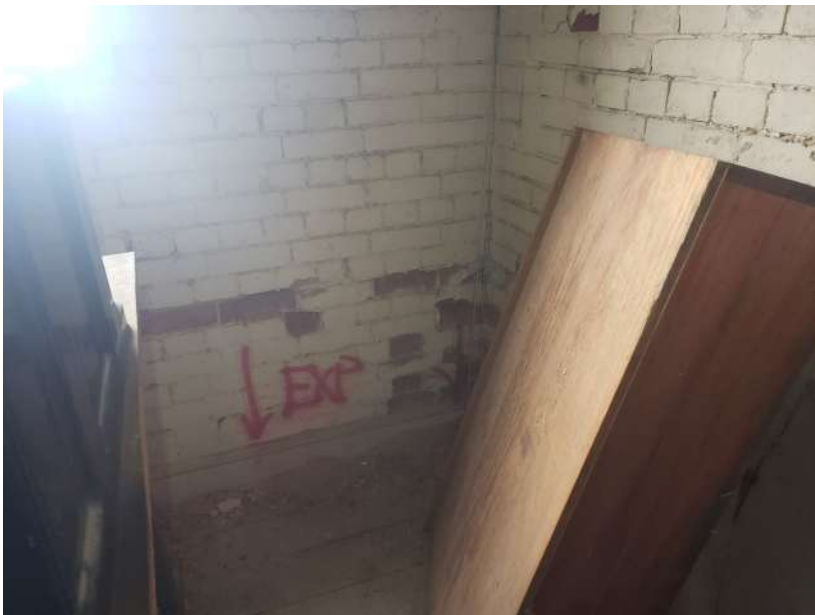
Fig 36:

Clocktower, second floor; showing a localised area of recommended exposure of the floor structure, in the south-east corner. To allow for further investigations of the condition and decay state of vulnerable timber floor members

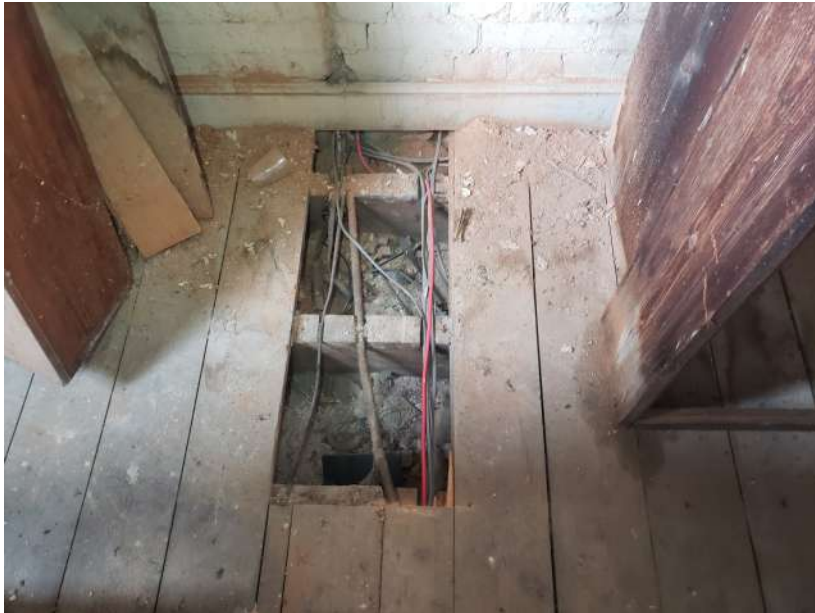
Fig 37:

Clocktower, second floor; showing a focused view of a representative exposed area, allowing for investigations into the structural floor elements. Note that due to the small level of exposure investigations were limited and no decay was detected. Also note the high levels of debris within the floor void, this could contain hazardous materials and should be removed and disposed of in an environmentally friendly and safe manner

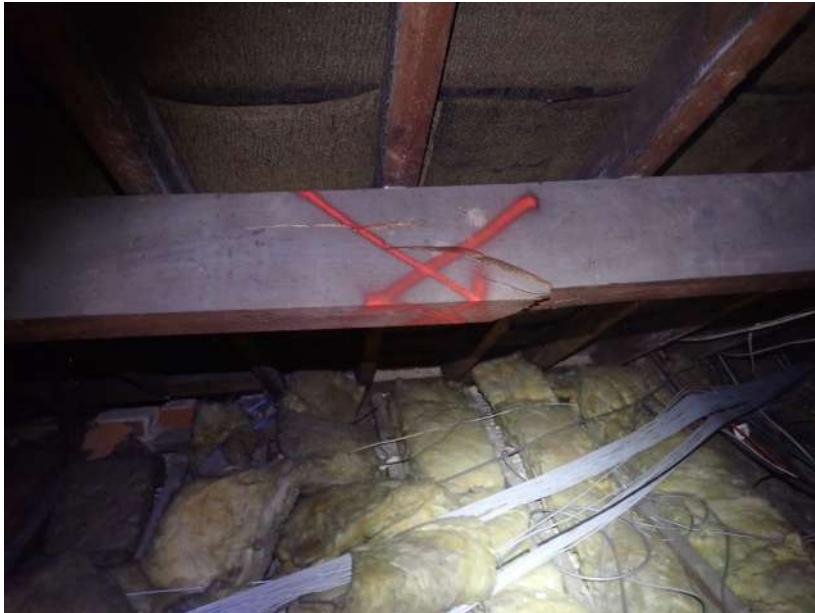
Fig 39:

Roof 1; showing significant structural fracture to east pitched roof purlin

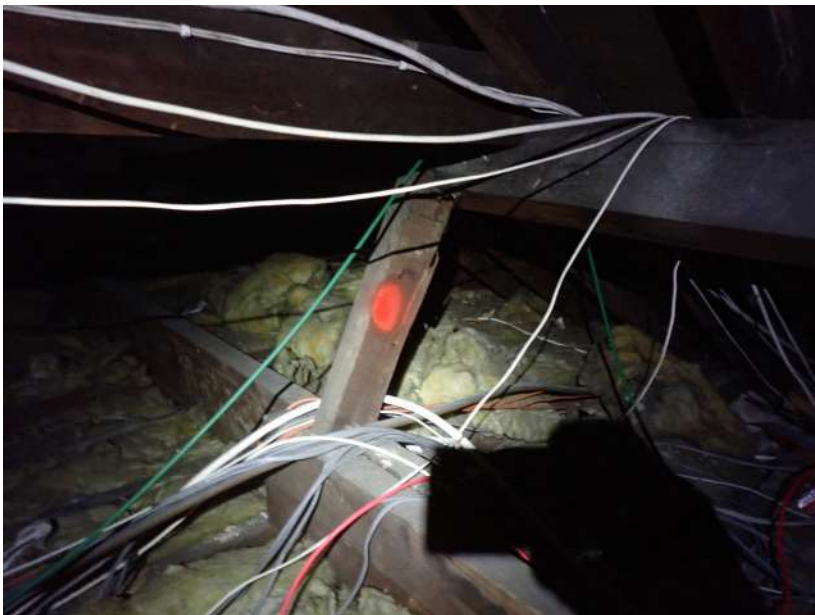
Fig 40:

Roof 1; showing structural fracture to west pitched roof raking strut

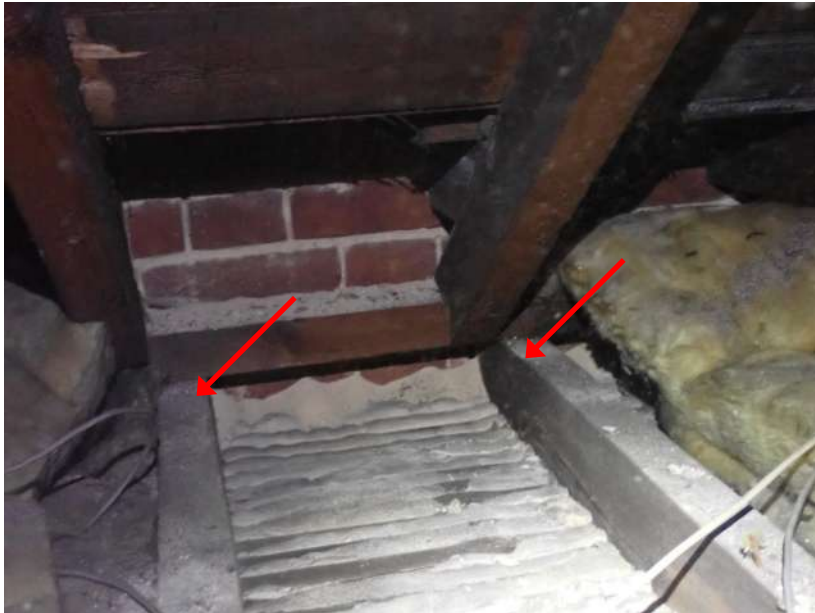
Fig 41:

Roof 1; showing representative view towards the east pitch roof detailing beneath the valley juncture. Note common rafters supported onto a perpendicular plate which is itself supported onto ceiling joists embedded into the historically vulnerable masonry wall. Allow for decay detection drilling and probing to all masonry embedded timbers when safe and convenient access is arranged

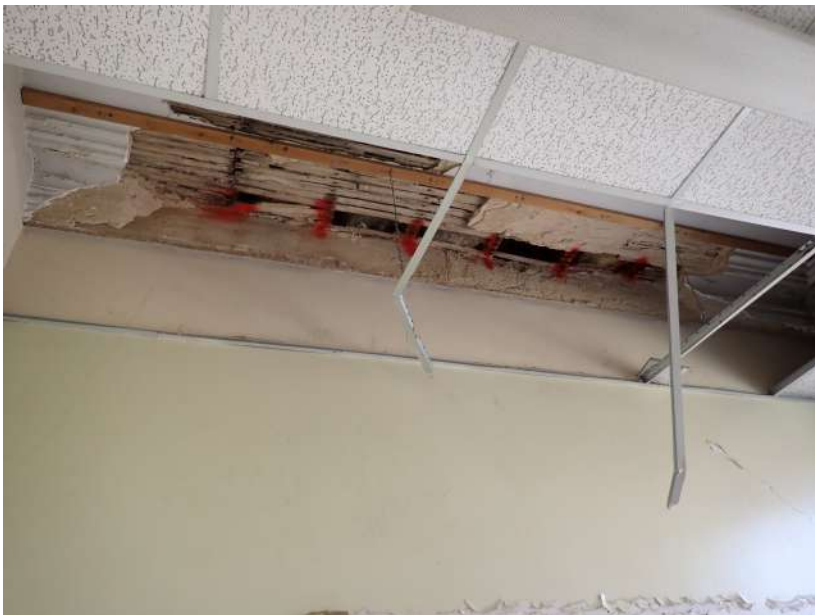
Fig 42:

Roof 1; showing view to the 6-10no. historically decayed embedded ceilings joists and common rafter ends to the north area to the west pitch. Concealed rafter plate also presumed decayed

Roof 1; showing thermal image to decayed structures shown at fig.42. Note no evidence of significant active moisture penetration at the time of investigation

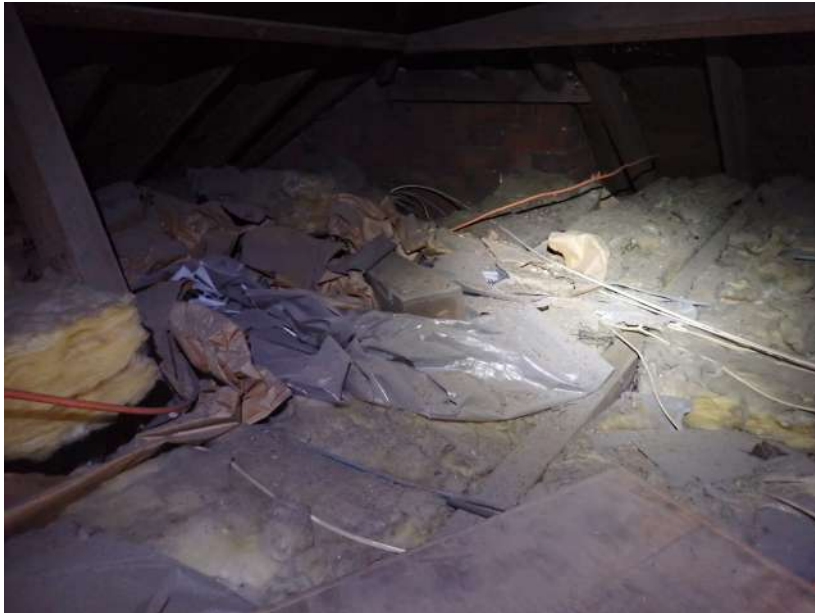
Fig 45:

Roof 2; showing significant build-up of historic debris and insulative material within roof void which may contain hazardous materials and should be removed and disposed of in an environmentally friendly and safe manner

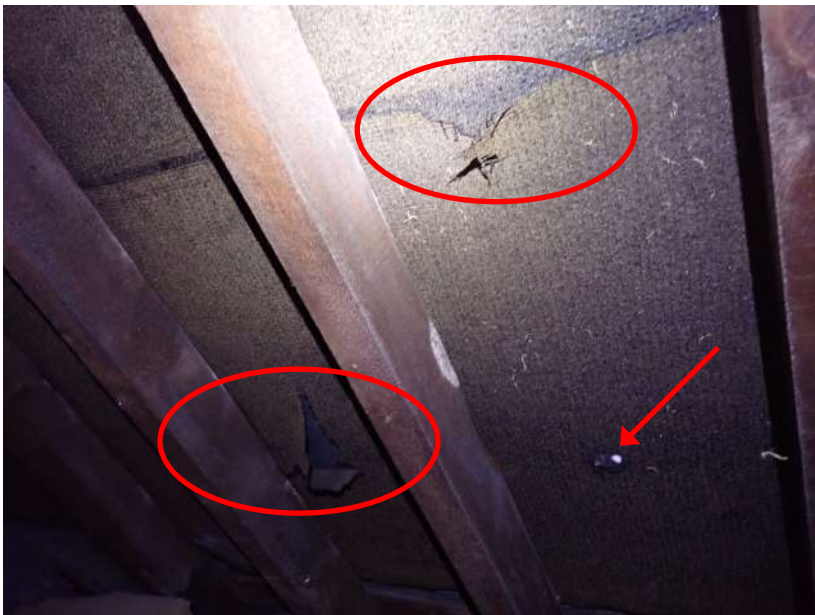
Fig 46:

Roof 2; showing representative area of roof felt formed of a non-breathable bitumen type membrane likely to create the conditions for interstitial condensation issues during periods of high humidity and temperature fluctuations. Also note multiple areas of damaged/compromised roofing felt membrane identified

Roof 2; showing significant evidence for surface mould growth to the underside of roof timber elements likely as a result of improper roofing felt membranes combined with inadequate ventilation. See also fig.46. NB. Airborne surface mould spores can cause serious respiratory health hazards to those occupying the same air-space

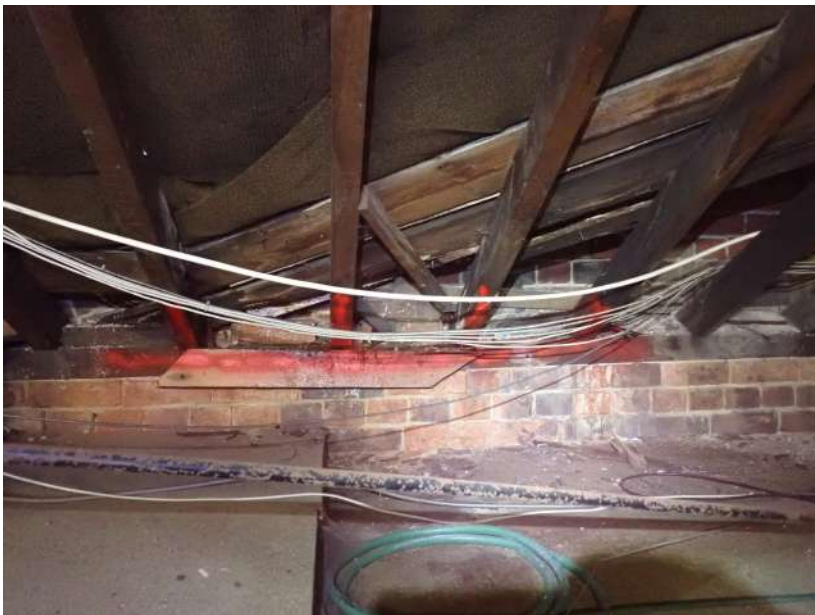
Fig 48:

Roof 2; showing area of ongoing structural decay issues to the central south area beneath failed parapet gutter linings

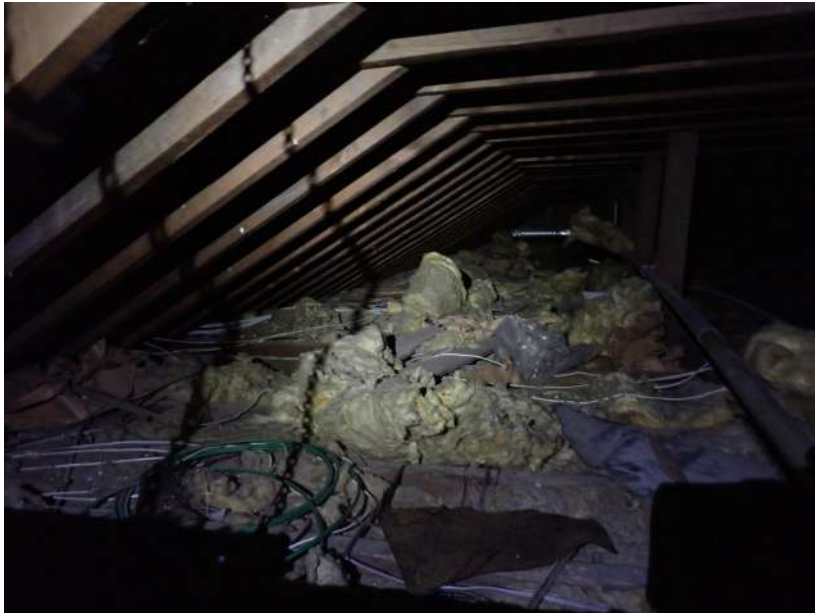
Fig 49:

Roof 2; showing general view of south pitch roof looking west. Note no safe/ convenient access to deep drill and moisture probe vulnerable timbers beneath the south perimeter parapet gutter. Further investigation warranted
