LOWESTOFT TOWN HALL

ROTHOUND INVESTIGATION OF DRY ROT INFECTION AND DECAY

JOB NO. 158-97

LOWESTOFT TOWN COUNCIL

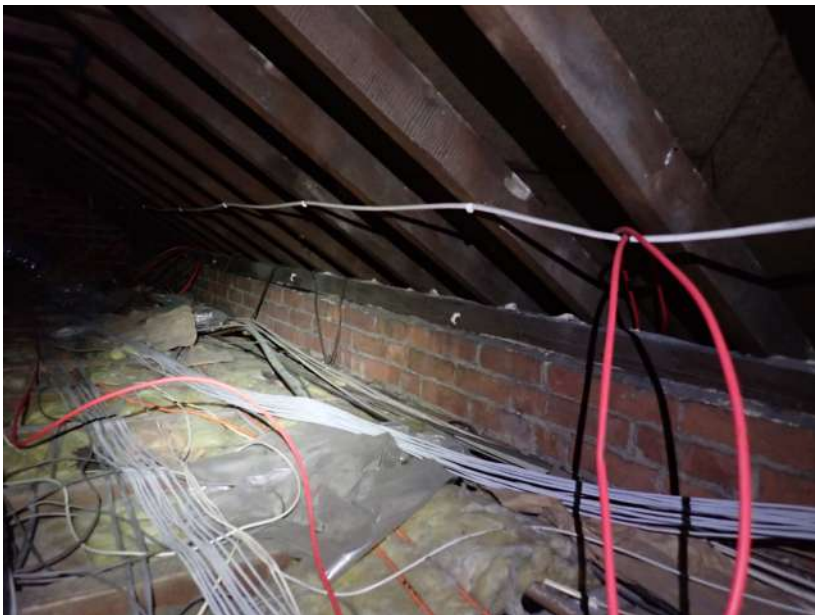
Fig 50:

Roof 2; showing general view of north pitch roof looking west. Note good access to the eaves rafter plate for ventilation, drying and inspection. No significant decay detected

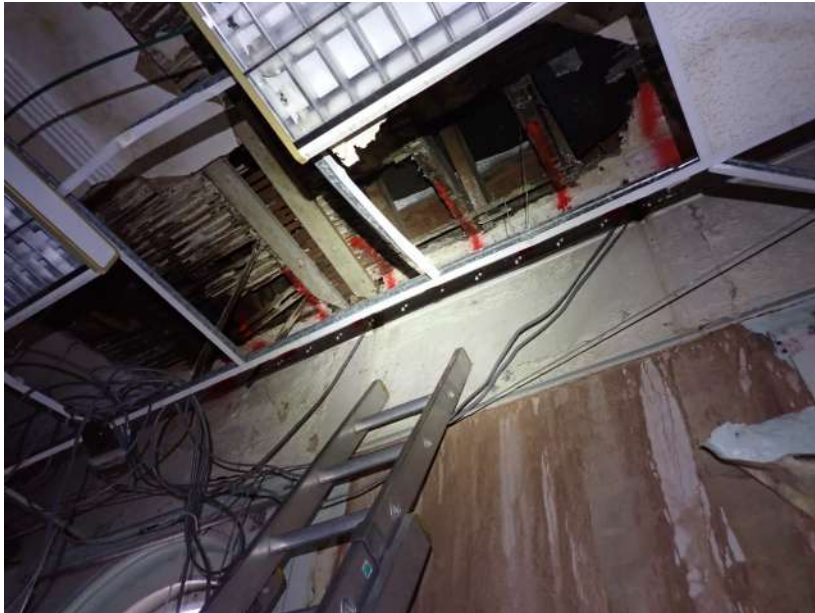
Fig 51:

Roof 2; showing area of ongoing structural decay issues to the central south area beneath failed parapet gutter linings. Decayed items include for ~10no. Common rafters and ceiling joist ends, as well as up to ~4m of rafter plate

Roof 2; showing thermal image to decayed structures shown at fig.51. Note no evidence of active damp penetration issues to general area from presumed failed parapet gutter linings above. Timbers remain highly vulnerable to further structural decay

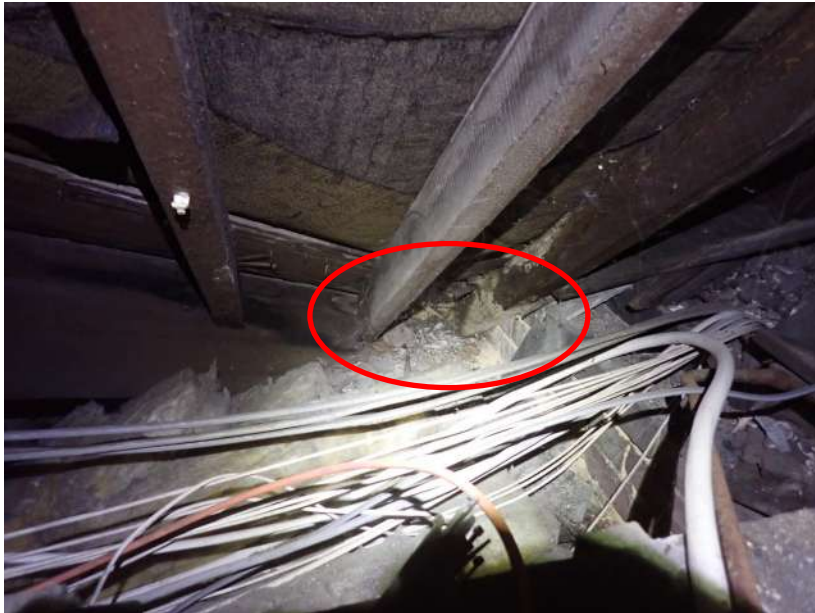
Fig 53:

Roof 2; showing north-east corner adjacent to the tower with multiple timbers subject to active moisture penetration issues and decay from failed external roof finishes and faulty guttering. Decayed items include for hip rafter end, ~2-4no. Common rafters and up to ~500mm of rafter plate. Allow for further inspection

Roof 2; showing external view towards faulty exterior lightwell area roof drainage goods symptomatic of decay issues shown at fig,53

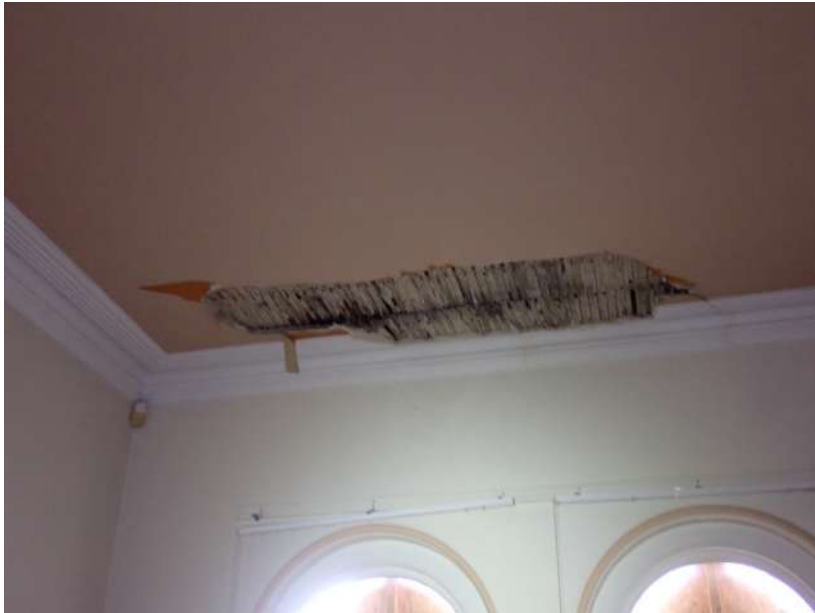
Fig 55:

Roof 2; showing area of apparently recent water penetration issues/ damage to ceiling structures over the principal south-east stairs. Rafter plate and common rafters ends beneath parapet gutter to this area presumed subject to decay issues. Further investigation warranted

Roof 2; showing thermal image to water damaged ceiling structures shown at fig.55. Note no significant evidence of chronic/active damp penetration issues to general area from presumed failed parapet gutter linings above. However, this may be accredited to the recent warm/dry spell preceding the investigation. Timbers remain highly vulnerable to further damp and decay

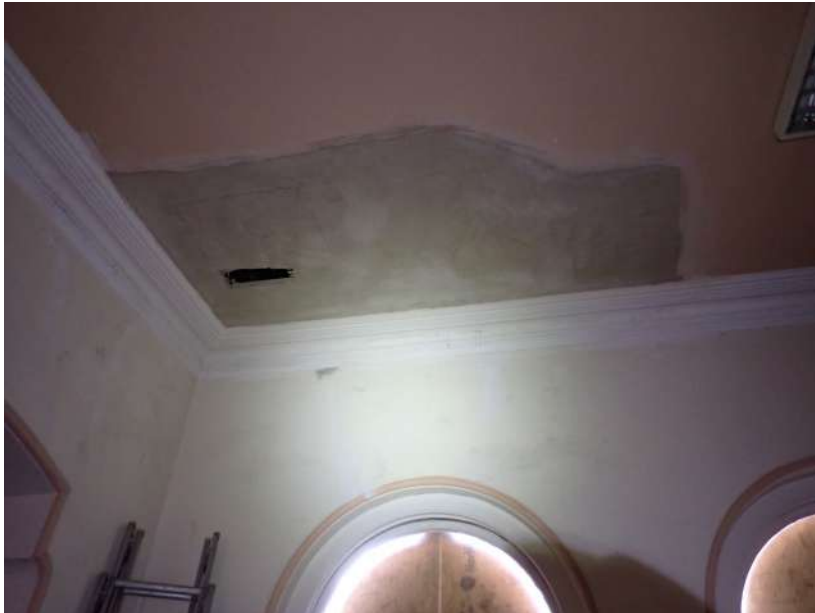
Fig 57:

Roof 2; showing area of apparently recent water penetration issues and subsequent patch repair from water damage to the north-east corner. Rafter plate and common rafters ends beneath parapet gutter to this area presumed subject to decay issues. Further investigation warranted

Roof 2; showing thermal image to repaired lath and plaster ceiling structures shown at fig.57. Note no evidence of active damp penetration issues to general area from presumed failed parapet gutter linings above. However, further investigation warranted to determine condition to vulnerable timbers beneath the historically failed parapet gutter

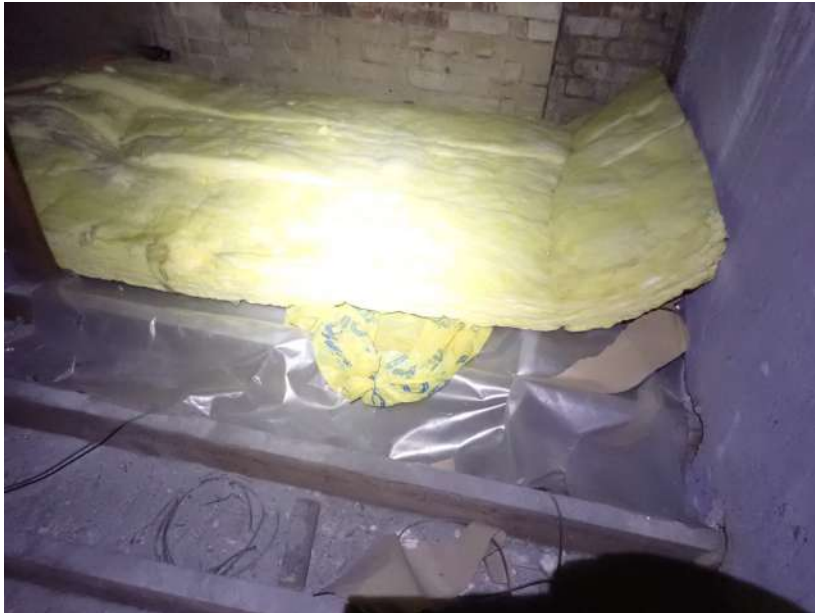
Fig 59:

Roof 3; showing improper detailing to the south area to the roof void indicative of recent remedial efforts to prevent water damage issues to historic lath and plaster ceilings. Roof envelope presumed compromised to this area

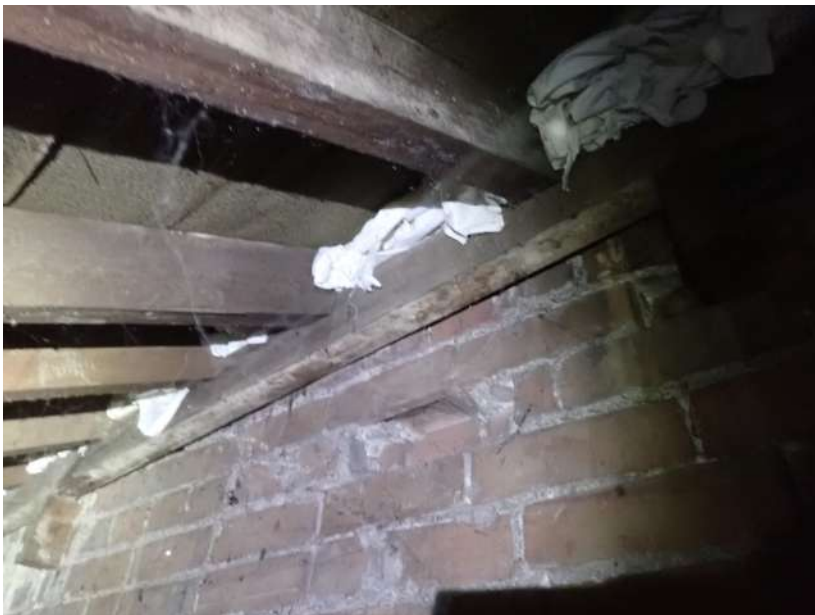
Fig 60:

Roof 3; showing general view towards upper rafter plate to lean-to roof structure. Note rafter plate eaves improperly packed with fabric, denying eaves ventilation and restricting drying

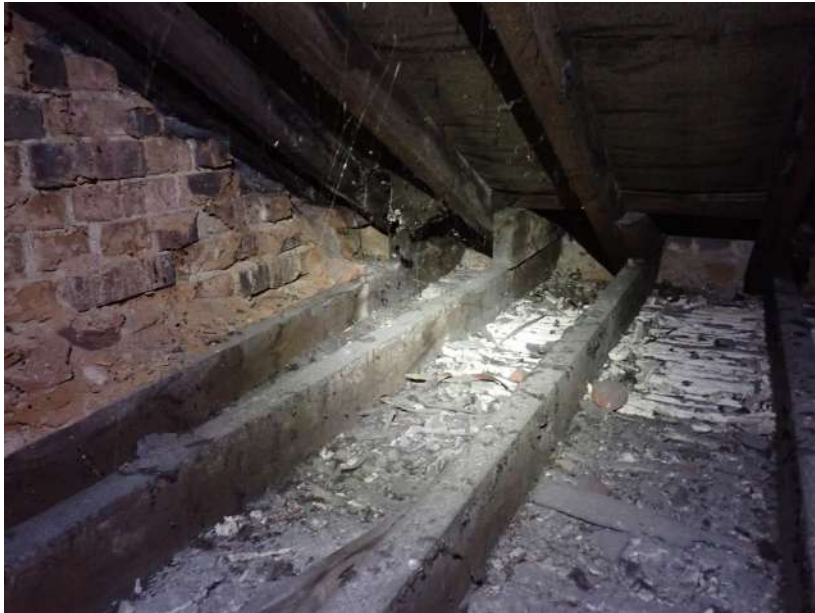
Fig 61:

Roof 3; showing north-east corner apparently subject to low-level recent damp penetration issues with visible early onset of decay issues to roof structural elements. Note embedded collars/ceiling joists deemed highly vulnerable to decay from potentially damp masonry

Roof 3; showing thermal image to vulnerable structures shown at fig.61. Note some evidence of active damp penetration issues to general area from presumed failed parapet gutter linings above. Timbers remain highly vulnerable to ongoing decay issues

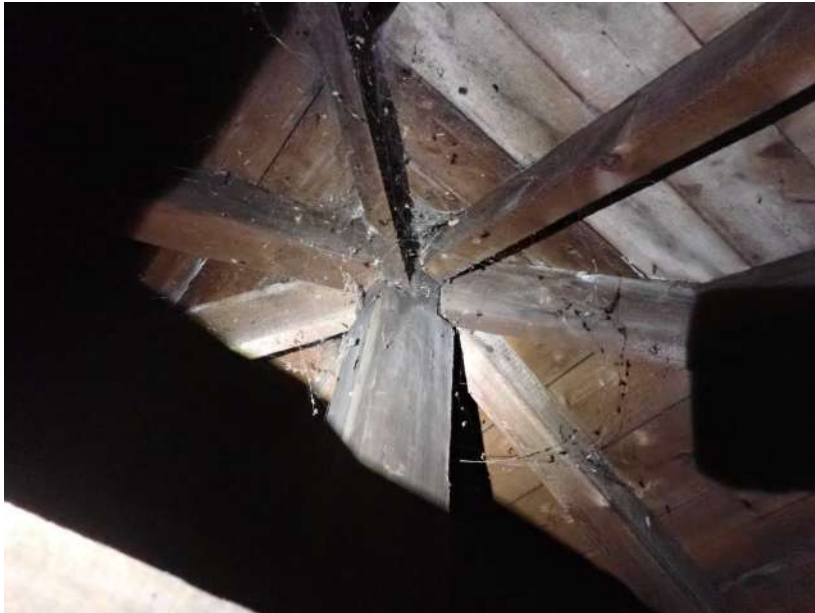
Fig 63:

Tower roof; showing general view of timber structures forming apex joinery. No decay or defects identified

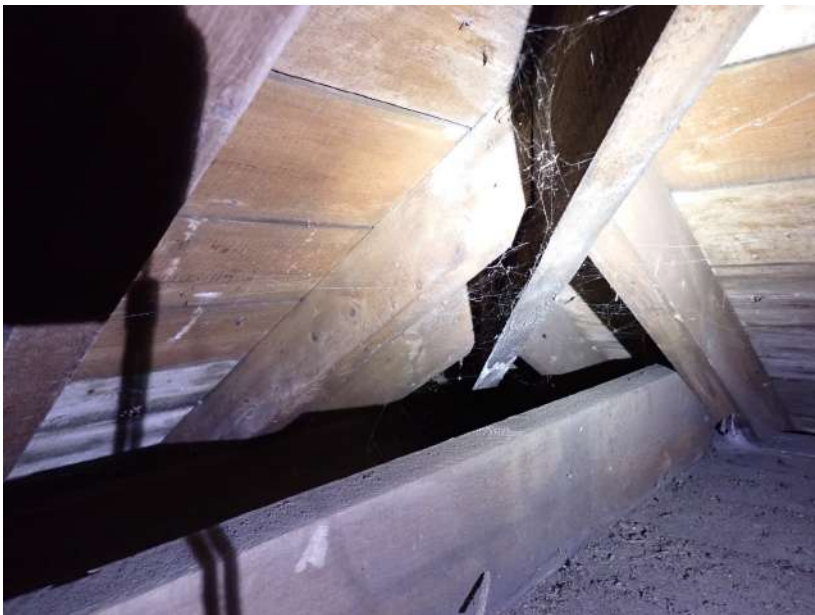
Fig 64:

Tower roof; showing representative view of roof structures forming the eaves hipped end juncture. Note no access to rafter plate for inspection. However, no decay anticipated

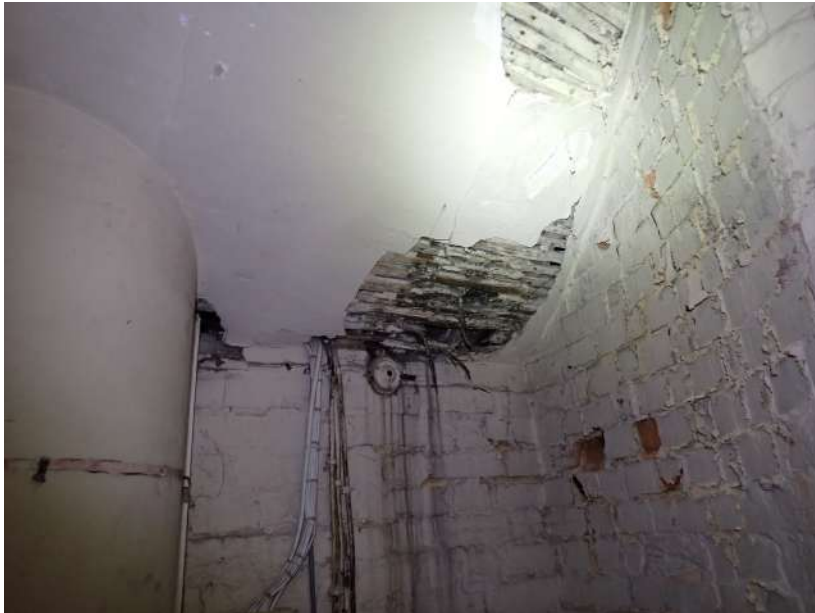
Fig 65:

Tower roof access; showing the small roof structures over the tower roof stairwell subject to active damp penetration issues causing ongoing decay to the rafter plate and rafter ends

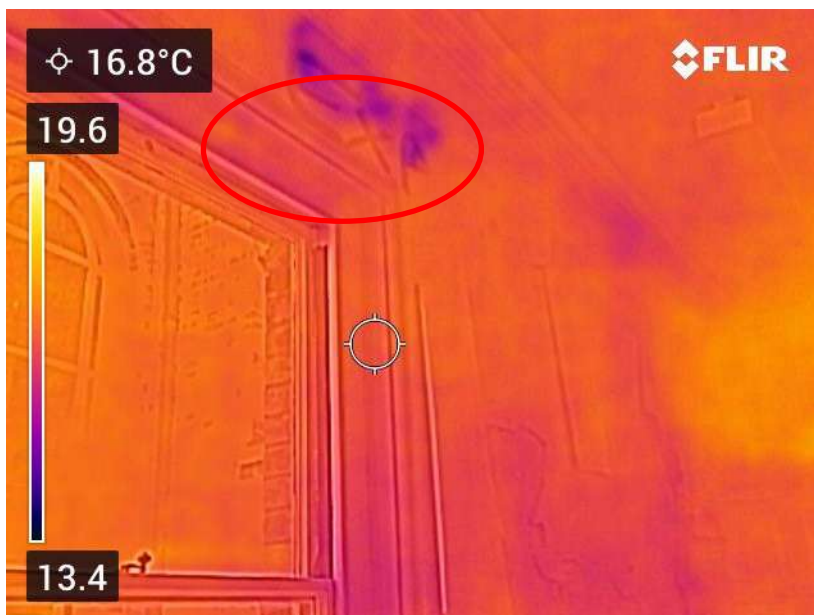
Fig 66:

Roof 2; showing thermal image to general area forming access to the Tower roof. Note masonry mass apparently subject to high moisture contents likely creating the conditions for damp and decay to the embedded adjacent north (lightwell elevation) timber lintels

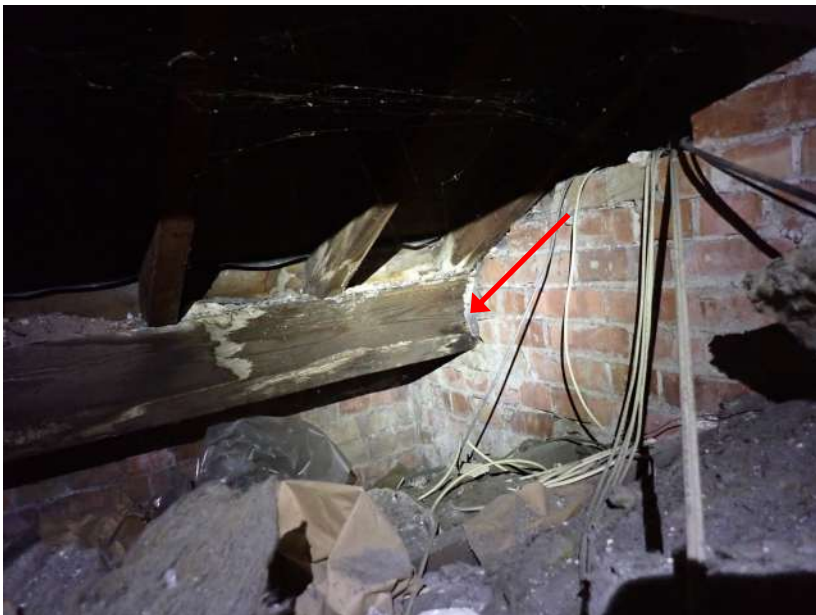
Fig 68:

Roof 6; showing partially decayed embedded rafter plate/parapet valley beam to the south-east corner

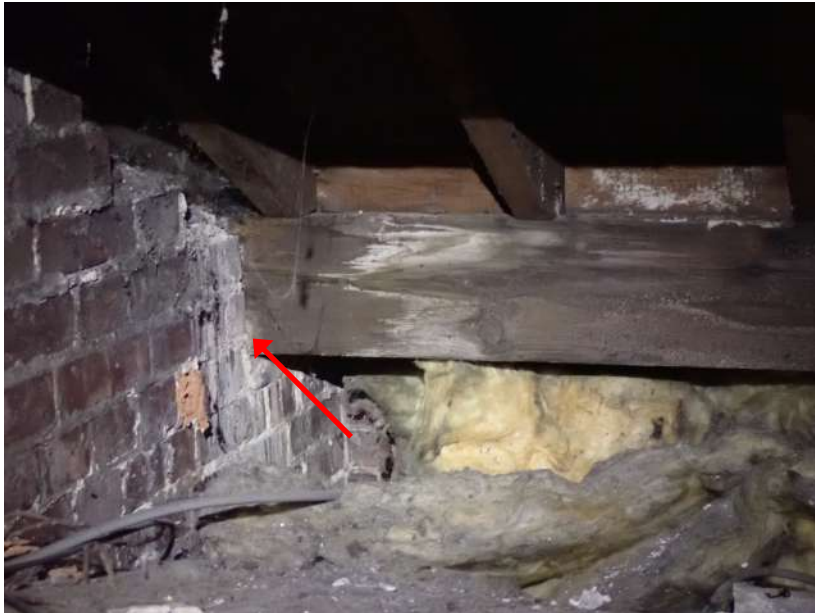
Fig 69:

Roof 6; showing partially decayed embedded plate/parapet valley beam to the north-east corner. Allow for cutting back and separating structural timber from damp masonry via a suitable steel bracket under the direction of the Structural Engineer

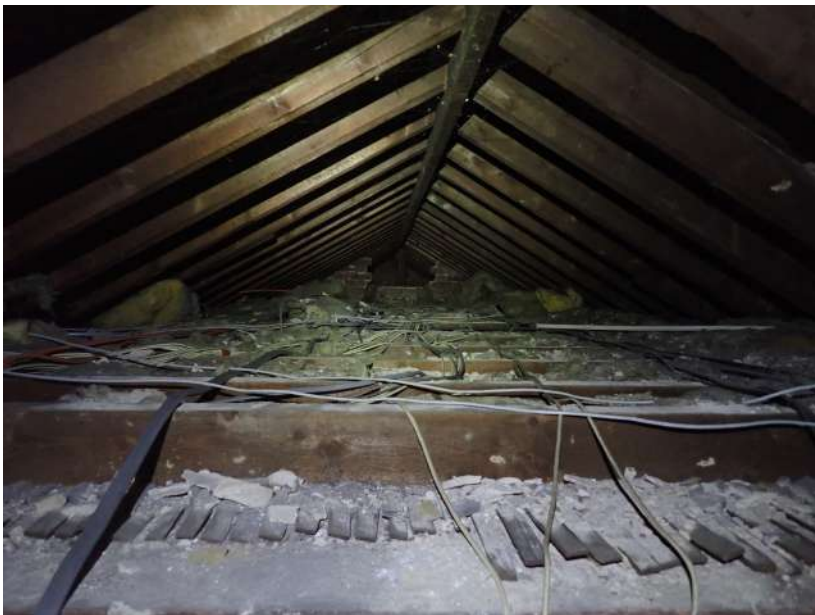
Fig 70:

Roof 7; showing general view of upper roof void looking west. No apparent decay detected although access was limited. All lower roof voids form first floor attic rooms

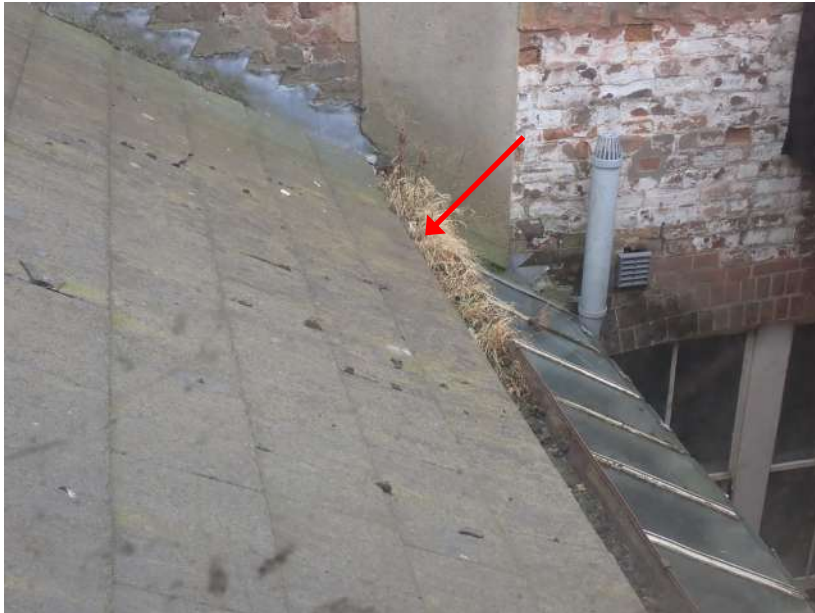
Fig 71:

Roof 6, west eaves area; showing view towards significant blockage to the west pitch eaves gutter. Rafter plate and rafter feet deemed highly vulnerable to decay to this area

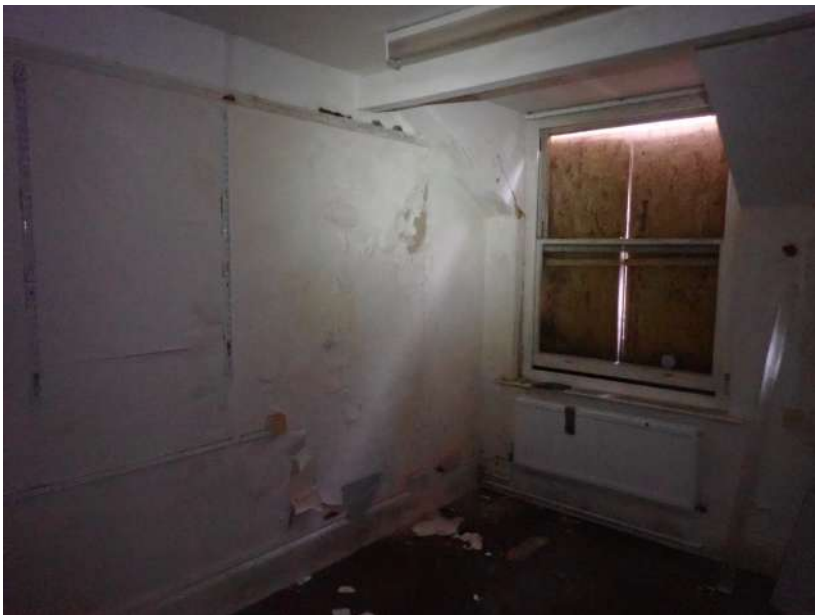
Fig 72:

Roof 7; showing view towards the first floor attic east room dormer. Note general area subject to severe damp penetration issues. Widescale decay issues suspected to concealed roof structures to this area. Further investigation required

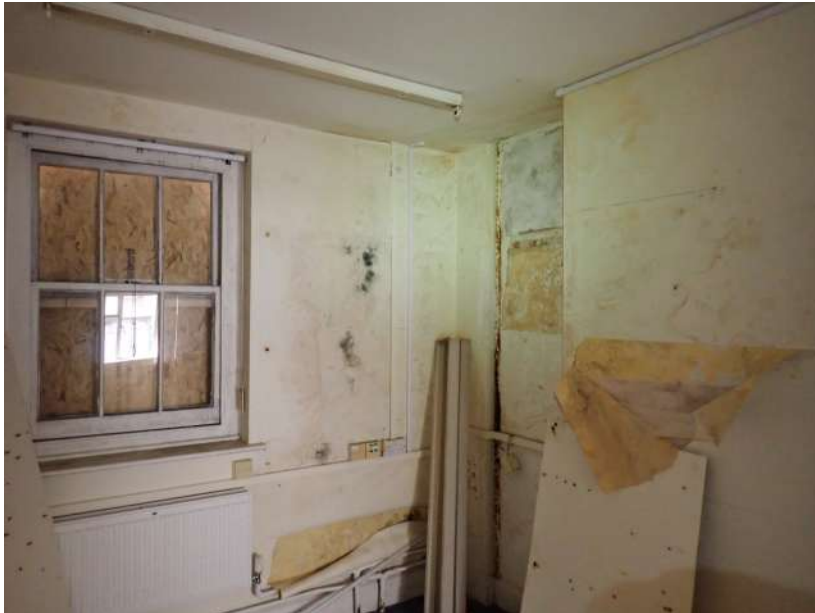
Fig 73:

Roof 7; showing view towards the first floor attic west room. Note north elevation wall subject to severe damp issues, presumably from failed roof finishes and drainage goods above. Widescale decay issues suspected to concealed roof structures to this area. Further investigation required

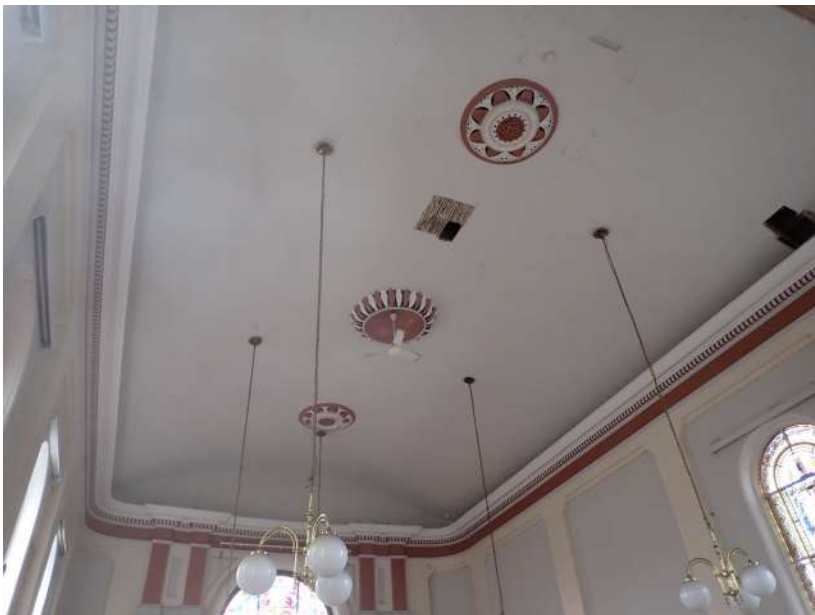
Fig 74:

Roof 3; showing general view towards main hall roof structures inaccessible for inspection at the time of investigation. However, no significant damp penetration issues identified

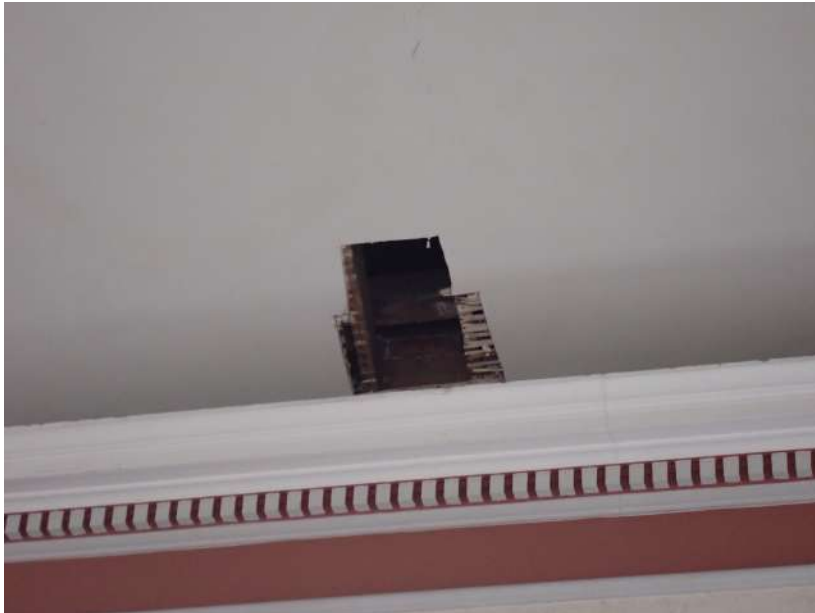
Fig 75:

Roof 3, main hall; showing very localised opening to the north-east corner. No decay suspected to principal roof structure

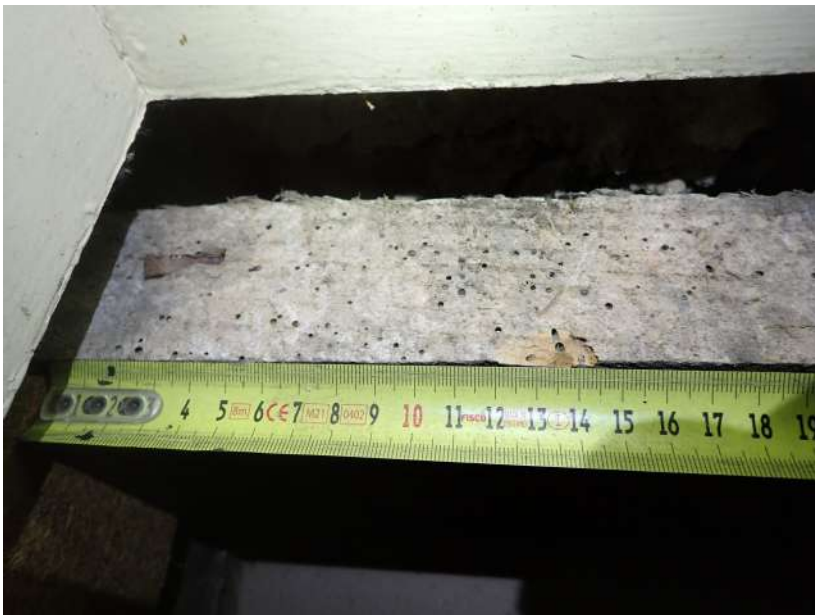
Fig 76:

First floor, west range; showing a representative floor joist subject to wood-boring beetle infestation to its vulnerable remaining sapwood band. Note the distinct ~1-2mm diameter flight holes indicative of Common furniture beetle (*Anobium punctatum*)

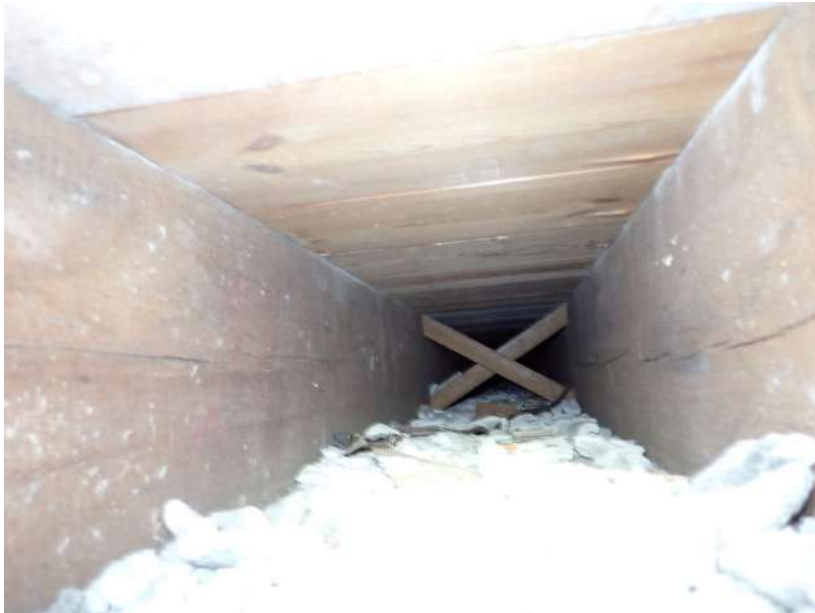
Fig 77:

First floor, west range; showing representative view of floor void between joist centres. Note no provision for insulation/pugging material however, joists apparently laterally strengthened via herringbone struts

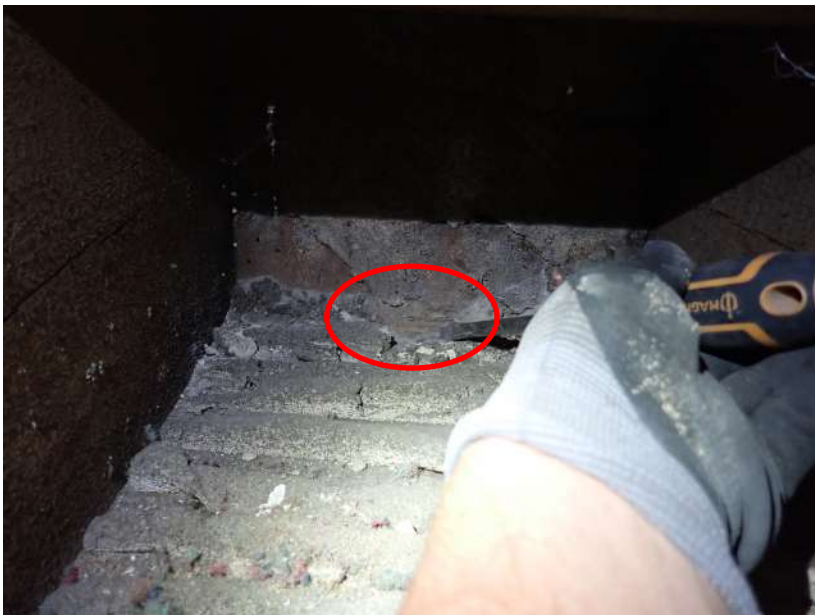
Fig 78:

First floor, west range; showing representative view to embedded wall plate location providing support to the suspended timber floor structures. All vulnerable embedded timbers require deep drilling and probing to determine decay state and deep moisture content/vulnerability to active decay organisms

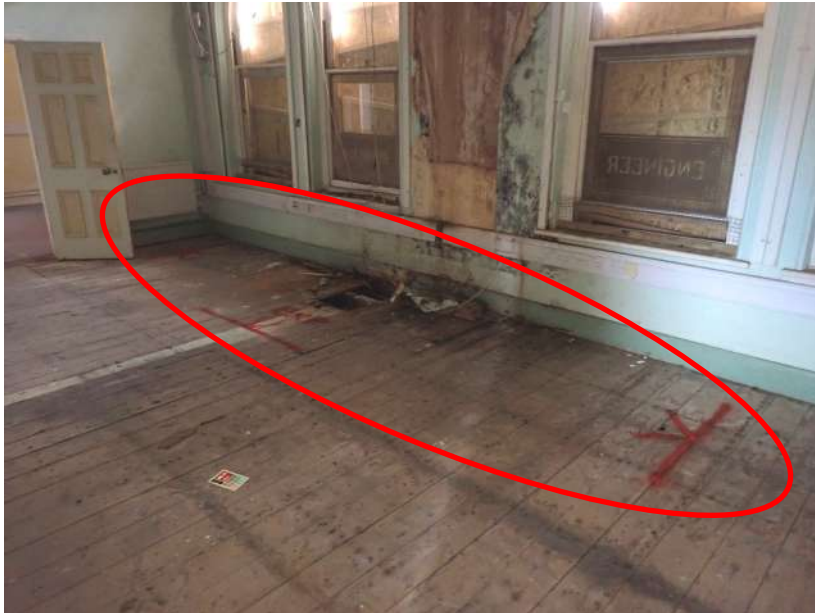
Fig 79:

First floor, south range; showing general view towards the central rooms south elevation subject to severe dry rot decay infection from failed parapet gutters above. Note areas recommended for exposure/further investigation works indicated on-site via water soluble red spray paint

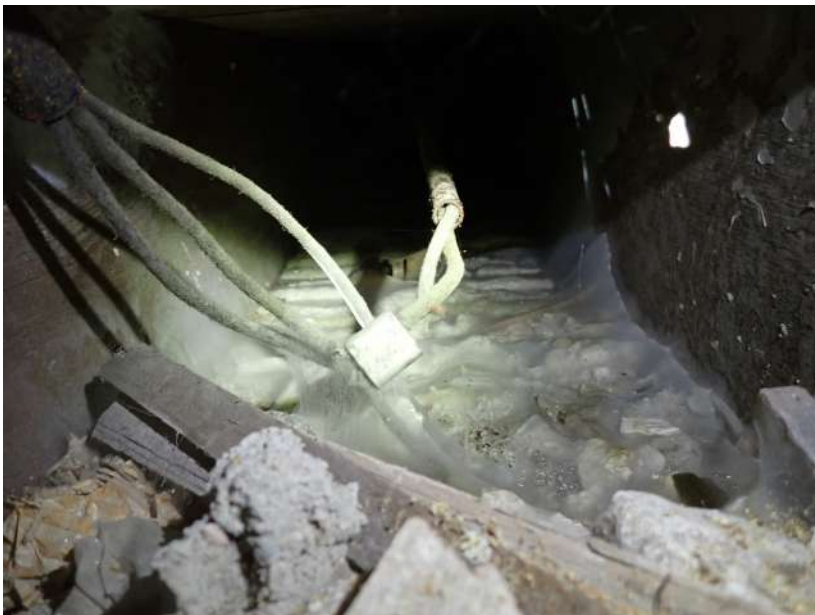
Fig 80:

First floor, south range; showing an active blanket of mycelial growth spreading within unventilated floor void indicative of dry rot decay (*Serpula lacrymans*)

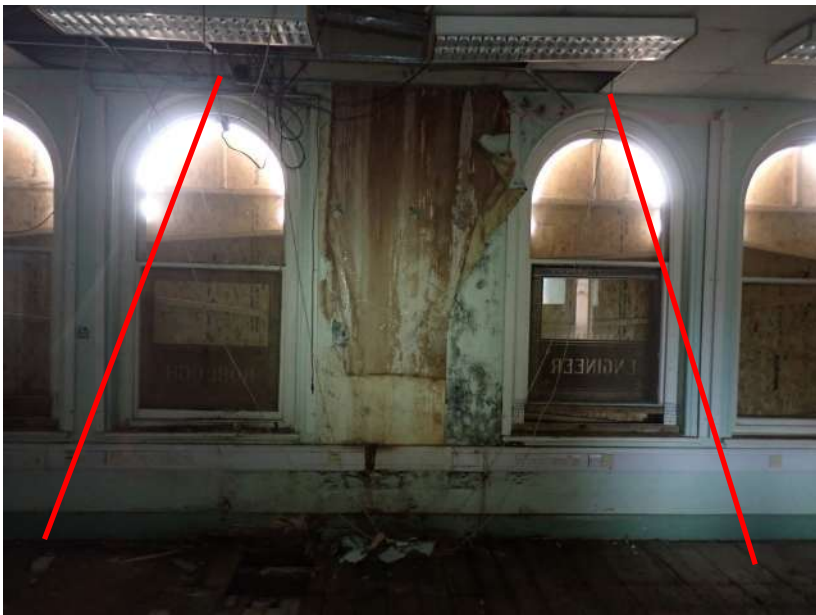
Fig 82:

First floor, south range; showing view towards the central roofs south perimeter wall subject to active decay organisms. All window joinery and secondary timbers local to dry rot outbreak presumed decayed beyond retention as indicated via red lines

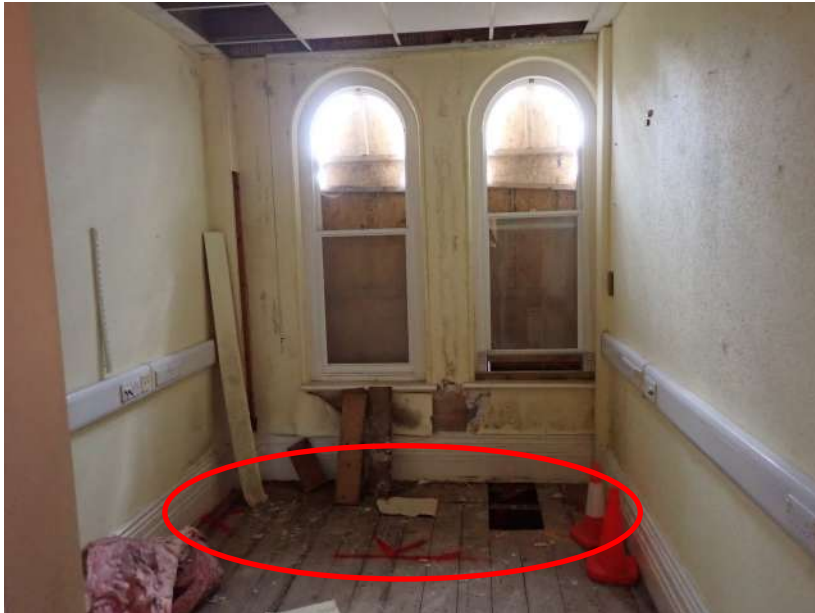
Fig 83:

First floor, south range; showing view towards the east rooms south perimeter wall subject to active damp penetration issues and early onset dry rot infection. Note floor areas recommended for exposure/further investigation works indicated on-site via water soluble red spray paint

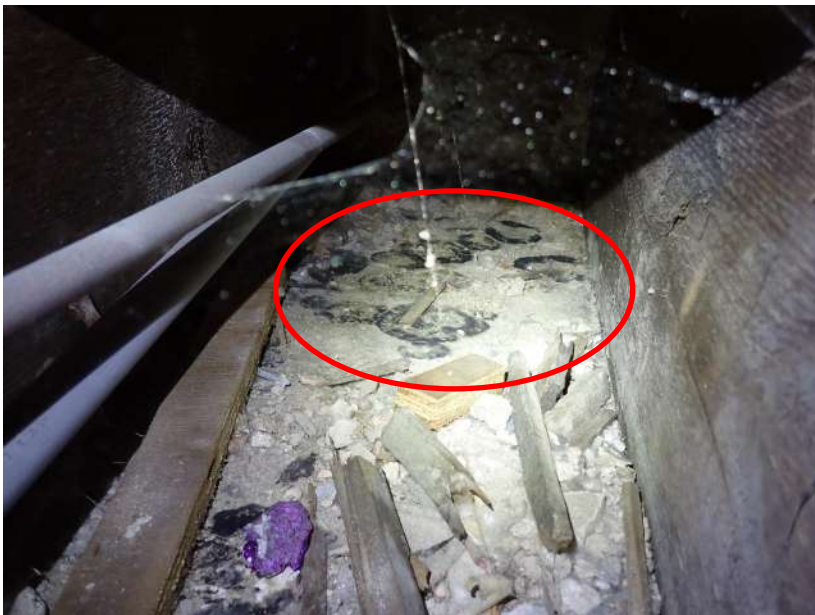
Fig 84:

First floor, south range; showing view to adjacent floor void to the east rooms south perimeter wall. Note evidence for prolonged damp penetration issues to the area creating the conditions for fungal growth

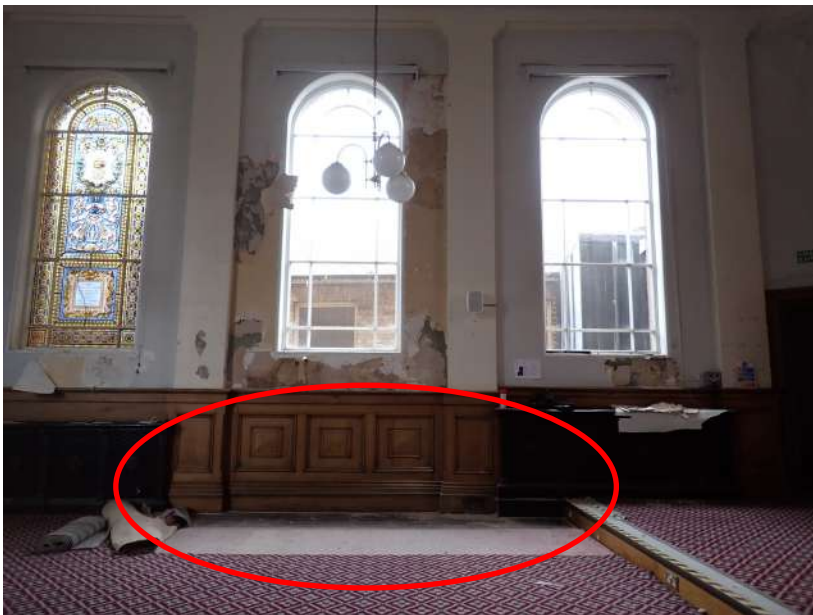
Fig 86:

First floor, main hall; showing view towards the south perimeter wall. Note damp issues visible to masonry wall potentially indicative of decay issues to concealed timber floor structures as well as to the decorative panelling. Further investigation warranted

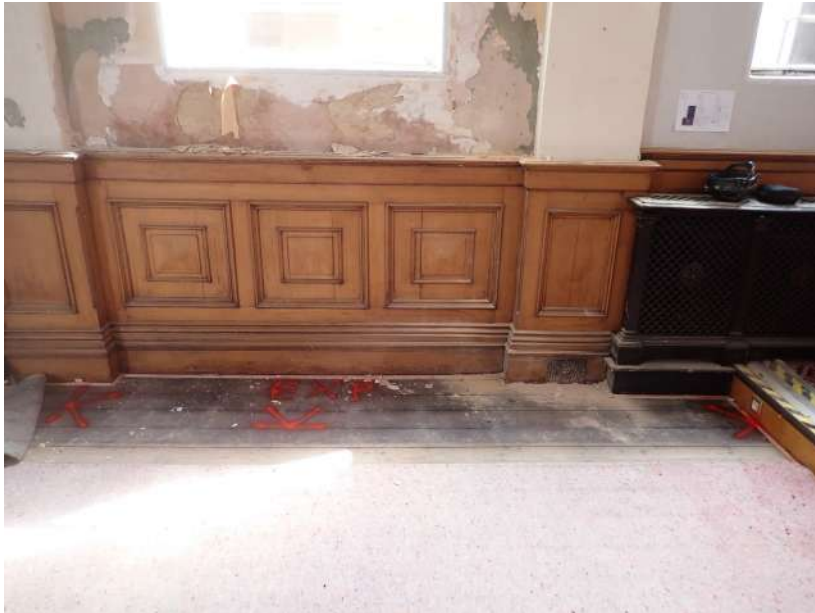
Fig 87:

First floor, main hall; showing view towards the south perimeter wall. Note damp issues visible to masonry wall potentially indicative of decay issues to concealed timber floor structures as well as to the decorative panelling. Further investigation warranted

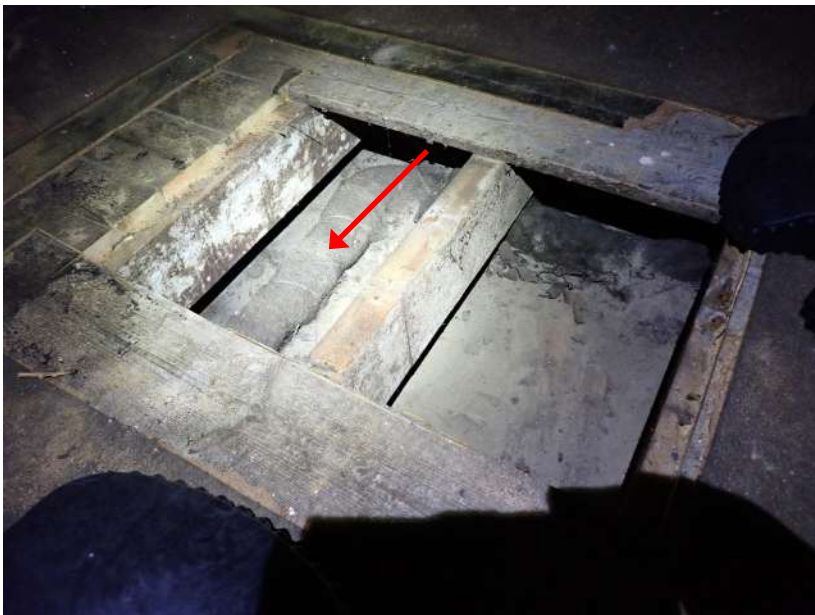
Fig 88:

Ground floor, west range; showing representative view to floor opening. Note fibrous lagging to historic underfloor services presumed to contain ACMs. Timbers inaccessible for deep drilling and moisture probing at the time of investigation

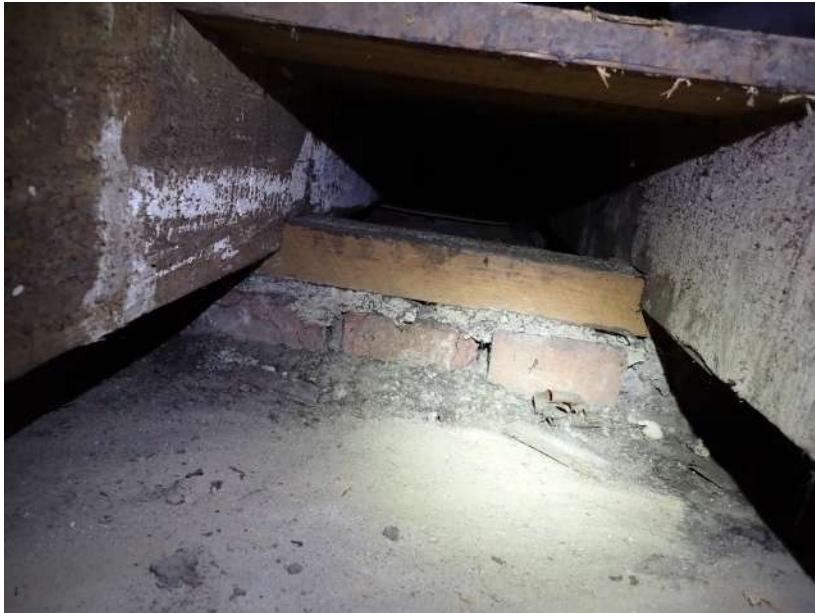
Fig 89:

Ground floor, west range; showing representative view to floor void. Note floor joist build-up supported onto floor plate supported onto a single brick dwarf wall. Note no apparent provision for damp proofing between dwarf wall and horizontal floor plate

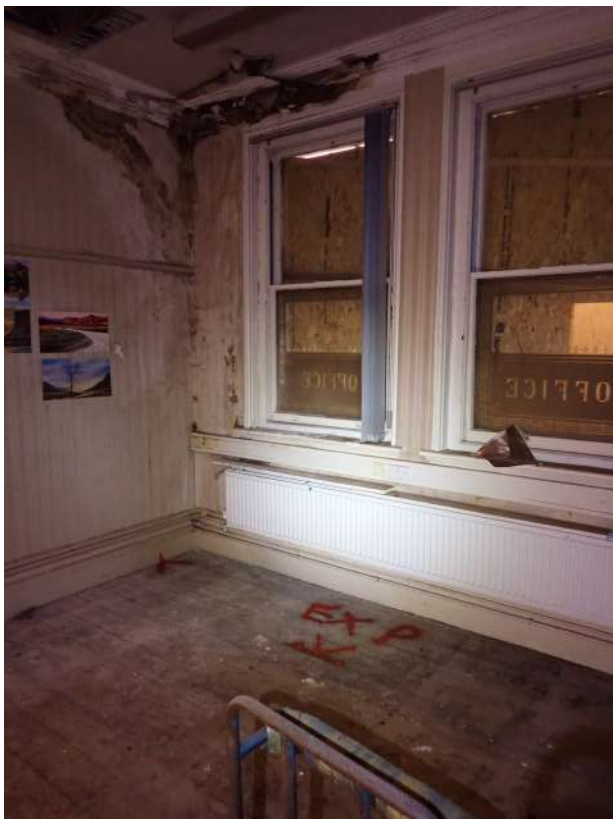
Fig 90:

Ground floor, west range; showing view towards the central room south perimeter wall. Note significant evidence for dry rot infection to south perimeter masonry. All timber elements within dry rot zone require separation from the infected masonry. Note floor exposure parameters indicated on site via water soluble red spray paint. ACMs presumed within floor void

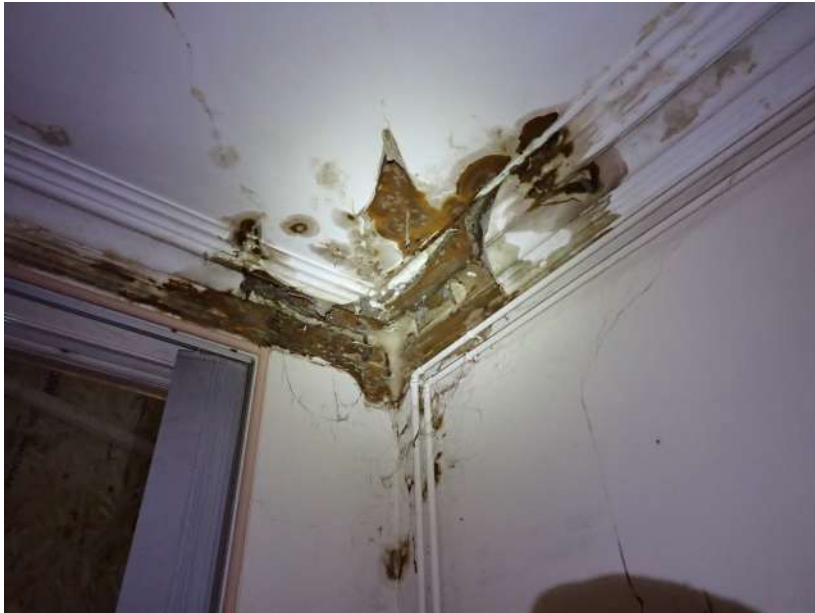
Fig 91:

Ground floor, central range; showing further evidence of historic dry rot fungus and mycelium growth visible to the underside soffit to the first floor adjacent to the south perimeter wall

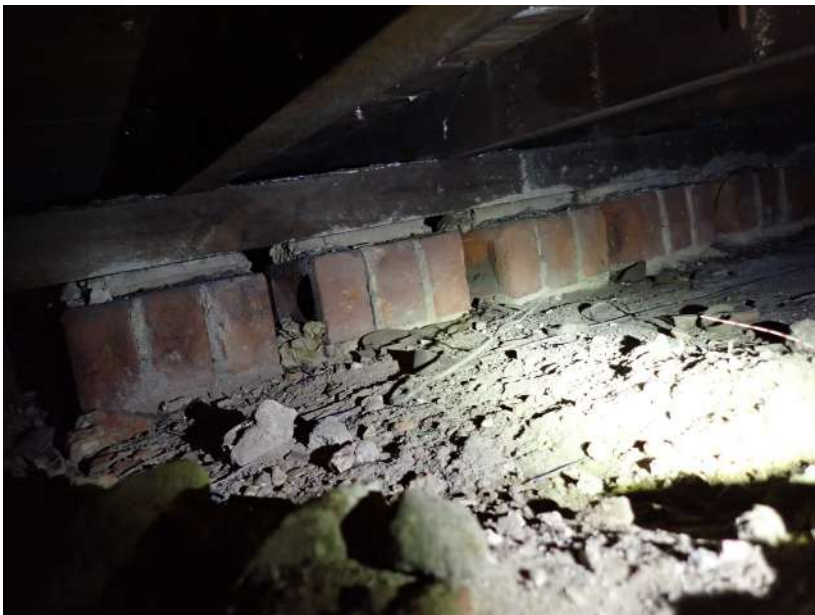
Fig 92:

Ground floor, south range; showing representative view to floor void. Note good detailing to plate dwarf wall incorporating vented openings at 1 in 3 bricks

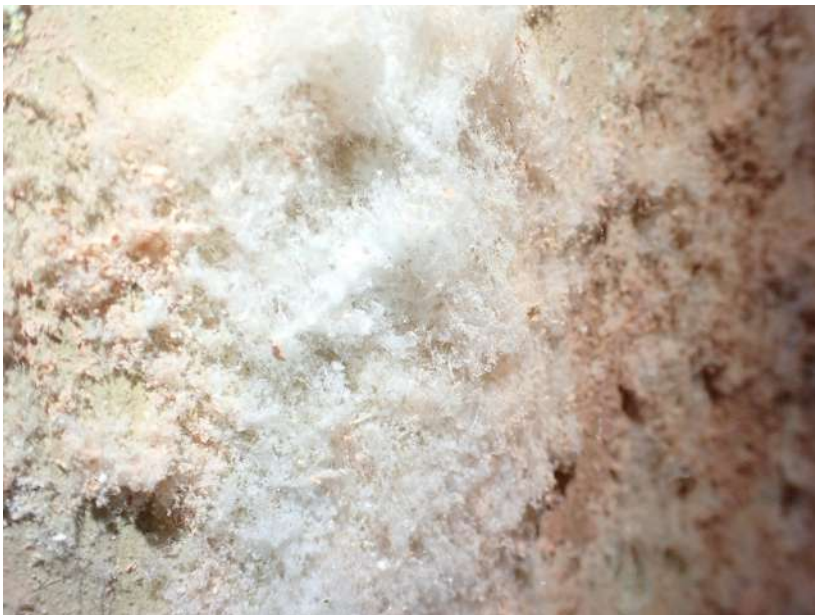
Fig 94:

Ground floor, south range; showing detailed view to the internal north corridor masonry wall subject to severe damp penetration issues causing significant salt efflorescence which is likely to damage any future finishes in contact to this wall upon refurbishment

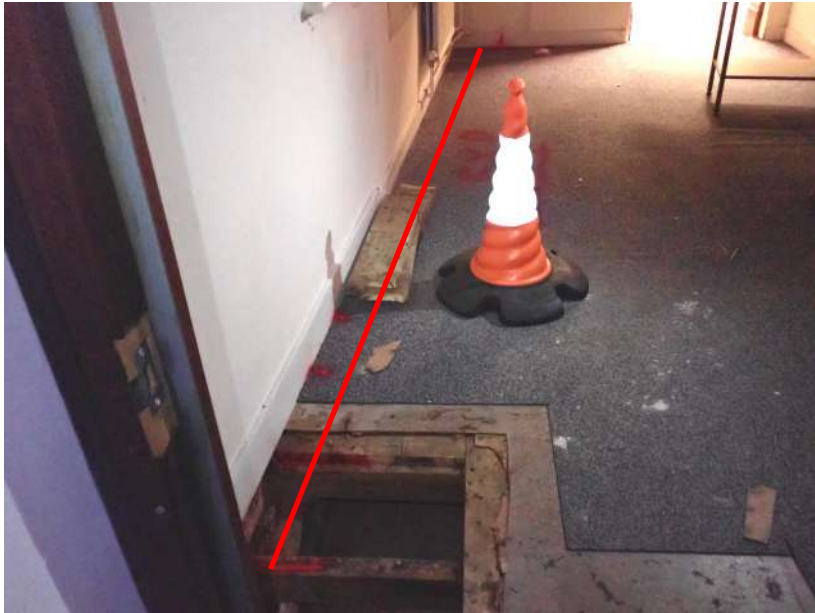
Fig 95:

Ground floor, north range; showing view towards the central corridor east perimeter wall. Note significant decay issues identified to the east perimeter timber floor structures due to apparent inadequate/blocked floor void ventilation and raised external ground levels. Decay indicated via red line. Allow for further exposure

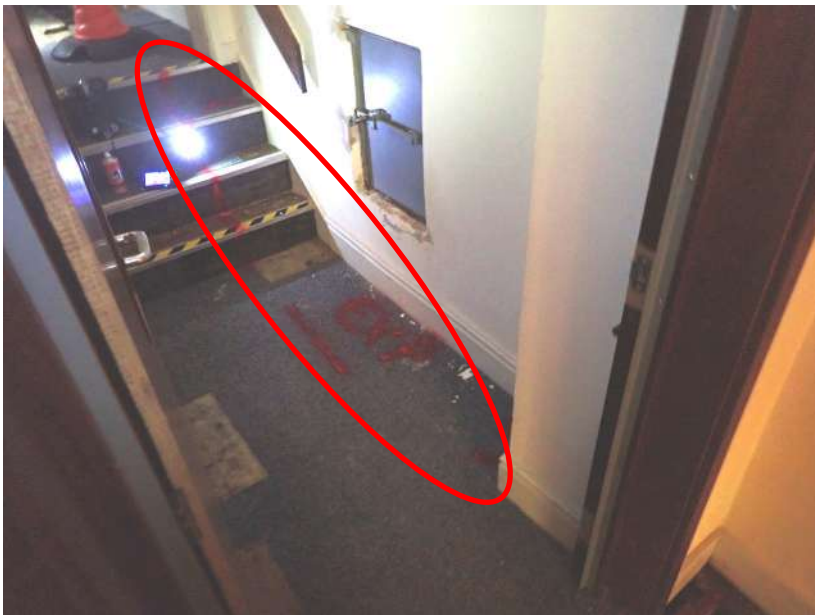
Fig 96:

Ground floor, north range; showing view towards the north-east corridor/ stair access adjacent to the east perimeter wall. Note no access at time of investigation although decay issues presumed. Allow for further exposure to determine extent of decay

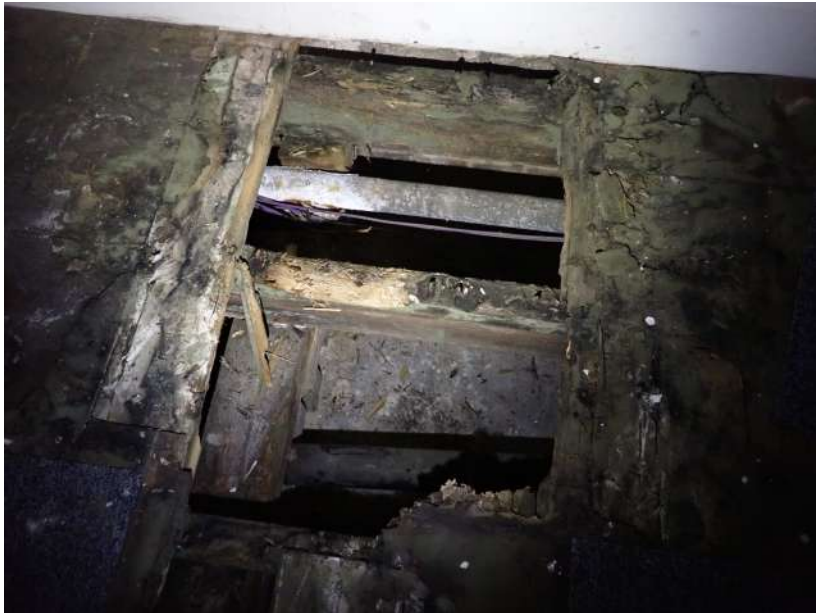
Fig 97:

Ground floor, north range; showing representative view of severe structural decay to the north-east rooms timber suspended floor. Floor structures deemed unsuitable for retention

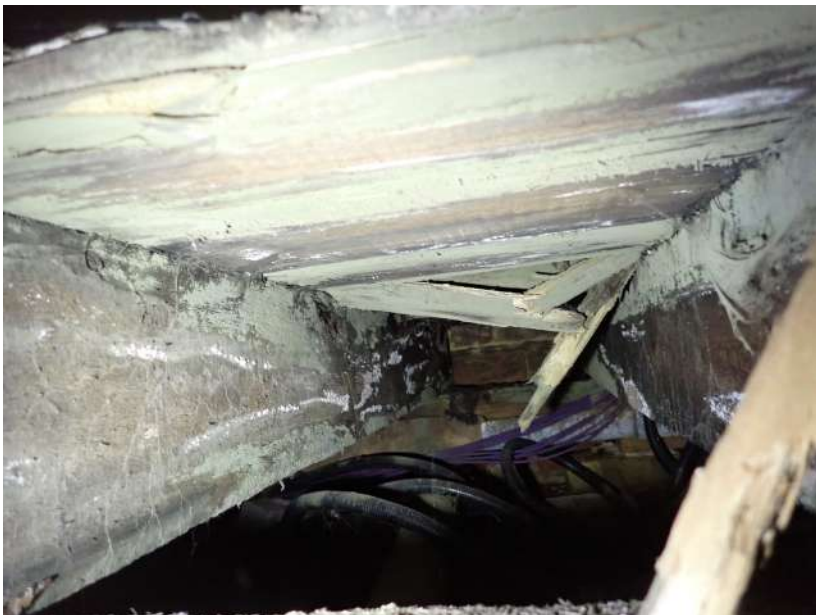
Fig 98:

Ground floor, north range; showing representative view of severe structural decay to the north-east rooms timber suspended floor as seen from within floor void. Floor structures deemed unsuitable for retention
