LOWESTOFT TOWN HALL

ROTHOUND INVESTIGATION OF DRY ROT INFECTION AND DECAY

JOB NO. 158-97

LOWESTOFT TOWN COUNCIL

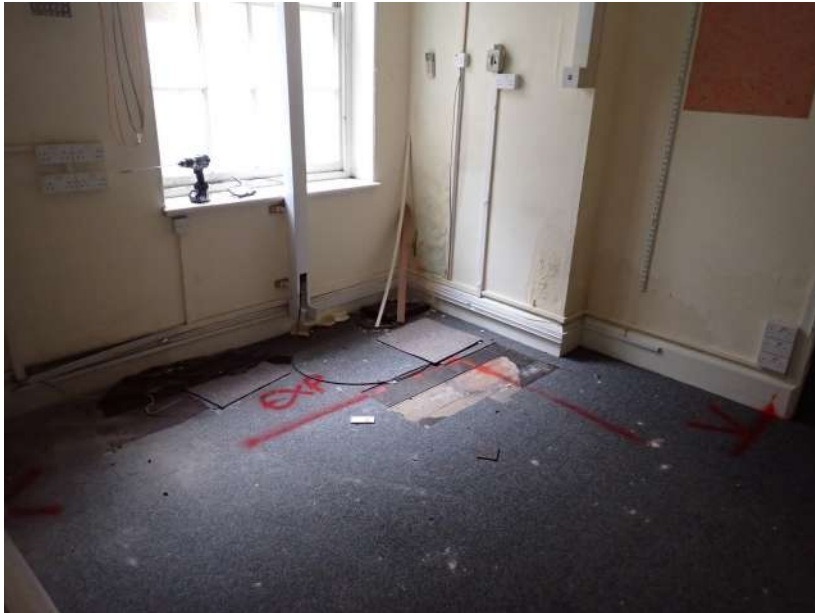
Fig 99:

Ground floor, north range; showing view towards the south rooms south lightwell perimeter wall. Note damp issues visible to masonry walls potentially indicative of decay issues to concealed timber elements including floor and lintel structures. All vulnerable inaccessible items identified for exposure/further investigations on site via water soluble red spray paint

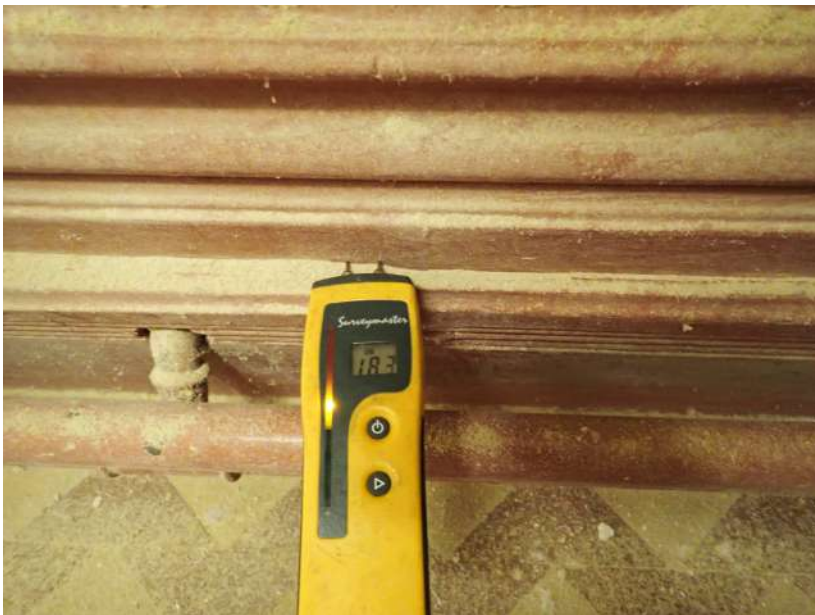
Fig 100:

Ground floor; showing indicative raised moisture content readings to historic high status skirting boards deemed vulnerable to decay issues due to improperly raised external ground levels and ground penetrating damp
