# Asbestos Report Management Survey

**Site: Belle Vue North West entrance  
Lowestoft  
Suffolk**

**On Behalf of: Lowestoft Town Council**

**Project Number: P-00116**

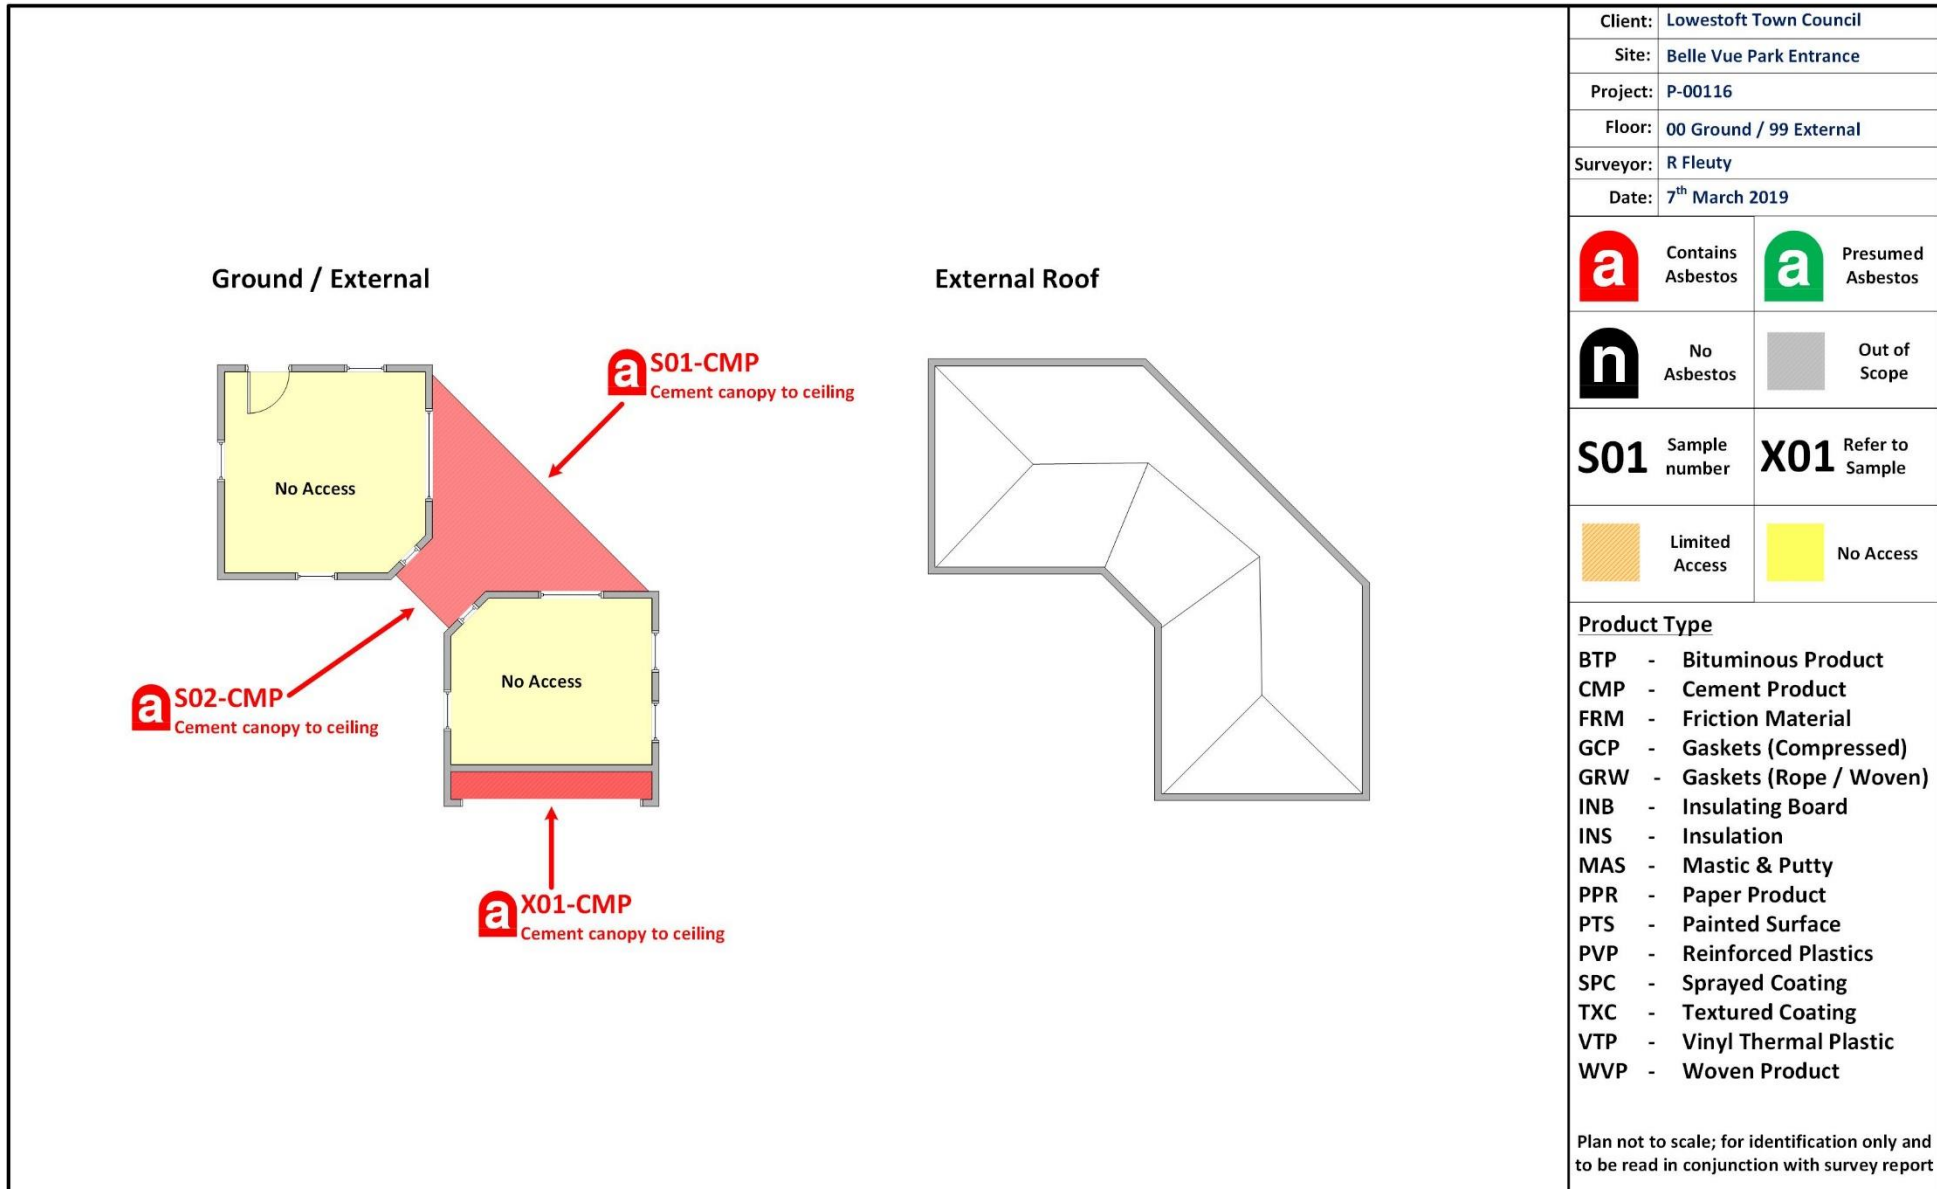
Belle Vue North West entrance / External												
Location	Sample ID	Item	Material Type	Extent	Asbestos Type	Condition	Surface Treatment	Material Score	Priority Score	Risk Rating	Recommendations	Date Reviewed
001 - External	S002-CMP	Canopy ceiling	Cement Product	8 m <sup>2</sup>	Chrysotile	Low Damage	Composite, reinforced or bonded	3	0	3 - Very Low	Manage In-Situ	
001 - External	S001-CMP	Canopy ceiling	Cement Product	8 m <sup>2</sup>	Chrysotile	Low Damage	Composite, reinforced or bonded	3	0	3 - Very Low	Manage In-Situ	
001 - External	X001-CMP	Canopy ceiling	Cement Product	3 m <sup>2</sup>	Chrysotile	Low Damage	Composite, reinforced or bonded	3	0	3 - Very Low	Manage In-Situ
