East Suffolk Drainage Board

Report to Lowestoft Town Council

Lowestoft town pond and watercourse appraisal

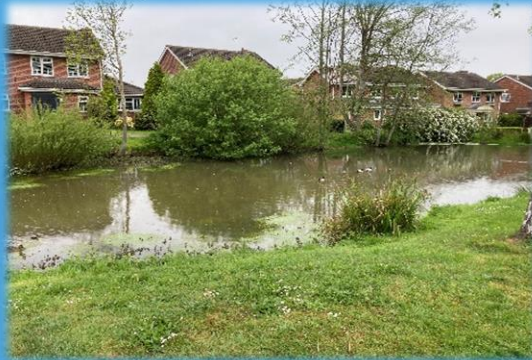
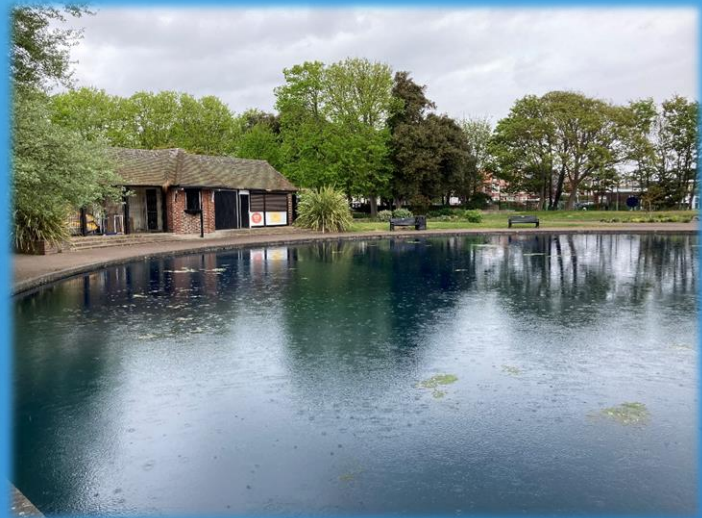
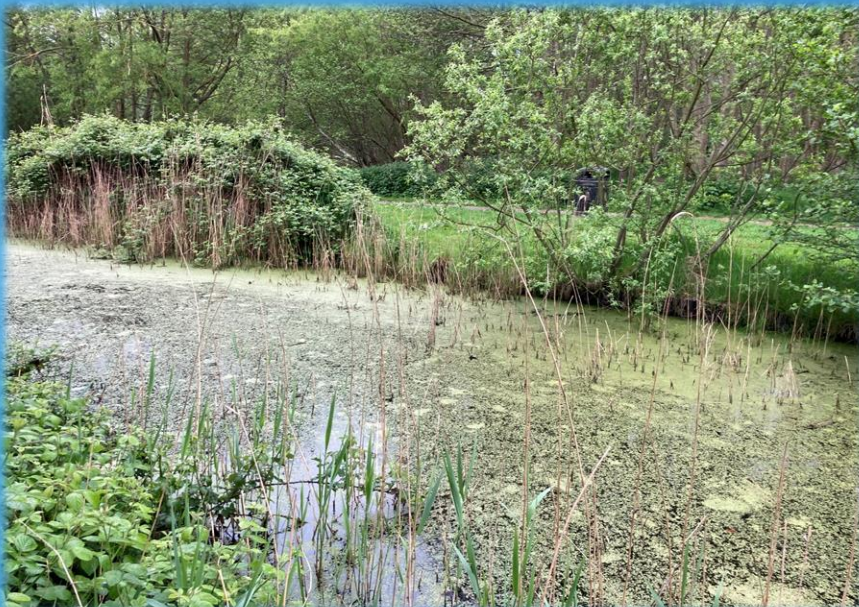
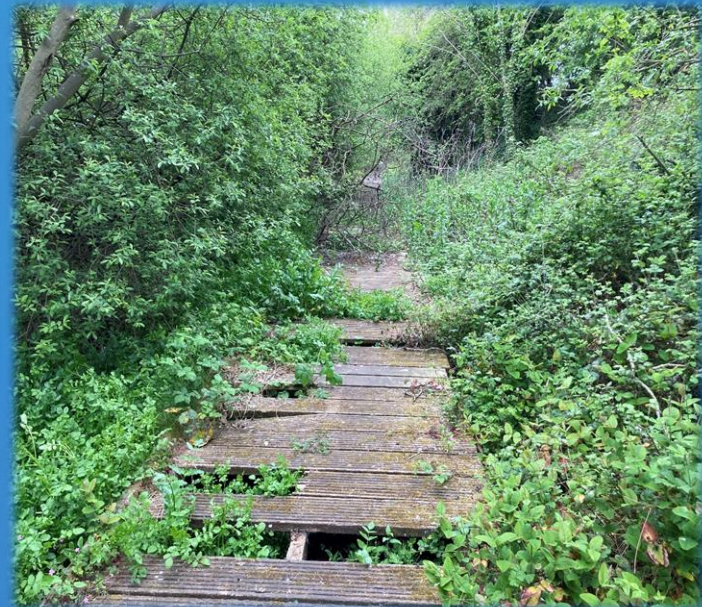
Front Cover: Gainsborough Road Pond, Kensington Gardens Boating Lake, Kirkley Fen Lake and Water Lane from site visits on 11/05/2022.
